Validation Report

Clay Borrow Pit Area
Hart Road, Loxford
New South Wales, Australia, 2326

Hydro Aluminium Kurri Kurri Pty Limited

DLH1155_H000638

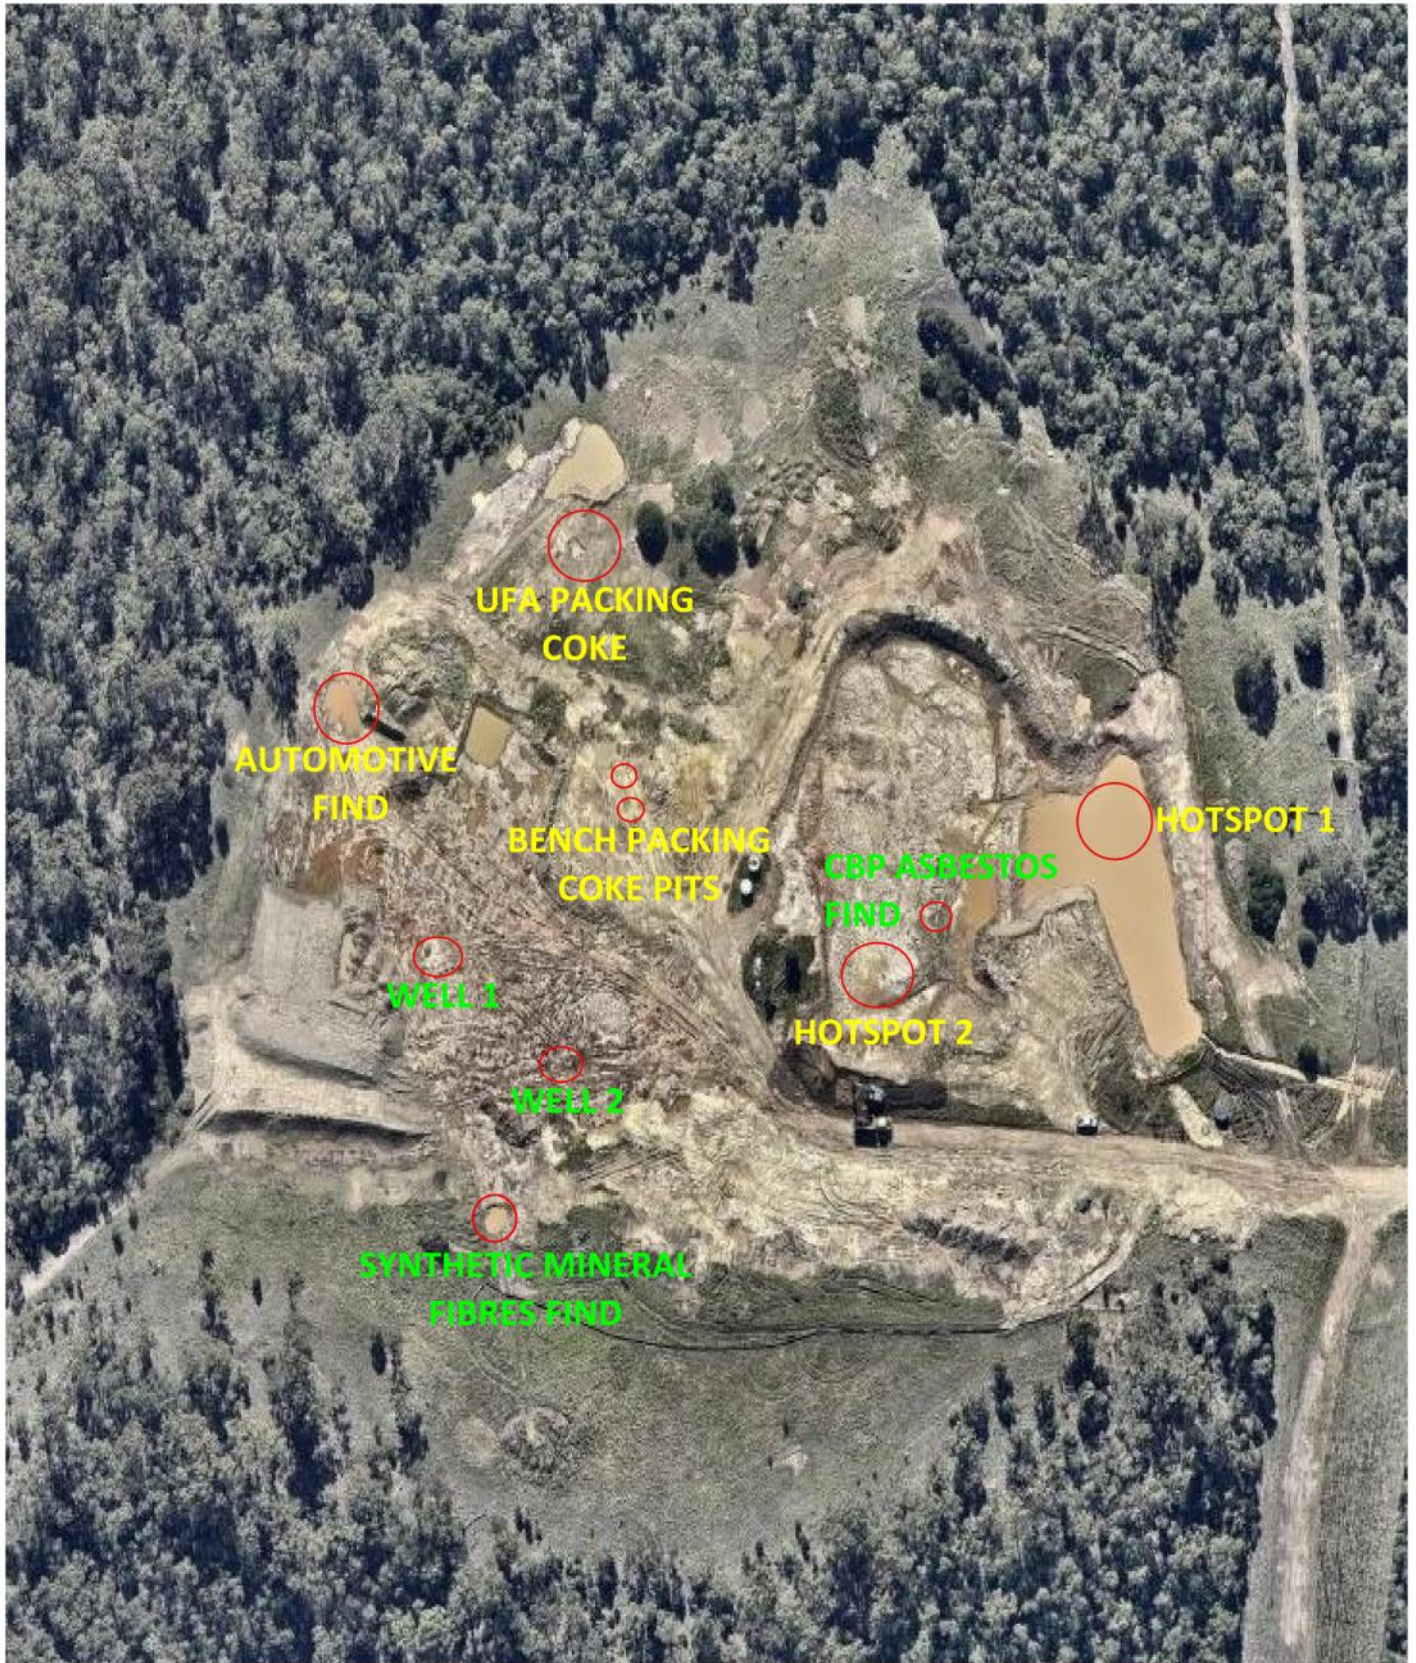
FIGURE 3 – HOTSPOT AREAS

- Asbestos Hotspot
- Area Boundary
- Chemical Hotspot

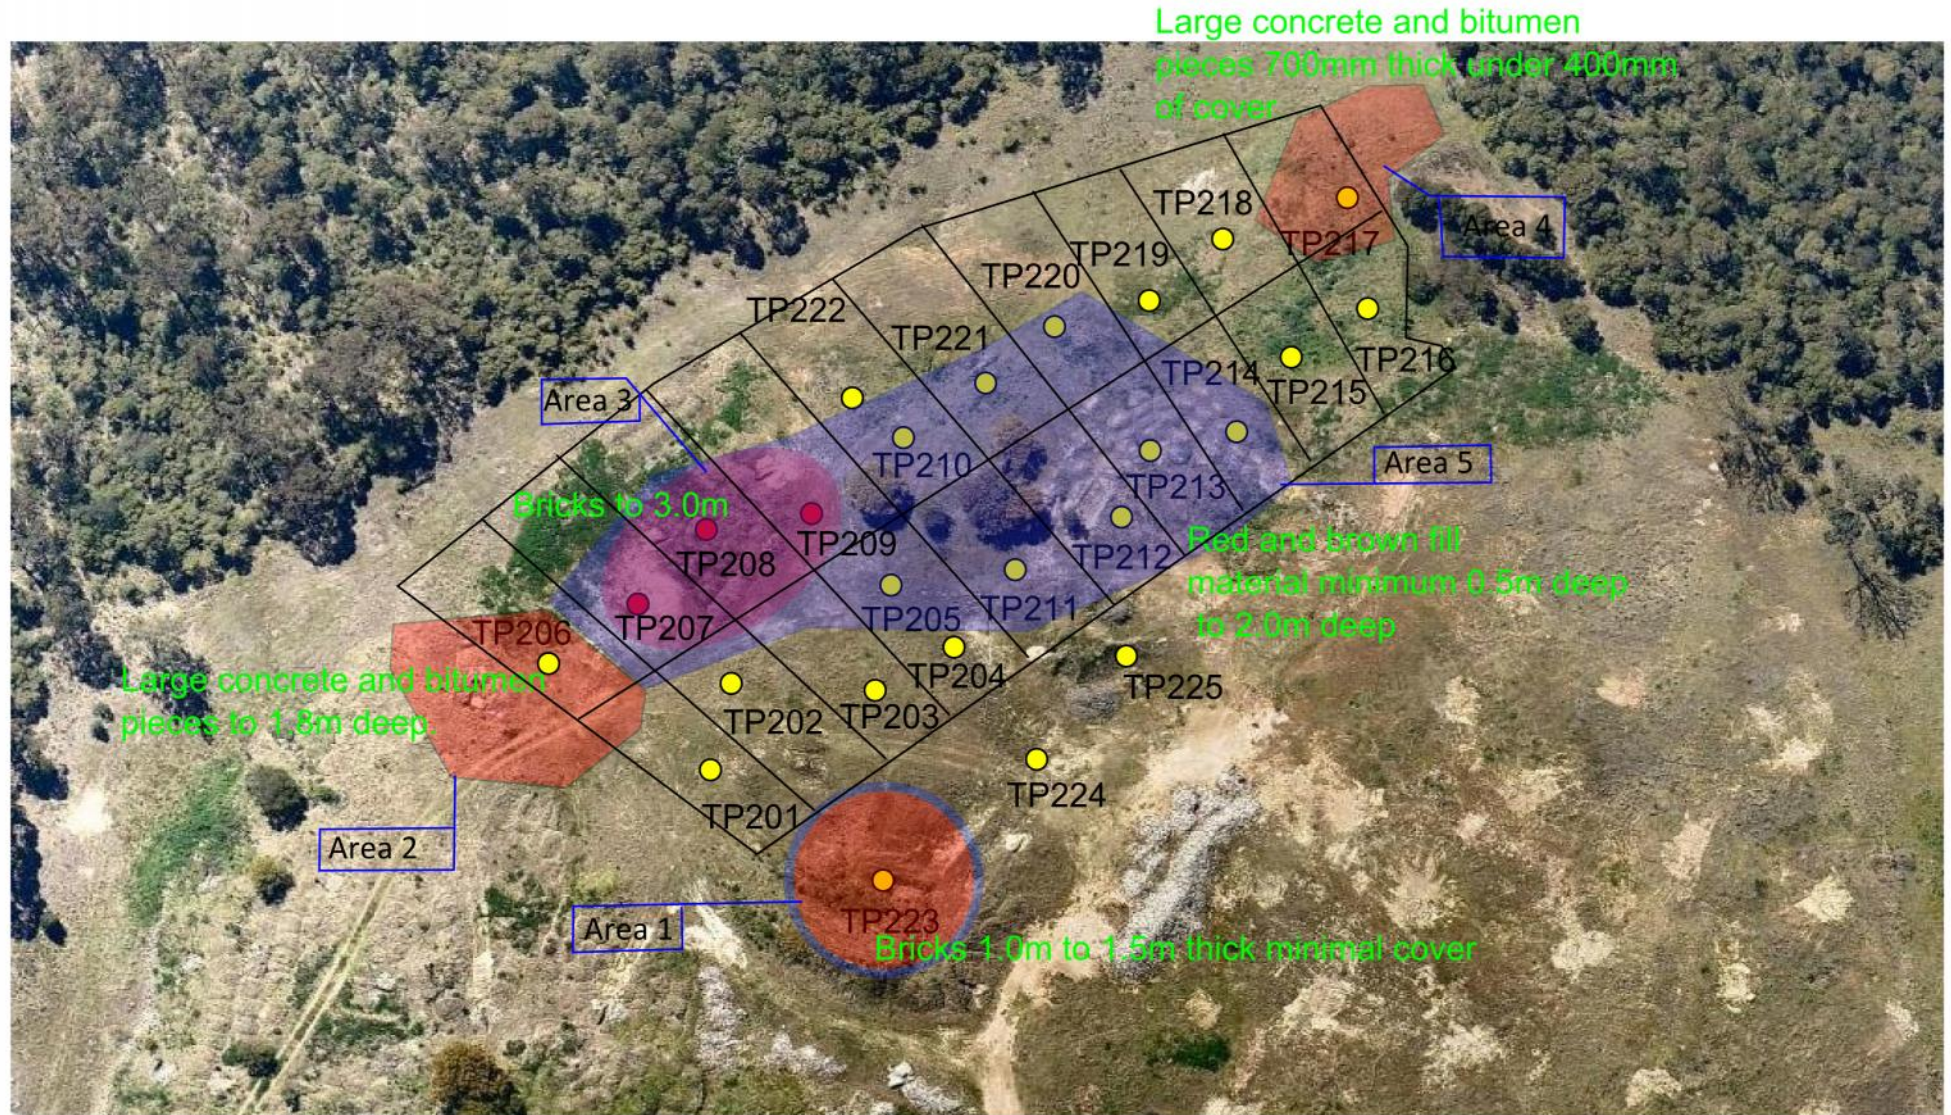
FIGURE 7 – UNEXPECTED FINDS AREA VOLUMES MAP

- **Area 2 (surrounding TP206)**
This area contains a volume of concrete and bitumen pieces at an estimated area of 720m². The concrete and bitumen pieces are found to 1.8m in depth and for the purposes of estimation averaged at 1.4m depth.

- **Area 3 (Within approximately half of TP207, TP208 and TP209)**
This area contains a volume of bulk refractory brick at an estimated area between TP207 and TP209 with a total area of 600m². The refractory brick is found between 1.0 and 3.0m in depth and for the purposes of estimation averaged at 1.4m in TP207 and TP209 and 3.0m in TP208.

- **Area 4 (Surrounding TP217)**
This area contains a volume of large concrete and bitumen pieces at an estimated area of 300m². The concrete is found in pieces to 700mm thick under 400mm of cover to a total average depth of 1.1m.

- **Area 5 (Throughout approximately half of TP206-210 and TP220-TP221, a small portion of TP202, TP203 and TP205 and all of TP211-TP214)**
This area contains a volume of red and brown fill material at an estimated area of 2450m³. The fill is found between 0.5m and 2.0m depth and for the purposes of estimation averaged at 1.5m depth.

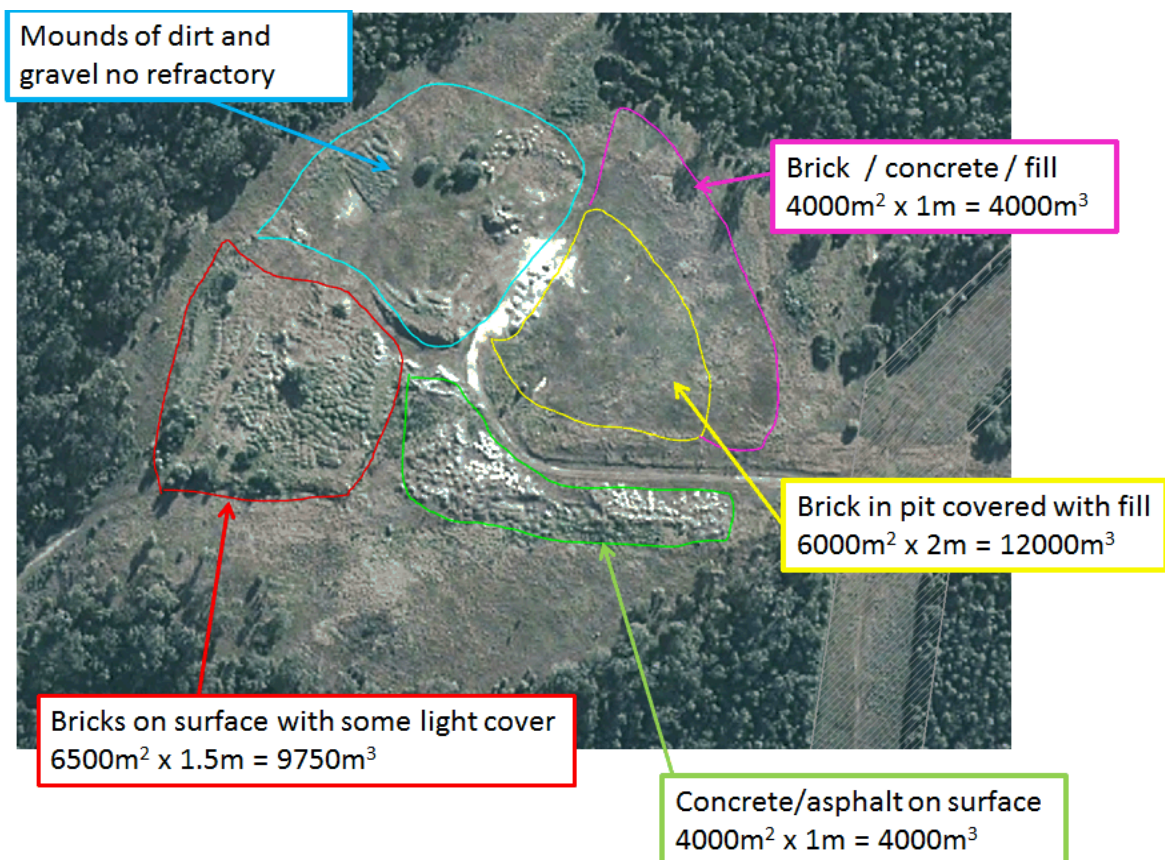
Figure 5: Estimated Material Volumes

The impacts to visual amenity identified comprise a former excavation being reinstated with smelter derived construction materials and subsequently stockpiling of these materials across an area adjacent to the filled excavation.
