Phase 1 ESA, Hydro Kurri Kurri Aluminium Smelter

Prepared for:
Hydro Aluminium Kurri Kurri Pty Ltd

Prepared by:
ENVIRON Australia Pty Ltd

Date:
22 October 2013

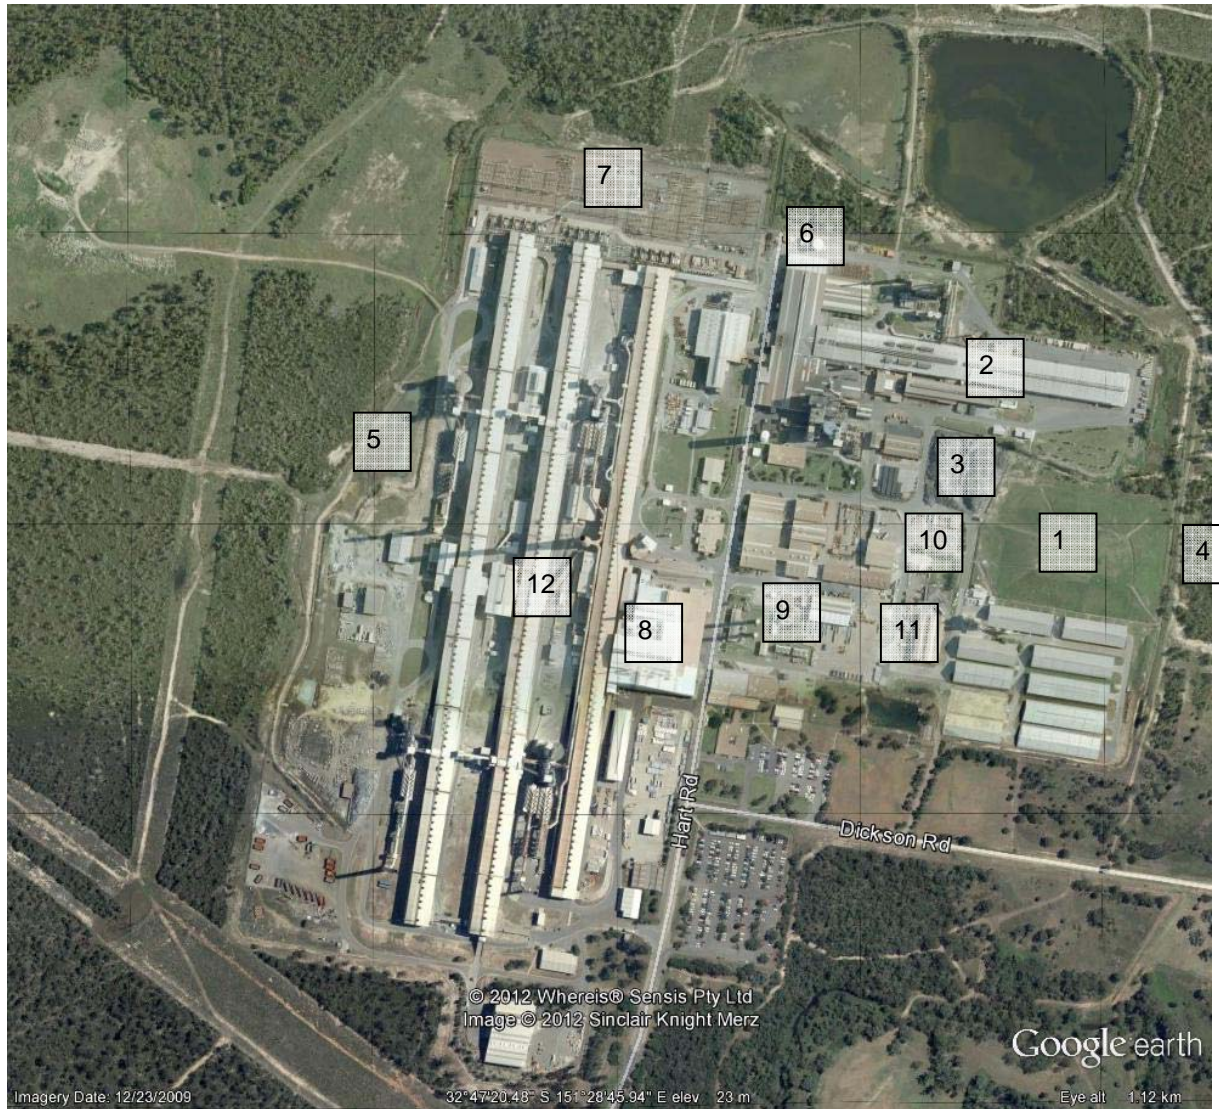
- 1 Alcan Mound
- 2 Carbon Plant
- 3 Anode Waste Pile
- 4 East Surge Pond and associated drainage
- 5 West Surge Pond
- 6 Diesel Spray Area
- 7 Switch yard
- 8 Most Buildings (Asbestos/ SMF)
- 9 Diesel Refuelling Area
- 10 Washdown Bay
- 11 Flammable Liquids Store
- 12 Pot Lines
