Phase 2 Environmental Site Assessment, Smelter Site, Additional Investigations

Prepared for:
Hydro Aluminium Kurri Kurri Pty Ltd

Prepared by:
ENVIRON Australia Pty Ltd

Date:
16 January 2015

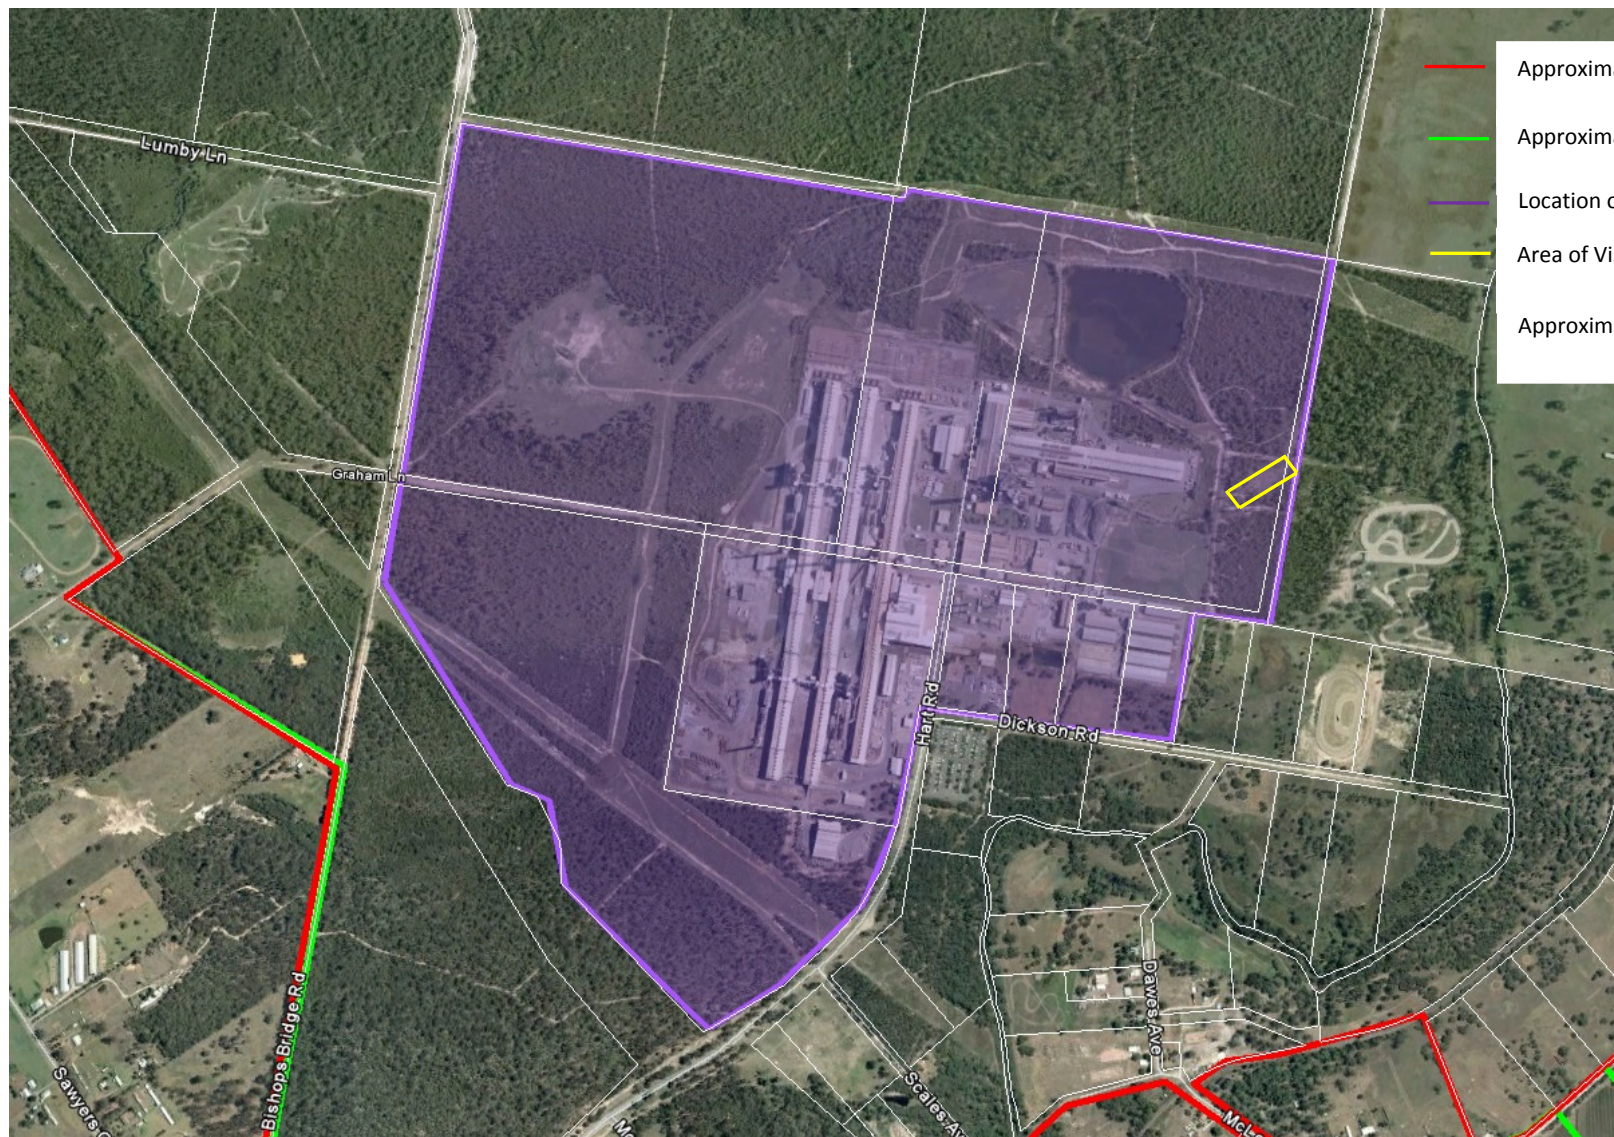
During site visits conducted by ENVIRON throughout 2012, 2013 and 2014, visible signs of plant stress were observed down gradient of the Capped Waste Stockpile near the eastern site boundary, as shown in **Figure 2**. The plant stress is likely due to a perched fluoride and

- Approximate Location of land owned by Hydro
 - Approximate Location of Buffer Zone
 - Location of Smelter Site
 - Area of Visible Plant Stress
- Approximate Scale 1cm:130m

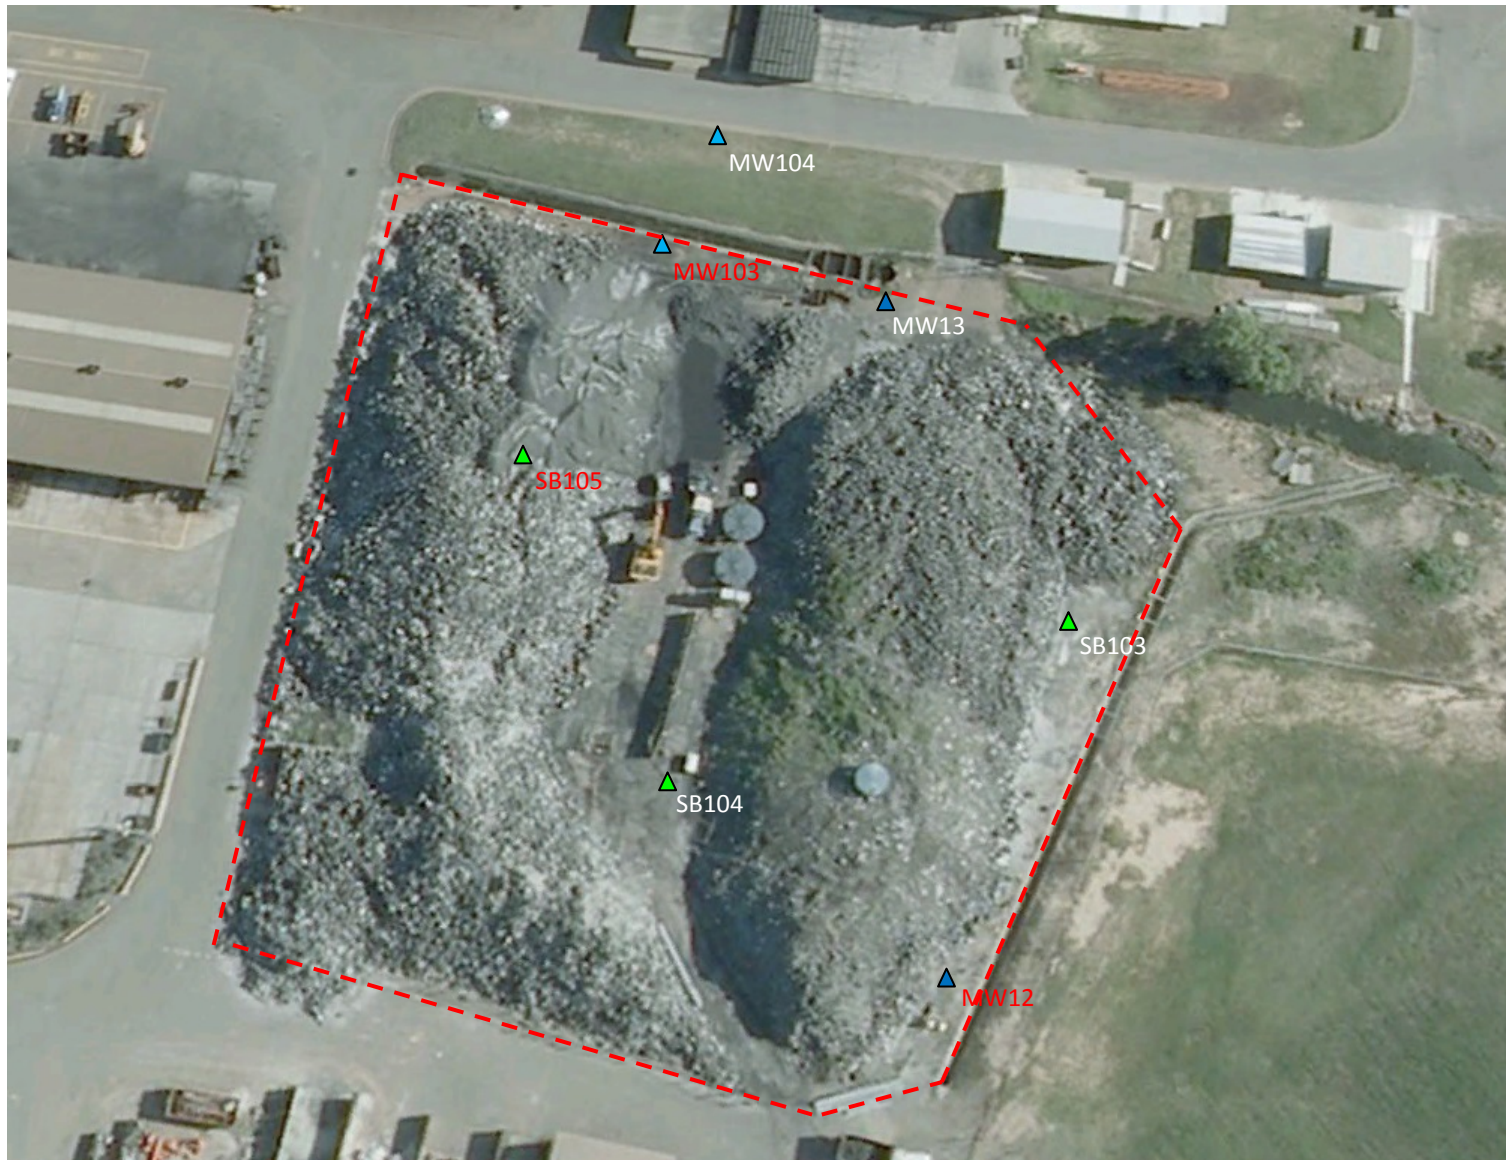
- ▲ 2014 groundwater well locations
 - ▲ 2014 soil sampling locations
 - ▲ 2012 groundwater well and soil sampling locations
 - MW103 Soil sampling locations with PAHs > guidelines
 - - - Approximate extent of soil contamination
- Approximate Scale 1cm:5m

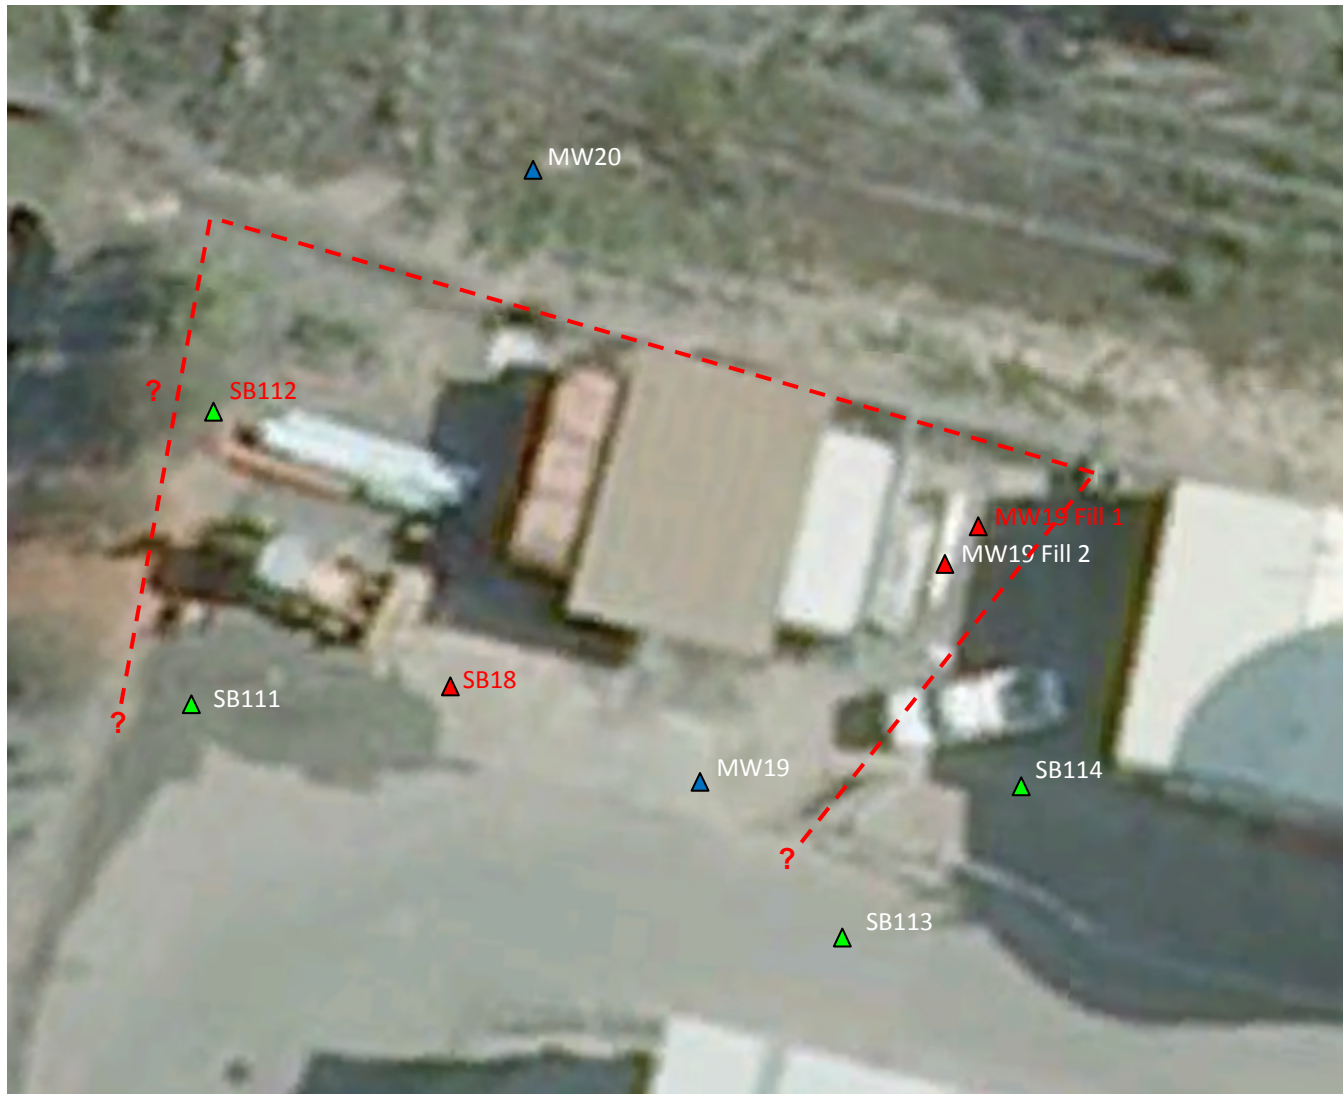
- ▲ 2014 soil sampling locations
 - ▲ 2012 groundwater well locations
 - ▲ 2012 soil sampling locations
 - ▲ Soil sampling locations with PAHs > guidelines
 - Likely extent of soil contamination
- Approximate Scale is 1cm:1.5m

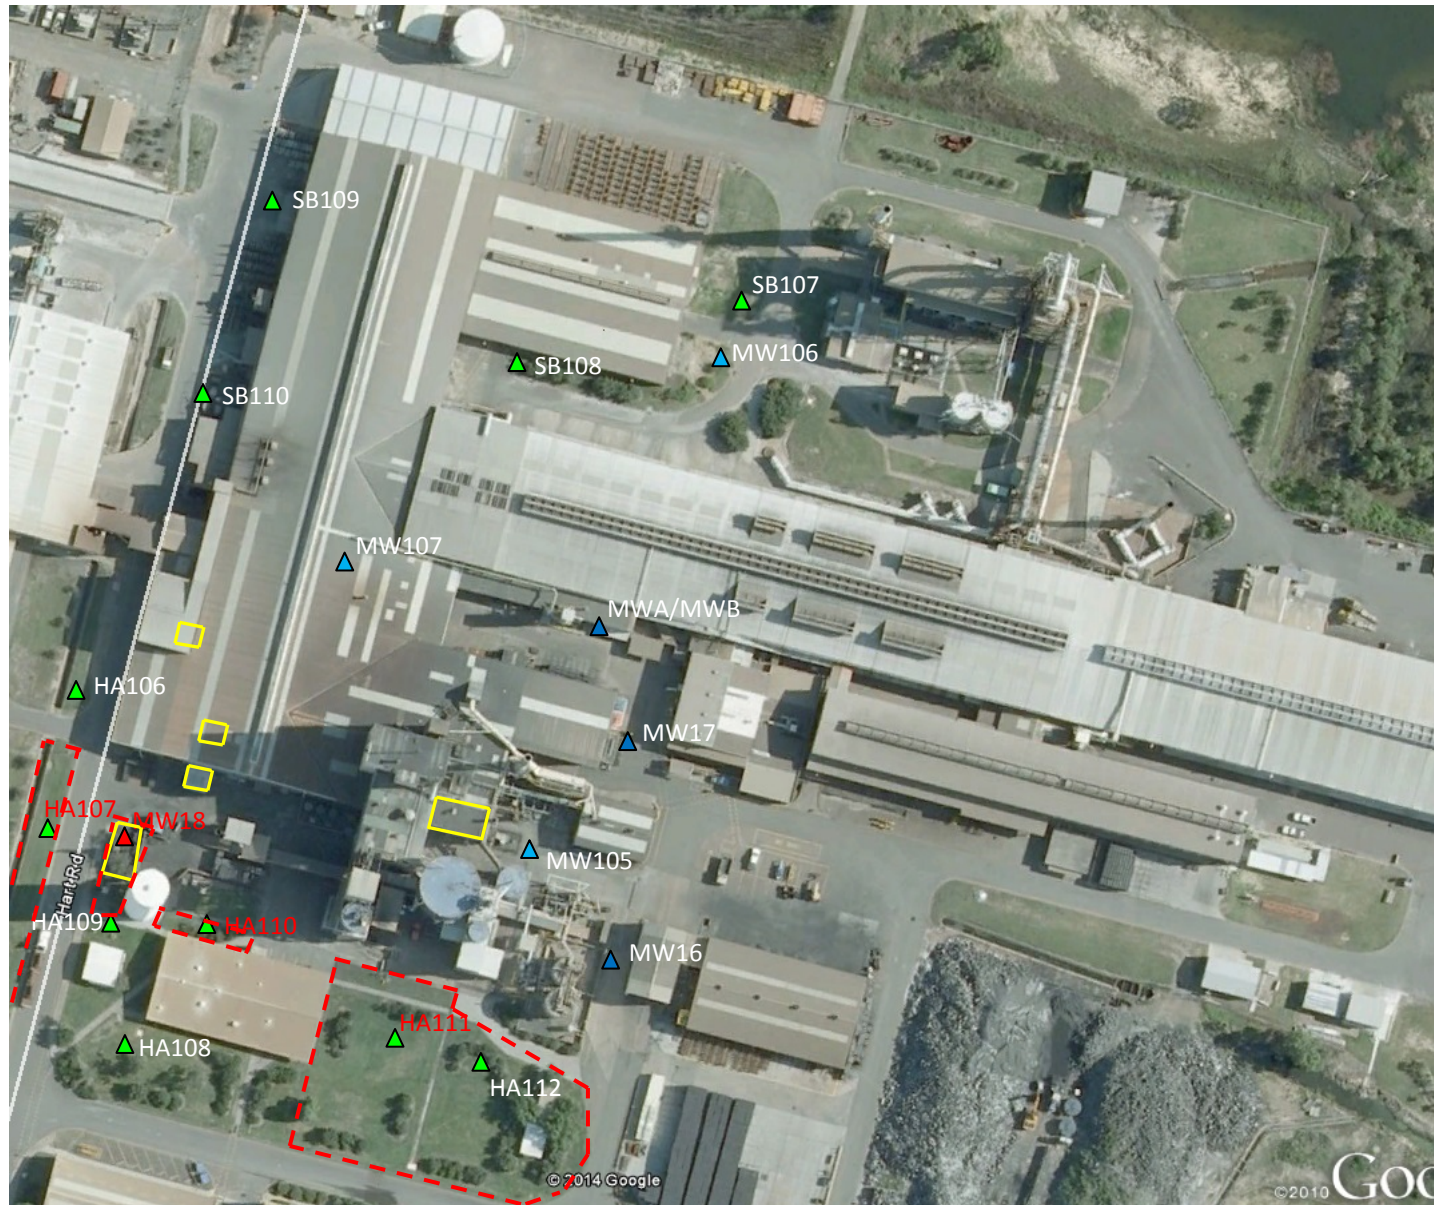
- ▲ 2014 groundwater well locations
 - ▲ 2014 soil sampling locations
 - ▲ 2012 groundwater well locations
 - ▲ 2012 soil sampling locations
 - HA111 Soil sampling locations with PAHs > guidelines
 - Areas of visible staining
 - - - Approximate extent of shallow soil contamination
- Approximate Scale 1cm:12m

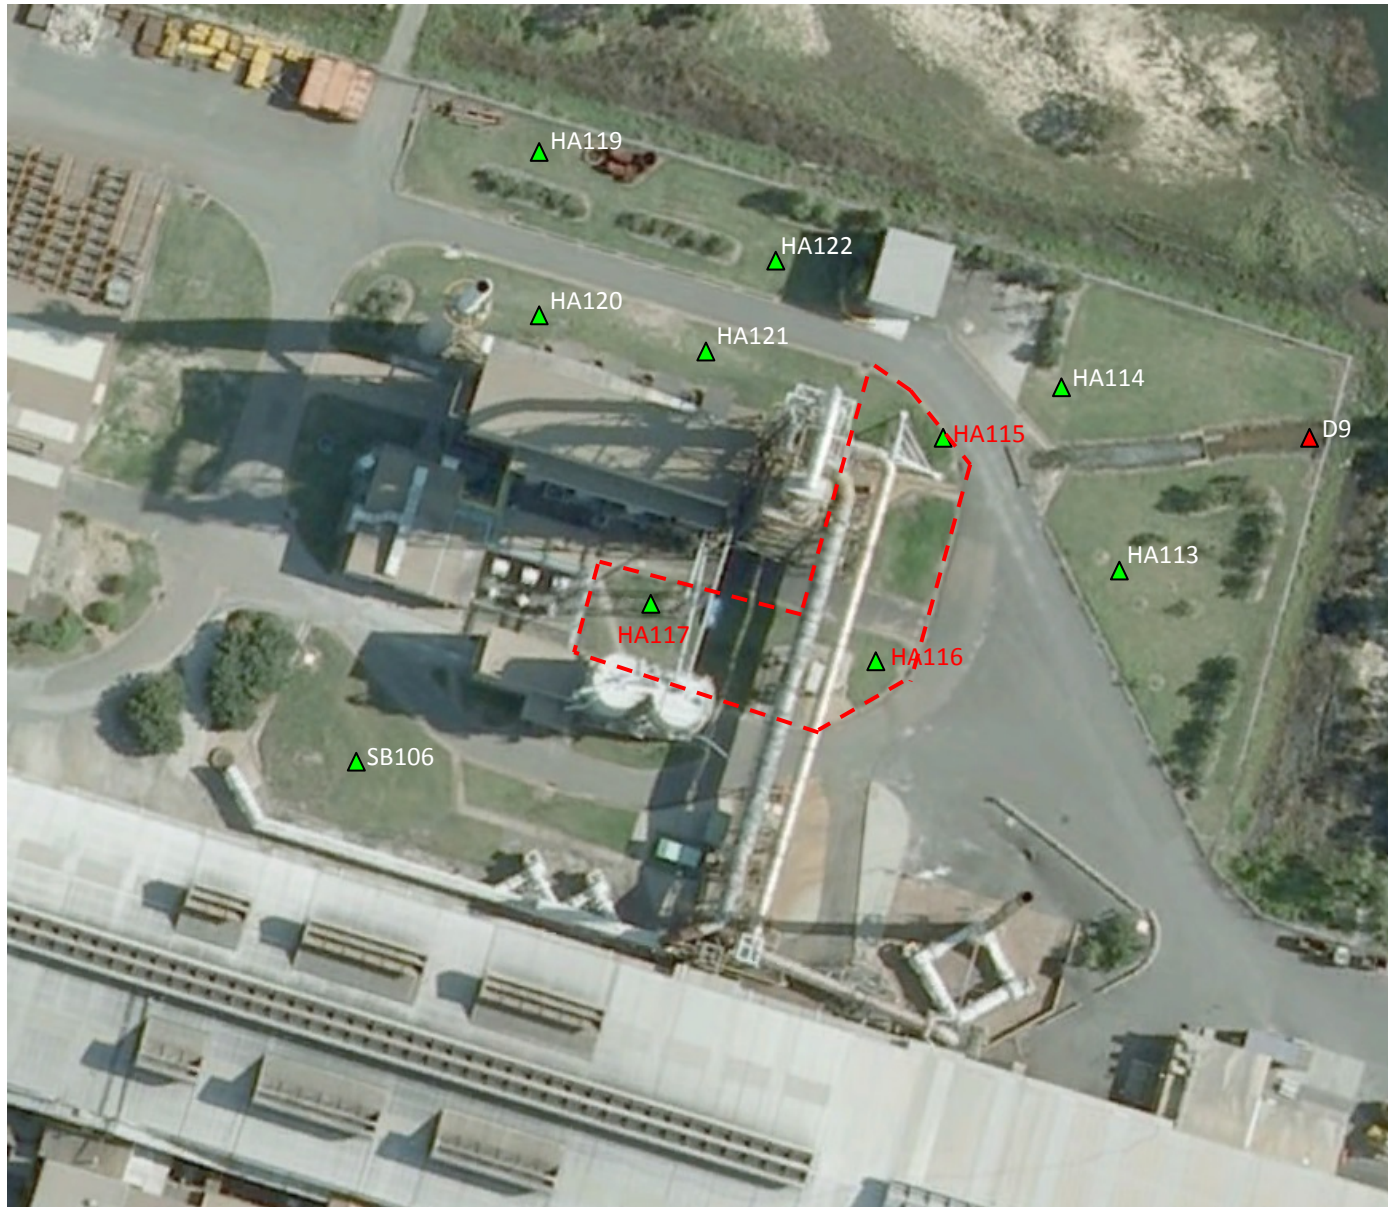
- ▲ 2014 soil sampling locations
 - ▲ 2012 soil sampling locations
 - HA116 Soil sampling locations with PAHs > guidelines
 - - - Approximate extent of shallow soil contamination
- Approximate Scale 1cm:5m

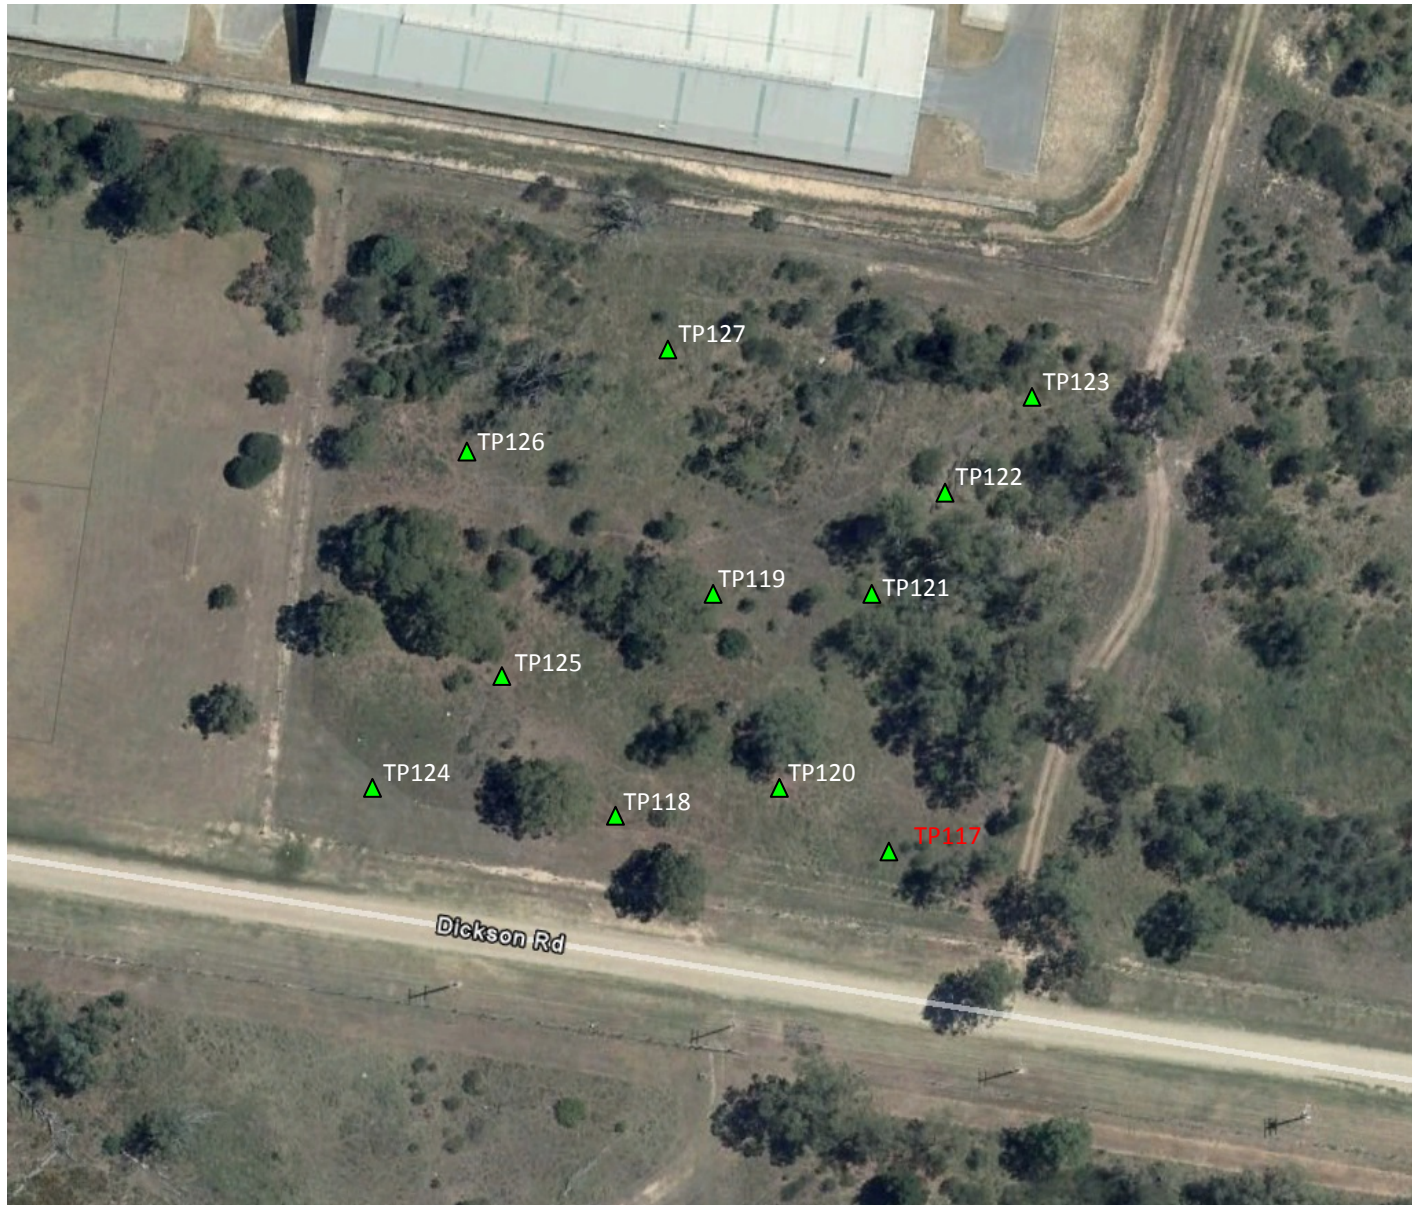
▲ 2014 soil sampling locations

TP117 Soil sampling location with PAHs > guidelines

Table 10.3: Recommended Remediation						
No.	PAEC	Approximate Volume (m³)	Media	Contaminants	Mechanism for Contamination	Remediation Required
8	Carbon Plant (western end only)	Approximately 1000m ³	Accessible soil	PAHs	Accumulation of PAHs associated with dust from the Carbon Plant.	-Remediation of PAH contaminated shallow soils in garden beds and grassed areas to the south of the western end of the Carbon Plant.
26	Bake Furnace Scrubber	Approximately 1,000m ³	Soil	PAHs	Accumulation of waste from the scrubber in surface soils.	- Delineation and remediation of the PAH hot spot at HA115 -Remediation of PAHs in surface soils in grassed areas beneath the scrubber duct work.
29	Area East of Playing Fields	Approximately 10,000m ³	Soil	PAHs	Burial of wastes in fill.	-Excavation and segregation of wastes for recycling and disposal to remove aesthetic impacts) -Validation of the removal of the PAH hot spot from test pit TP117
