**APPENDIX 3
EXISTING PRACTICES FOR LEGACY ALUMINIUM SMELTER LANDFILLS**

A3.1 Existing Management Practices

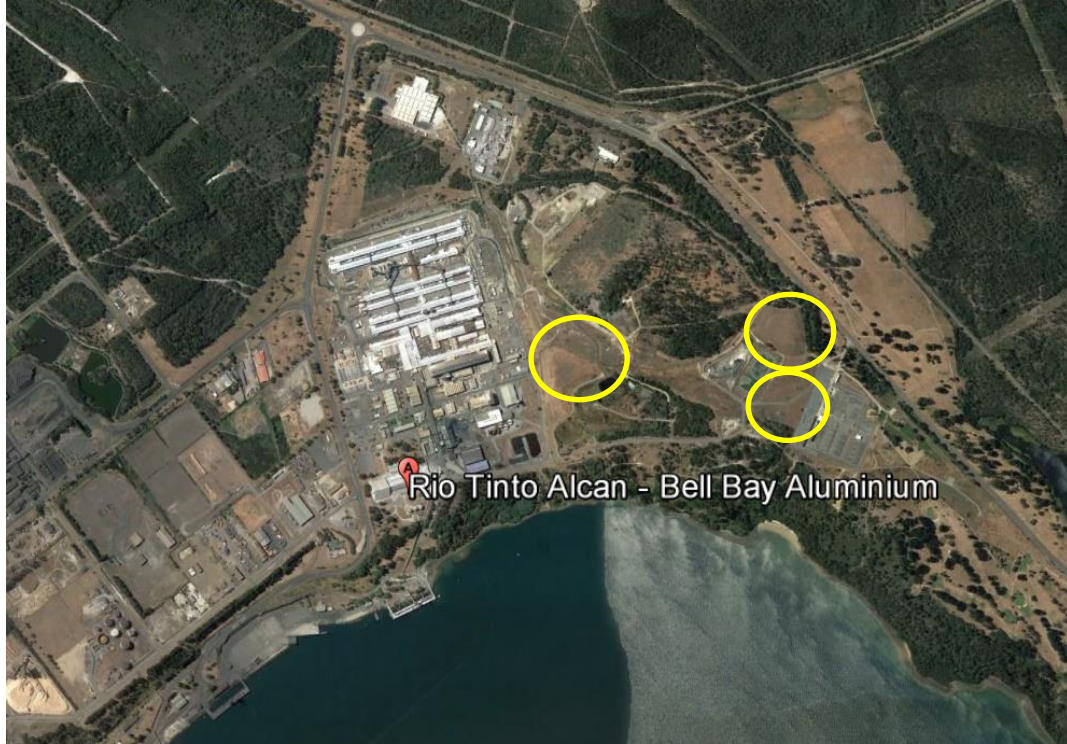
Photo A3.1: Bell Bay Smelter Waste Stockpiles and Landfills (Source: Google Earth, 2017)

Pacific Aluminium Bell Bay had a number of smelter waste stockpiles (including spent pot lining) and landfills that were consolidated in the mid 1990's within three purpose built containment cells (see **Photo A3.1**). In October, 1994 the Director of Environmental Management of the (now) Tasmania Environment Protection Authority (Tasmania EPA) provided a Letter of Approval (in principle) for the relocation of SPL to multiple sealed stockpiles. This 'in principle' approval was given in lieu of the Final Environmental Project Evaluation Spent Pot Lining Encapsulation Report, which was to clarify engineering details, hydrology and geology of wetlands, water balance of the system, and review of groundwater boreholes.

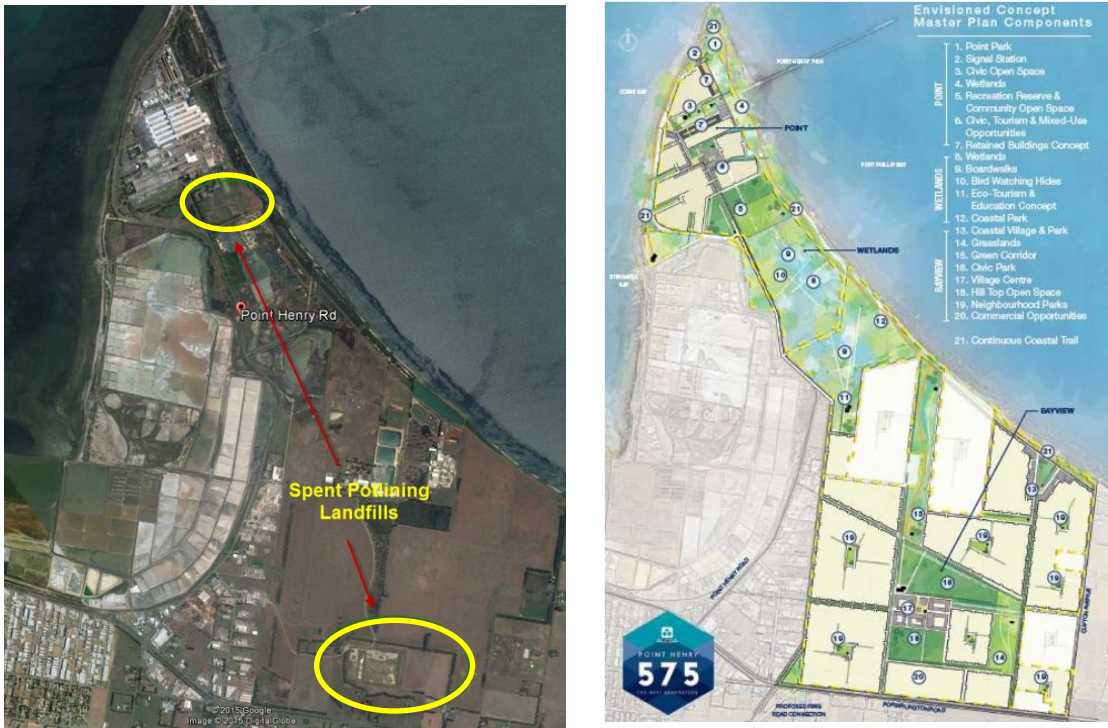
Photo A3.2: Alcoa Point Henry Capped Mixed Smelter Waste Stockpiles and Envisioned Concept Master Plan Components (Source: Alcoa, 2016)

From information available on the Alcoa Point Henry website Point Henry has a number of capped waste stockpiles and landfills, some that included mixed smelter wastes. This available information indicates that Alcoa intends to retain these capped stockpiles and landfills *in situ* as part of the site closure plans and future redevelopment and reuse (see **Photo A3.2**).

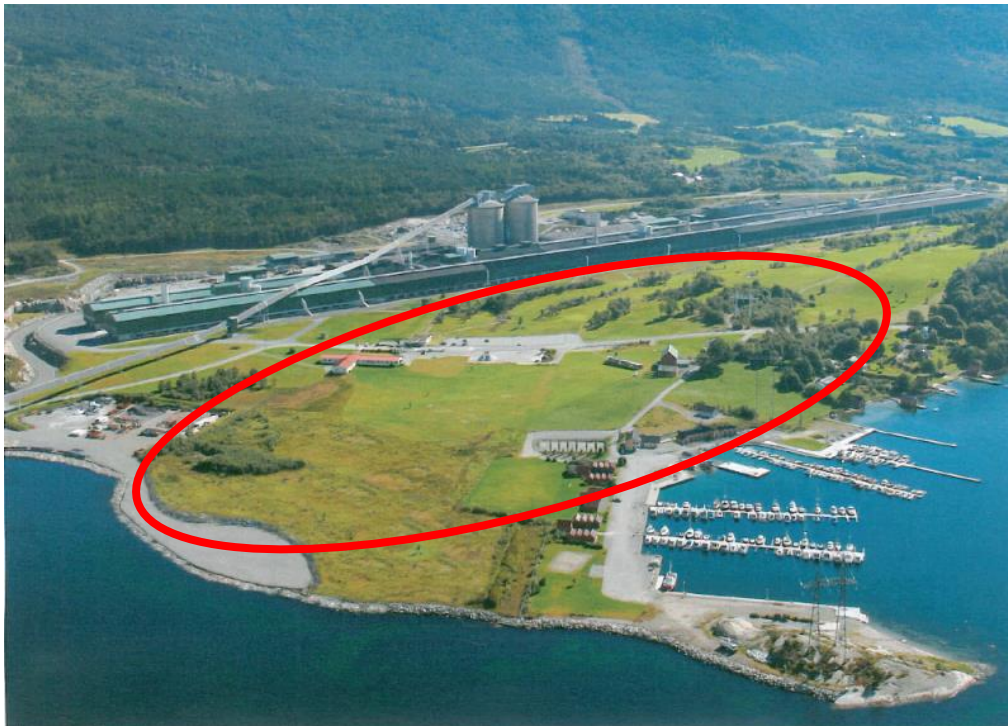
Photo A3.3: The rehabilitated Hydro Husnes mixed aluminium smelter waste location

A golf course and marina were constructed on the former landfill (as shown in **Photo A3.3**). Due to the positive results of monitoring in the fjord adjacent to the landfill and the surrounding area there are no fishing or farming restrictions.
