Plume Delineation Report, Capped Waste Stockpile

Prepared for:
Hydro Aluminium Kurri Kurri Pty Ltd

Prepared by:
ENVIRON Australia Pty Ltd

Date:
16 September 2016

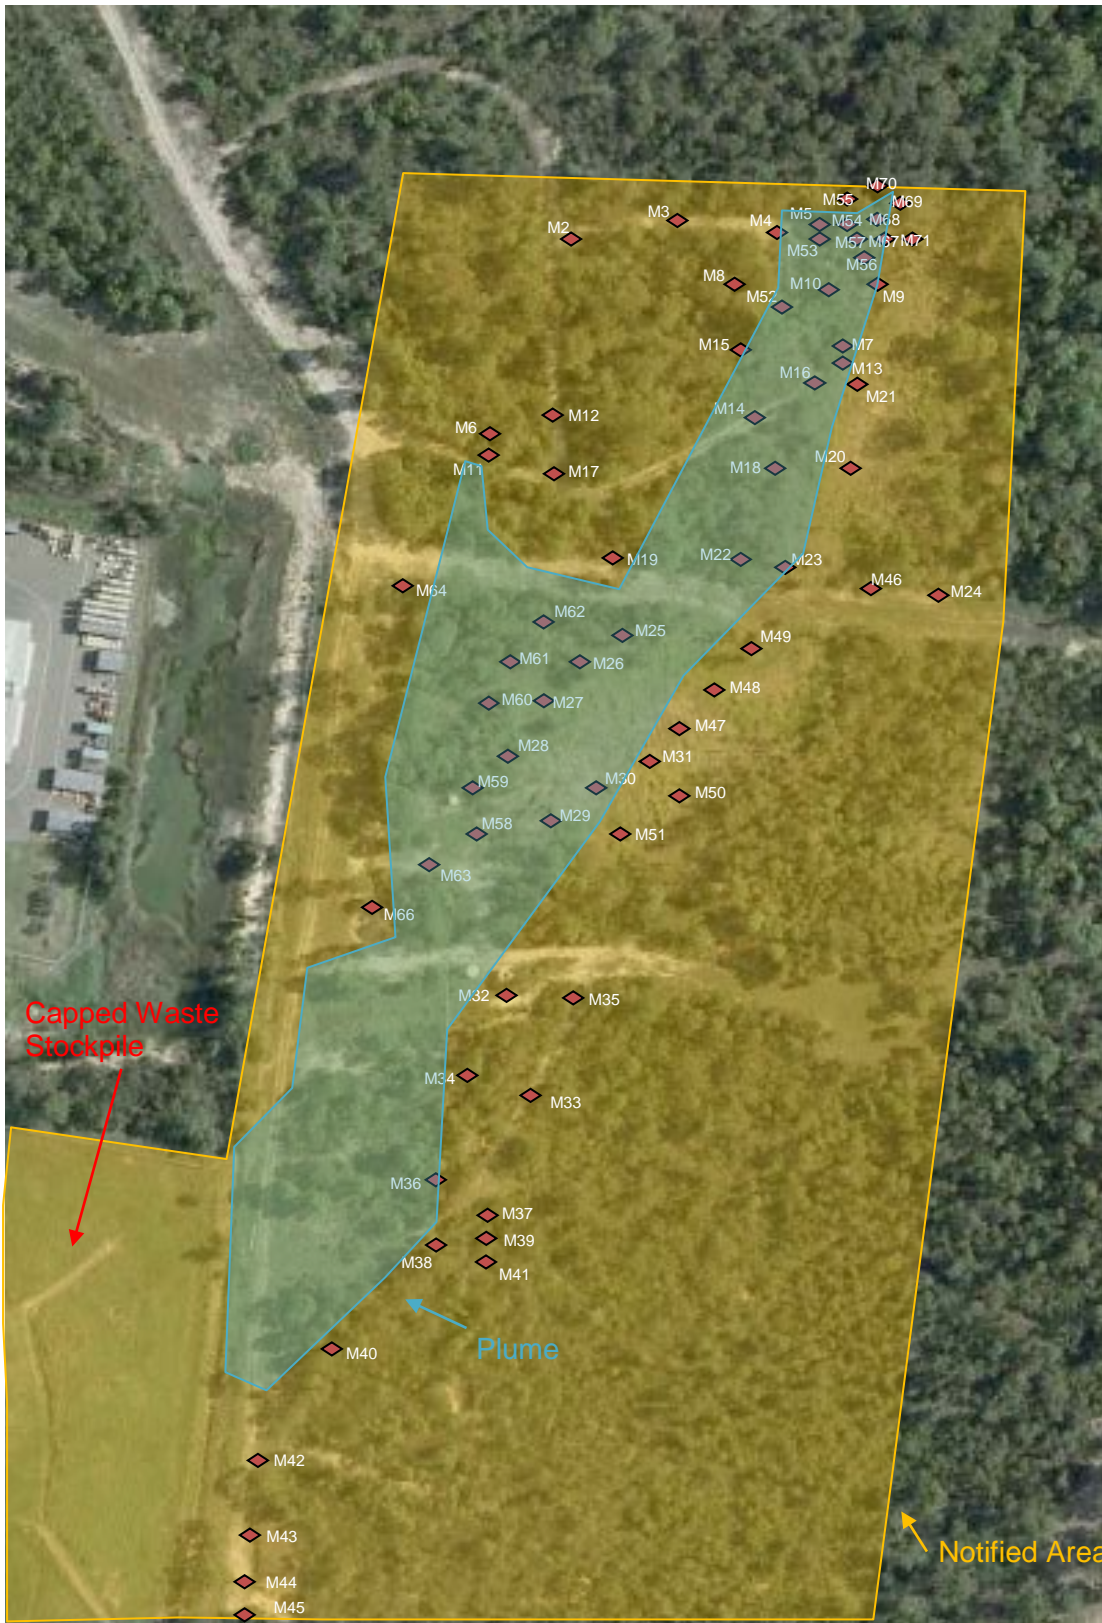
Stage 1 Hand Auger Hole Locations and Plume Delineation

◆ Location of Hand Auger Holes

Field investigations involved the use of a hand auger to auger to as deep as possible below groundwater (depths achieved were between 0.5m and 2m), depth to groundwater measured and the soil profile logged. A stainless steel probe will be driven into the ground beside the hand auger hole to depths equal to the top of the water table and a groundwater sample will be collected from a Teflon tube with a pH reading taken and the colour of the water noted. This information provided a depth profile of the near surface groundwater across the areas of investigation. The northern, eastern and southern edges of the plume were delineated in this manner, with the completion of 70 locations.

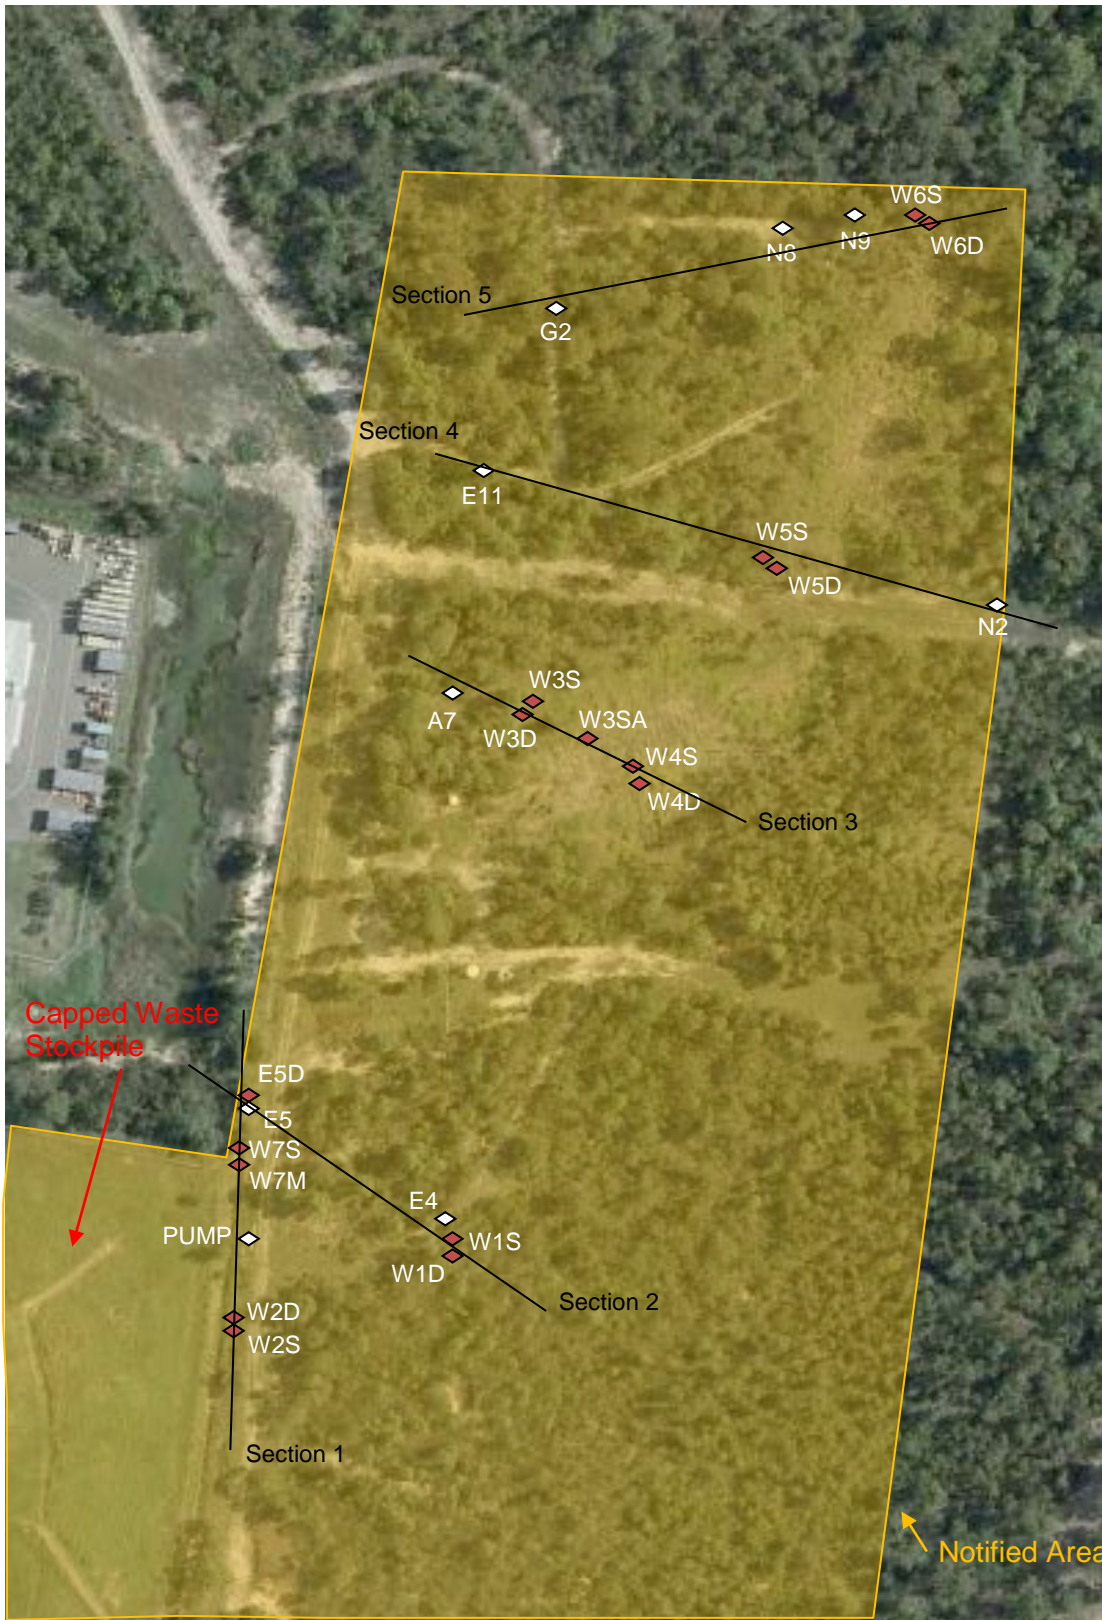
New Groundwater Well Locations

- ◆ New Wells
- ◇ Existing Wells for Quarterly Sampling
