Site Audit Report and Site Audit Statement for the Remedial Action Plan, Hydro Aluminium Kurri Kurri Smelter Site Audit

Part B2 - Appropriateness of RAP for Smelter Area

Client: Hydro Aluminium Kurri Kurri Pty Ltd

AECOM Australia Pty Ltd

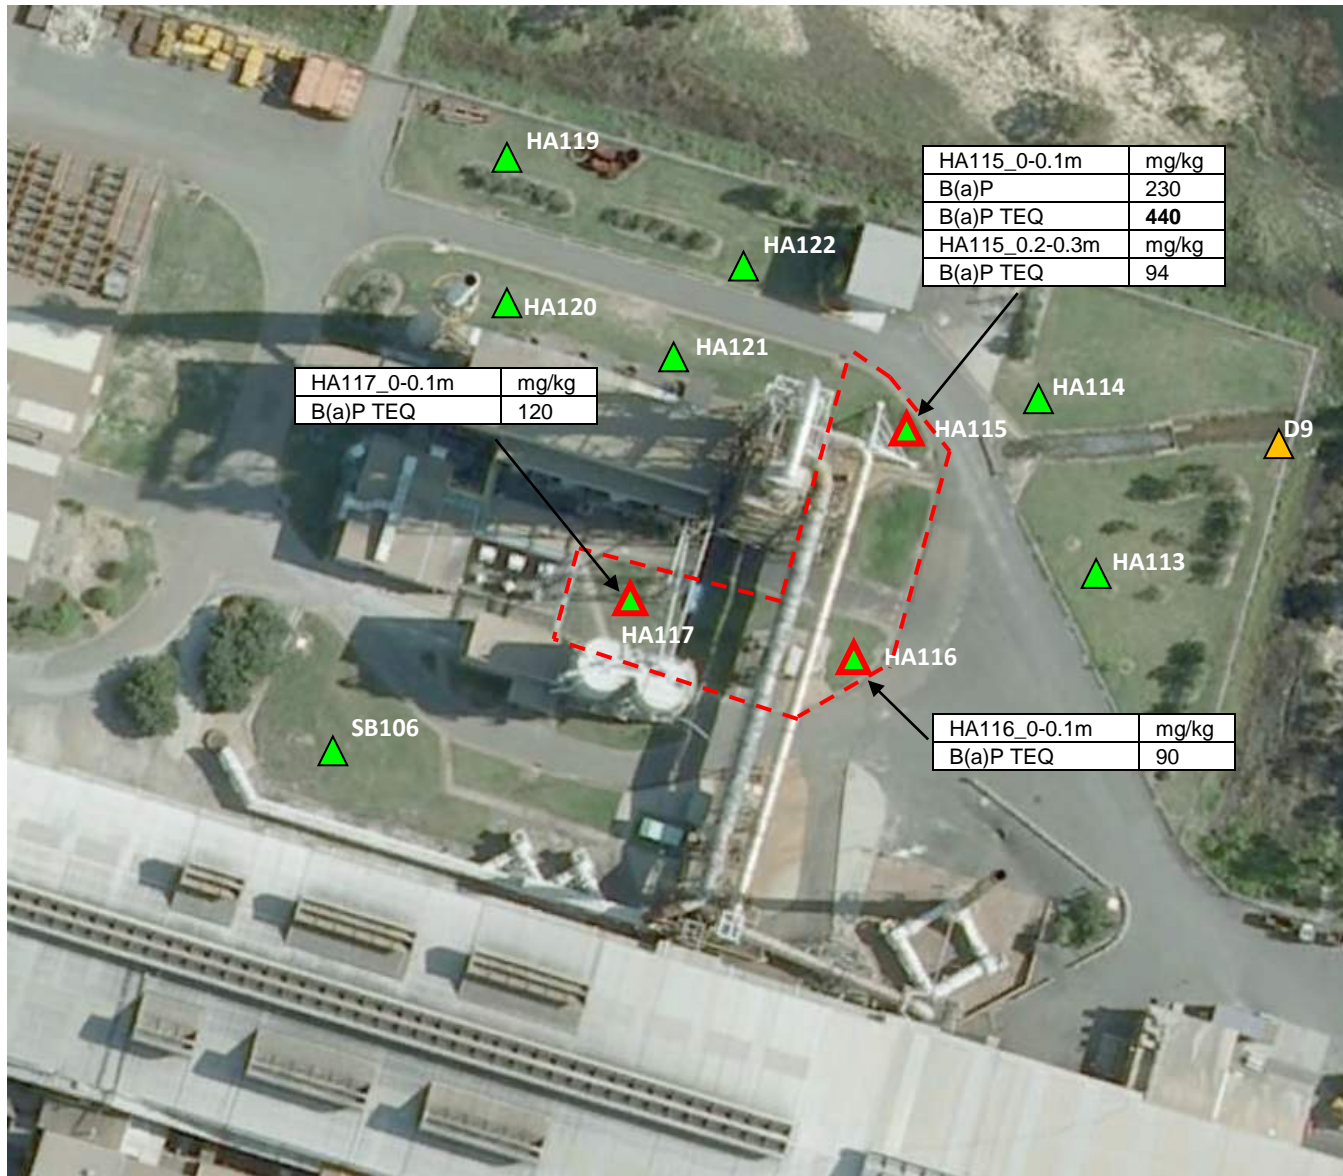
HA117_0-0.1m	mg/kg
B(a)P TEQ	120

HA115_0-0.1m	mg/kg
B(a)P	230
B(a)P TEQ	440
HA115_0.2-0.3m	mg/kg
B(a)P TEQ	94

- ▲ 2014 soil sampling locations
 - ▲ 2012 soil sampling locations
 - ▲ Soil sampling locations with PAHs > guidelines
 - - - Approximate extent of shallow soil contamination
- Approximate Scale 1cm:5m

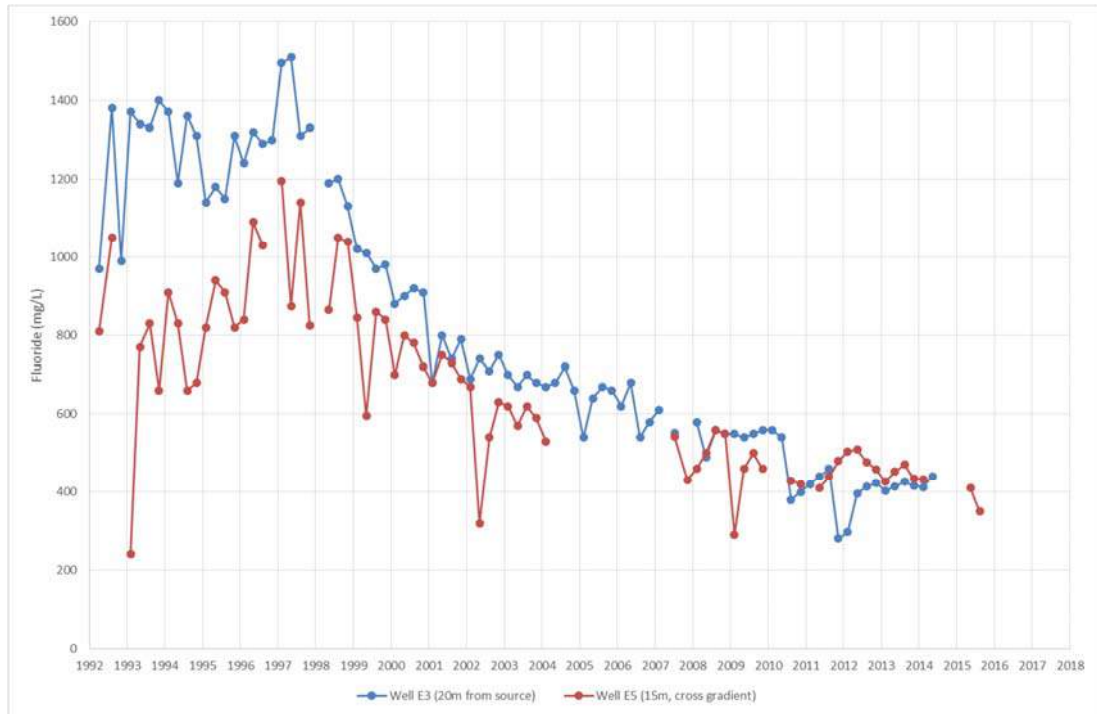
Figure 13 Fluoride concentrations in groundwater

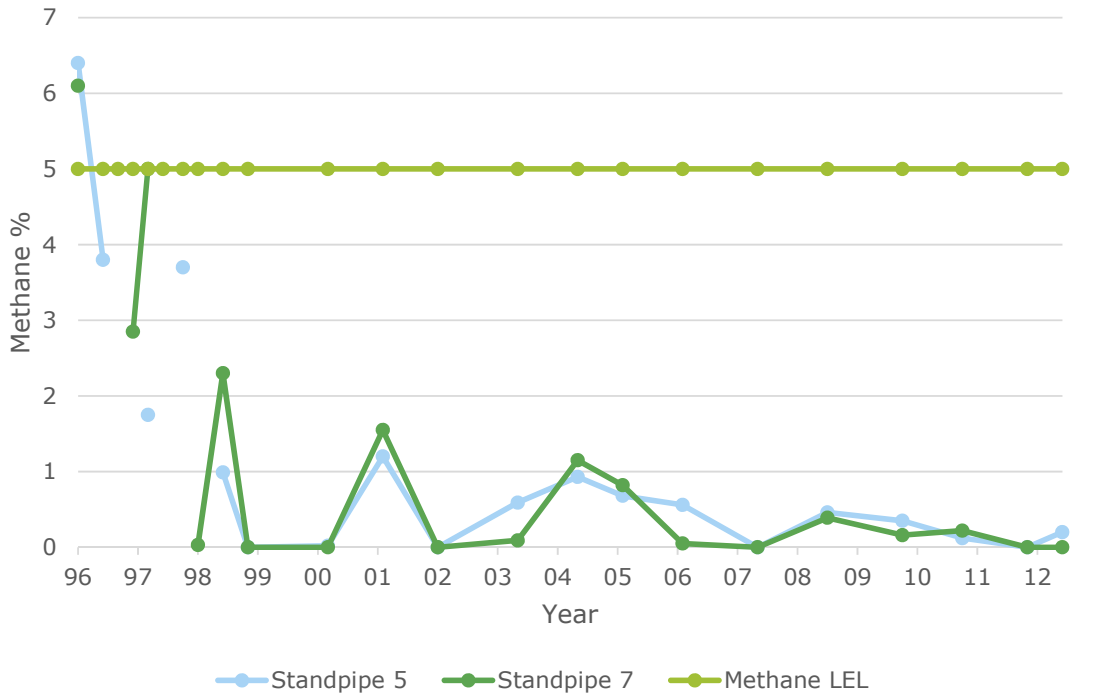
Figure 14 Methane concentrations over time

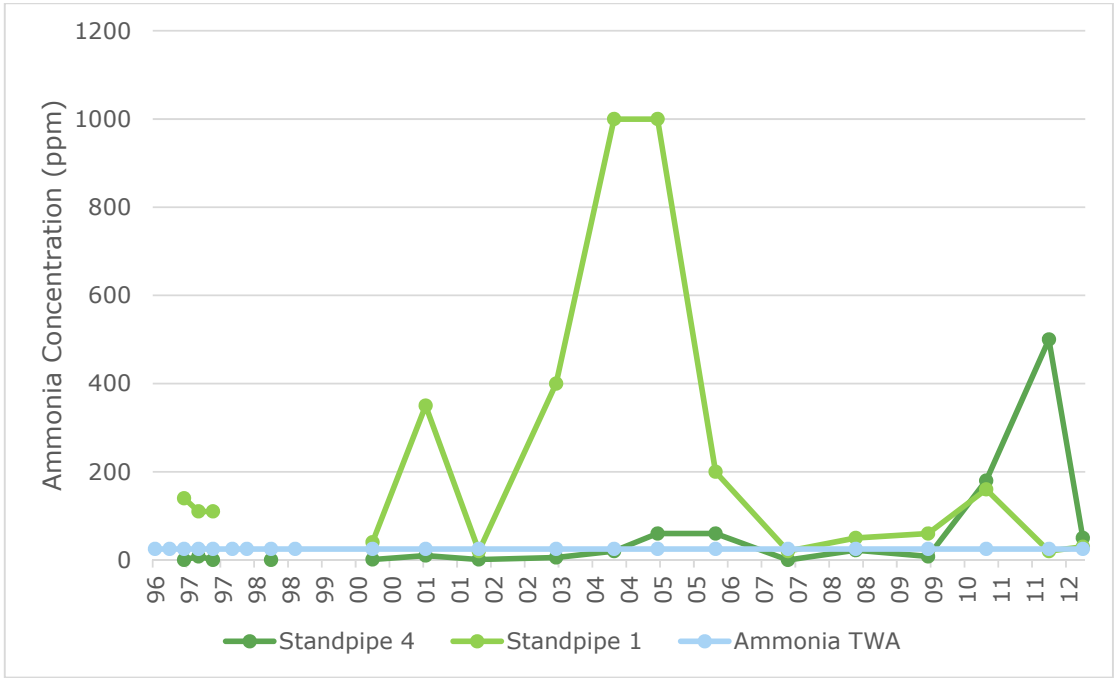
Figure 15 Ammonia concentrations over time

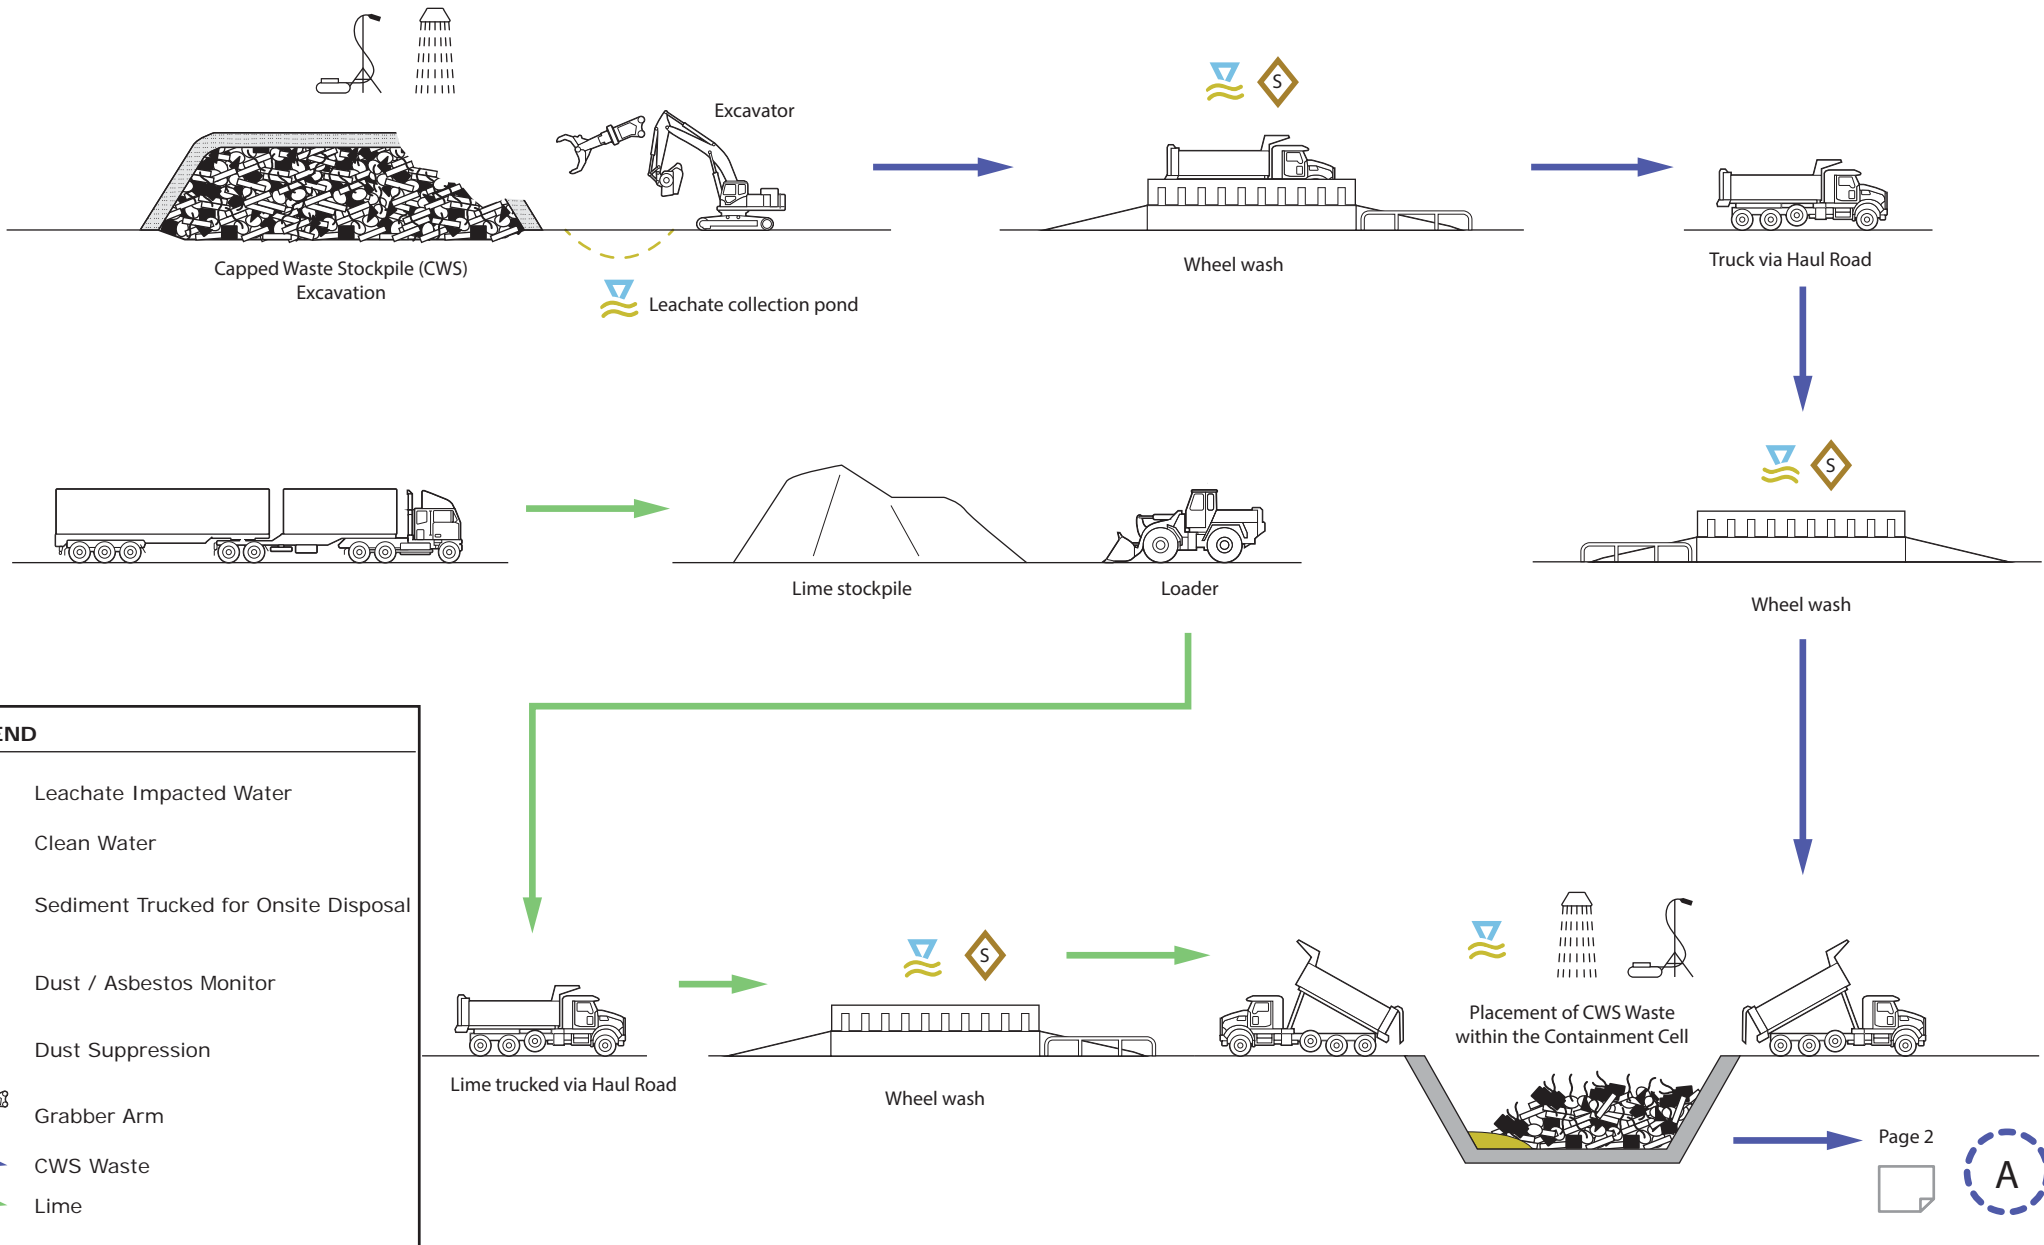
FIGURE 16
 AS13505

OPTION 4 - Page 1
 Onsite Containment Cell With Lime Application

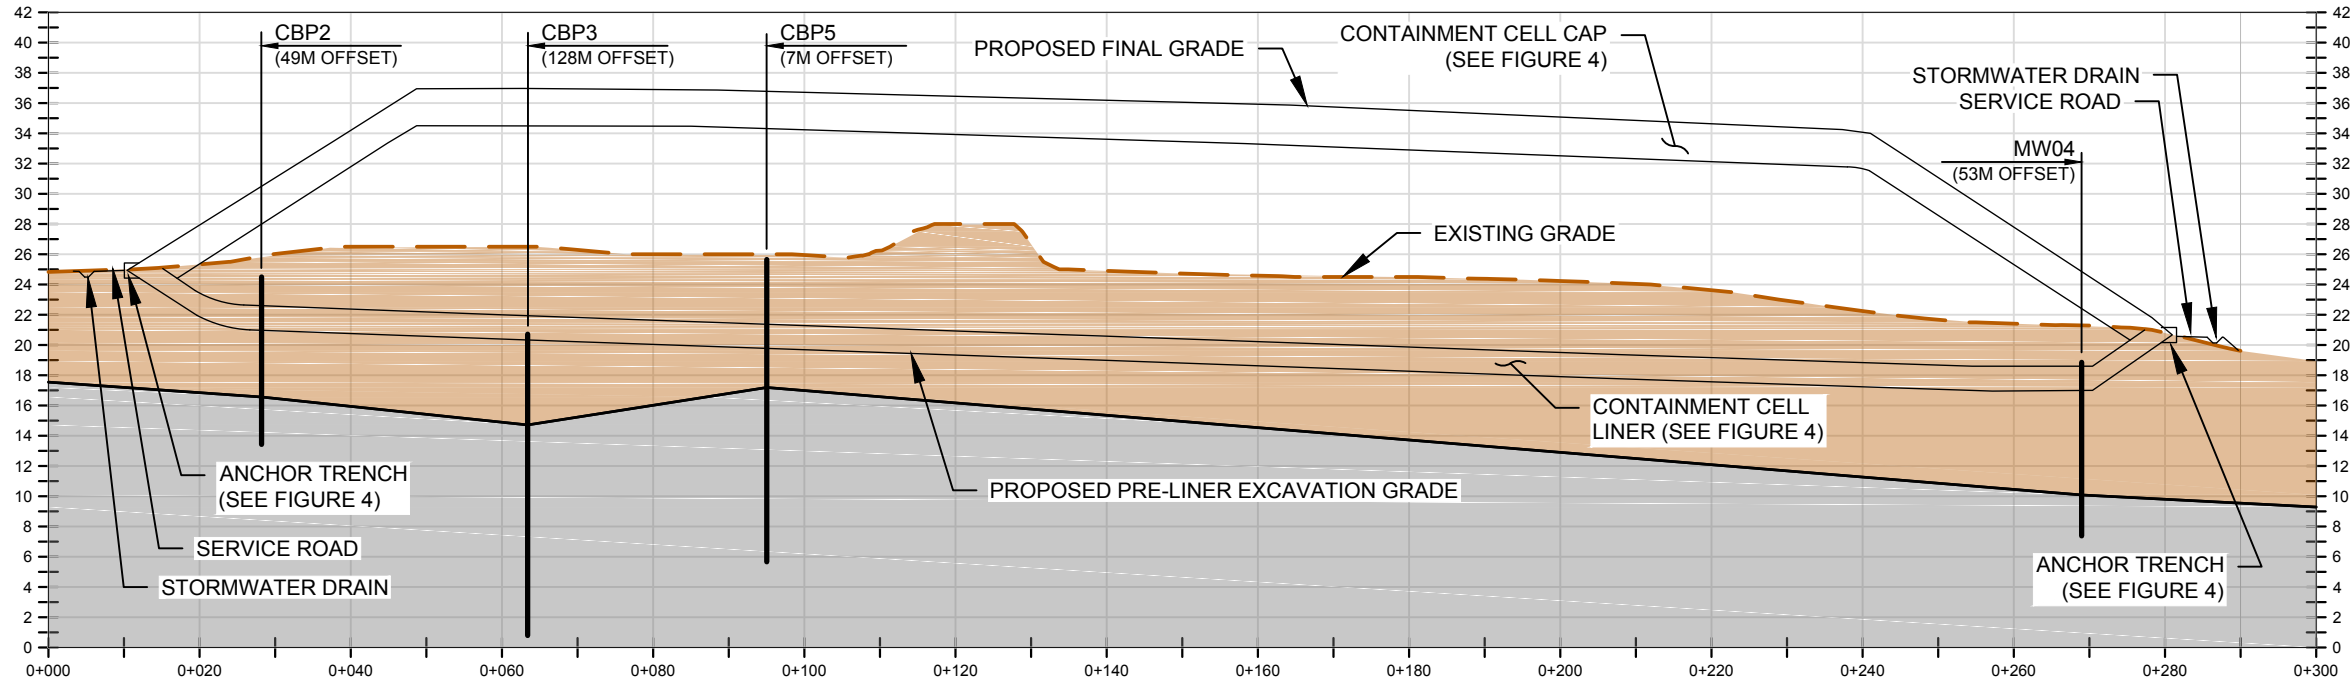
CROSS SECTION A-A'
 HORZ: 1:1000 (VERTICAL EXAGGERATION OF 2)
 VERT: 1:500

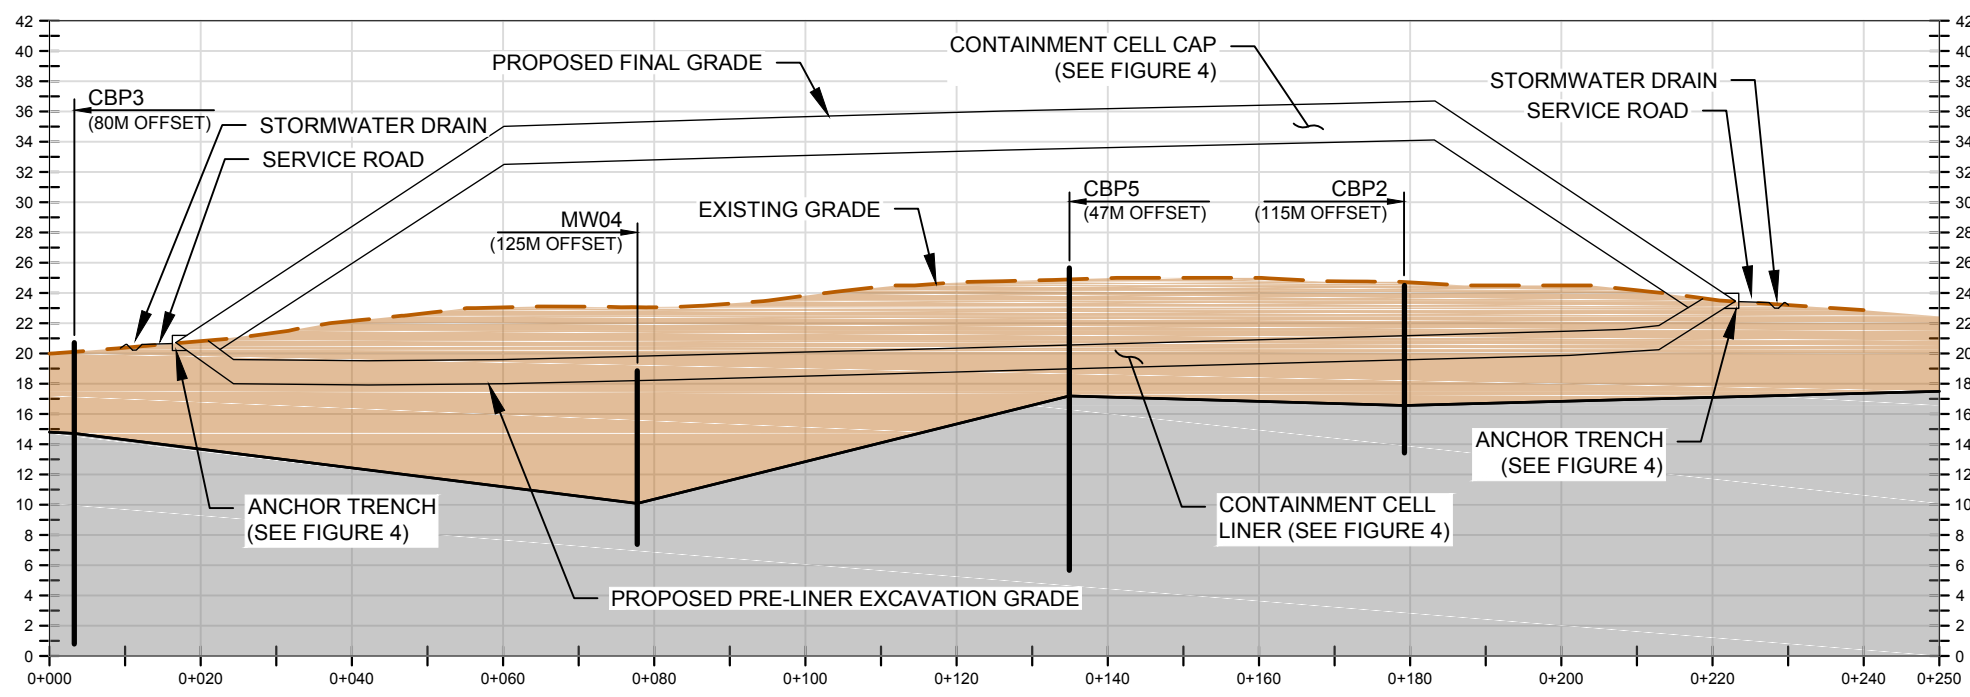
CROSS SECTION B-B'
 HORZ: 1:1000 (VERTICAL EXAGGERATION OF 2)
 VERT: 1:500

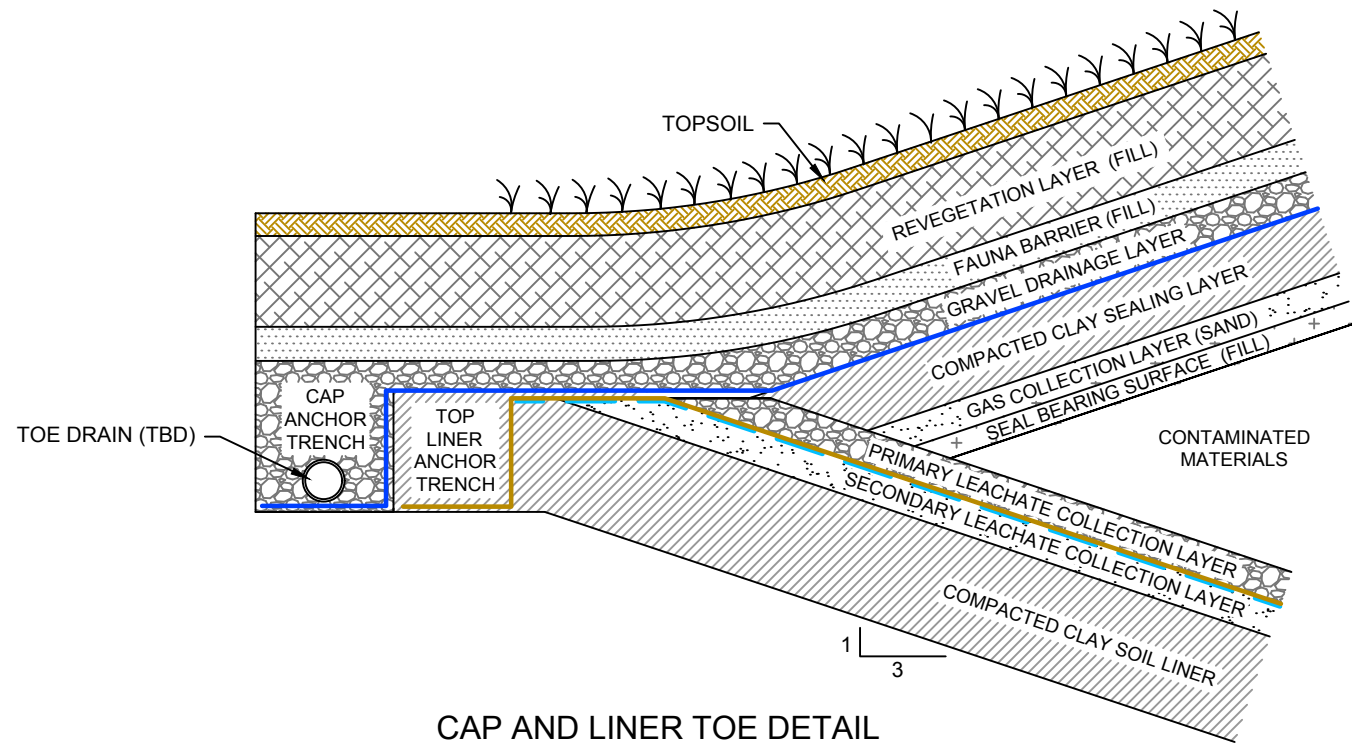
CAP AND LINER TOE DETAIL
N.T.S.

4. GEOSYNTHETIC CLAY LINER (GCL) OF PERMEABILITY LESS THAN 5×10^{-11} M/S, TO MEET SPECIFICATIONS OUTLINED IN NSW EPA SOLID WASTE GUIDELINES 2016.
5. THE LINER AND CAP DETAILS ARE SUBJECT TO CHANGE BASED ON ECONOMIC OR FUNCTIONAL CONSIDERATIONS DURING DETAILED DESIGN.

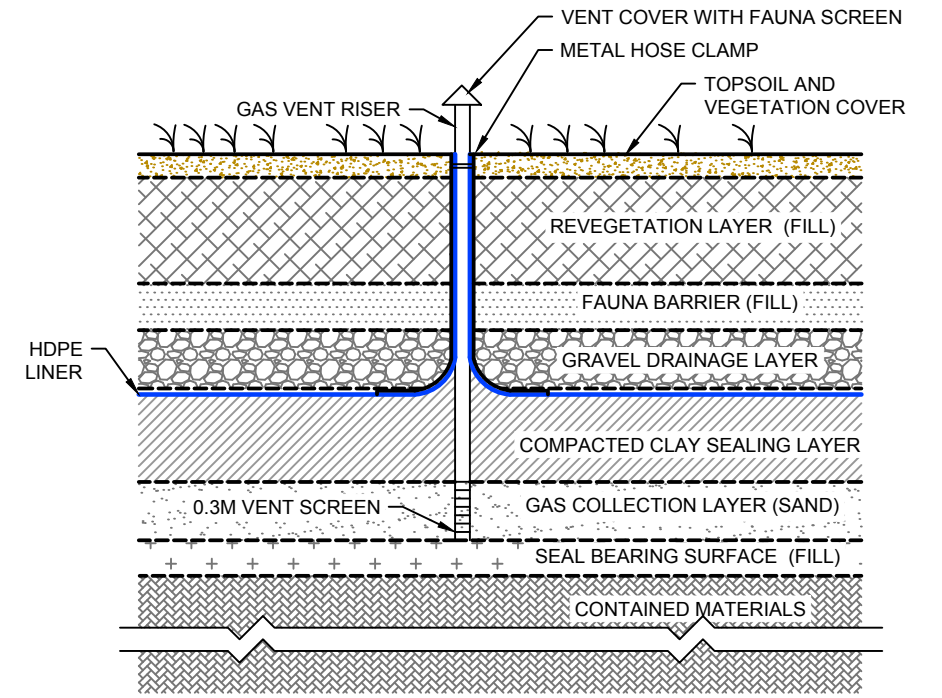
TYPICAL GAS VENT PENETRATION THROUGH CAP DETAIL
N.T.S.

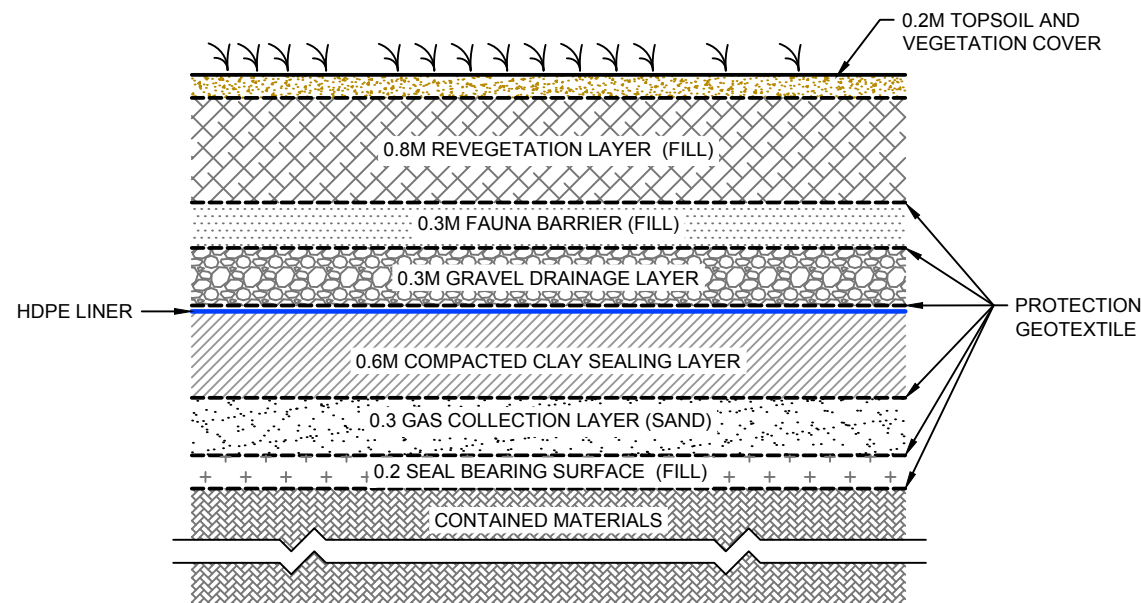
CAP DETAIL
N.T.S.

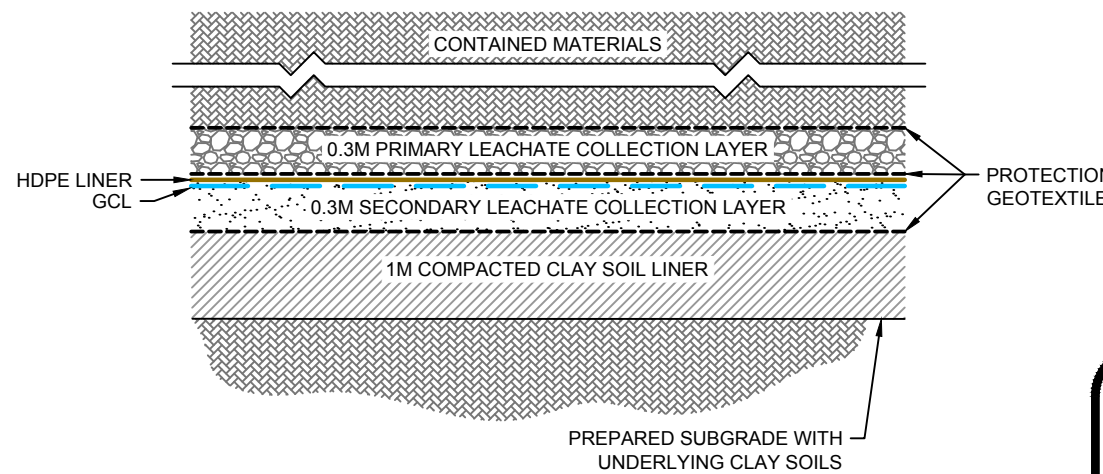
LINER DETAIL
N.T.S.

6. GRAVEL DRAINAGE LAYER IS TO COMPRISE ROUNDED GRAVEL OR ALTERNATE GEOSYNTHETIC MATERIAL COULD BE CONSIDERED, EG/ GEONET OR SIMILAR.

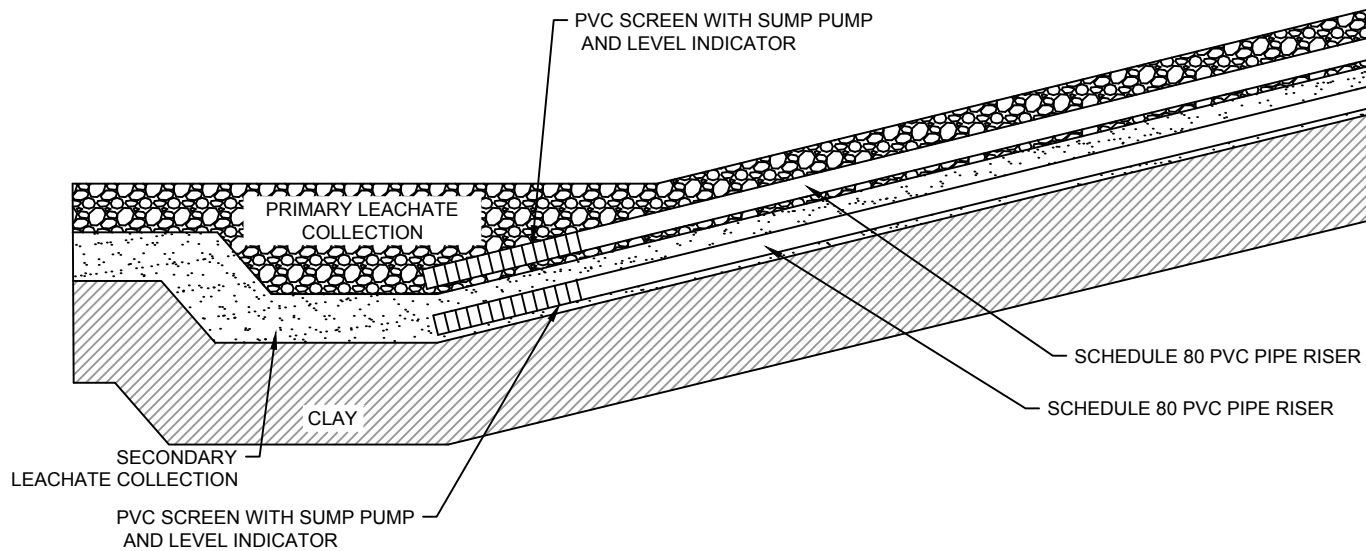
TYPICAL SUMP AND LEACHATE DETECTION DETAIL
N.T.S.
