Report

December, 2020

KURRI KURRI ALUMINIUM SMELTER DECOMMISSIONING, DEMOLITION AND REMEDIATION CONTAMINATED SOILS MANAGEMENT PLAN

HYDRO ALUMINIUM SMELTER KURRI KURRI

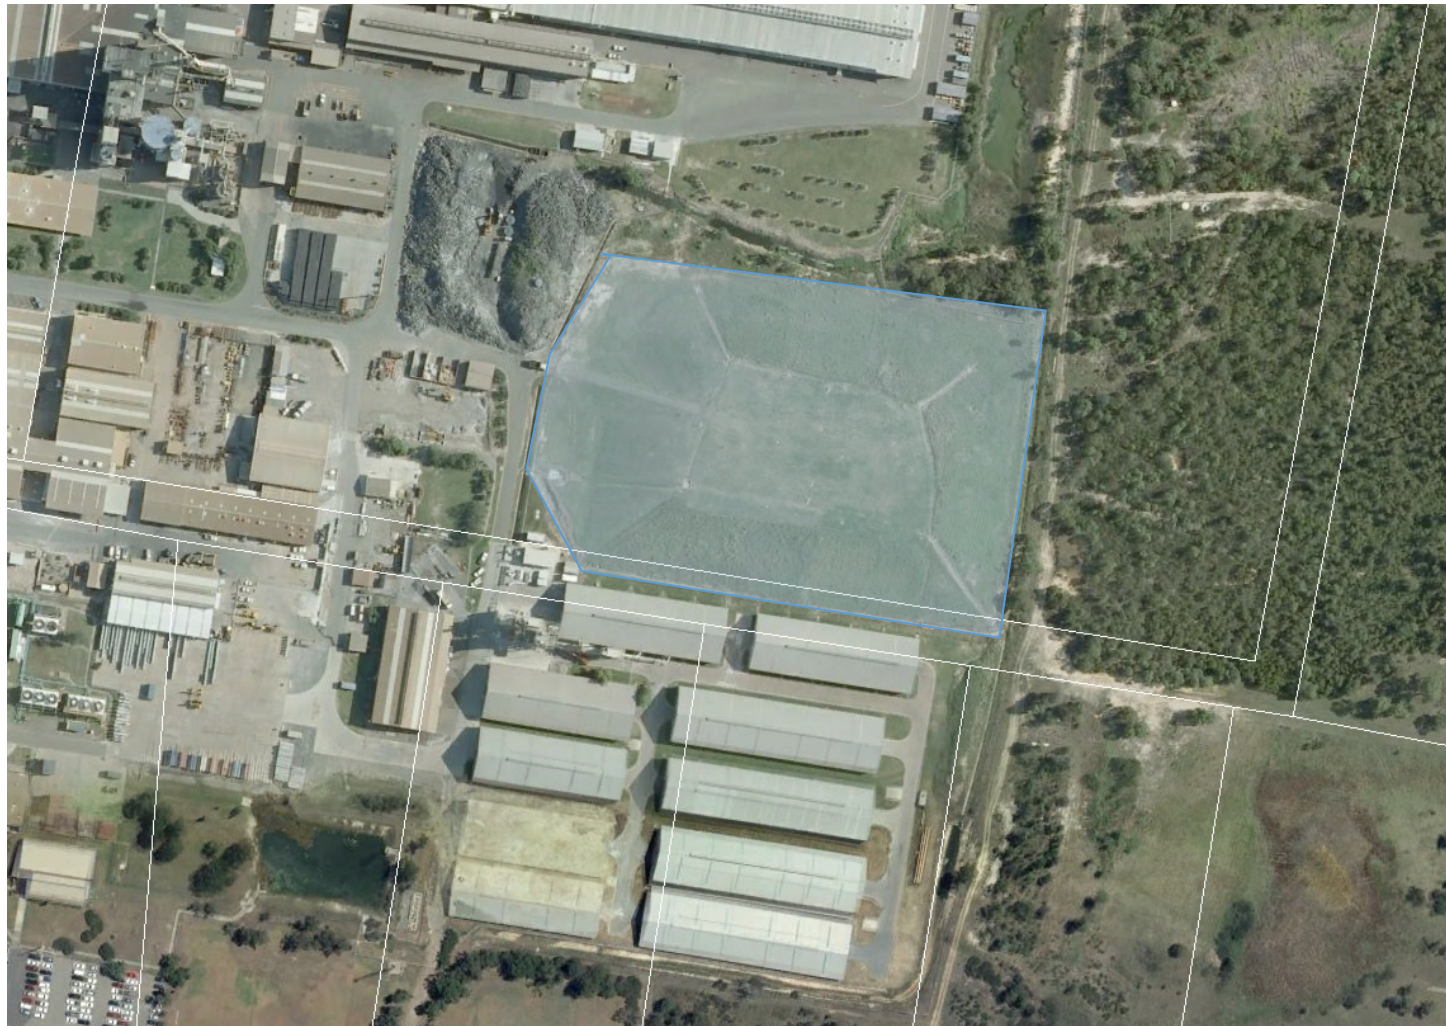
Approximate Scale 1cm:15m

The extent of the Capped Waste Stockpile is shown in **Figure 5**. The Capped Waste Stockpile contains spent pot lining and other wastes associated with aluminium smelting which was capped with clay to prevent human contact and infiltration of precipitation in the mid-1990s. The capping from the Stockpile needs to be removed, with separation of the capping layers and stockpiling for later reuse. The capping layers include the following:

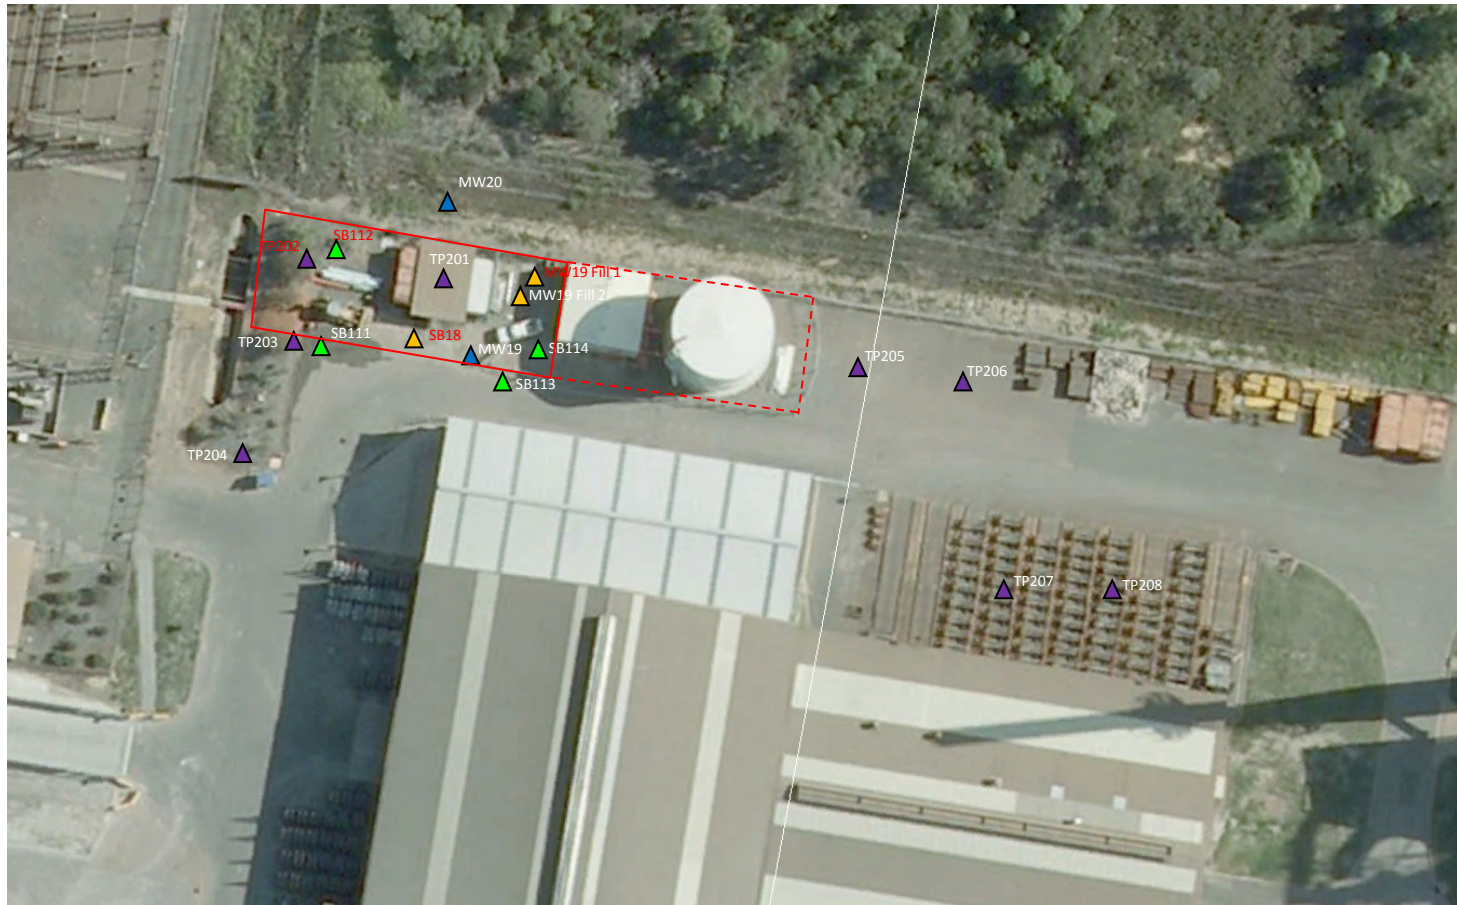
- ▲ 2015 soil sampling locations
- ▲ 2014 soil sampling locations
- ▲ 2012 groundwater well locations
- ▲ 2012 soil sampling locations
- SB18 Soil sampling locations with PAHs > guidelines
- Likely Contamination Extent
- - - Potential Contamination Extent
- Approximate Scale is 1cm: 5m

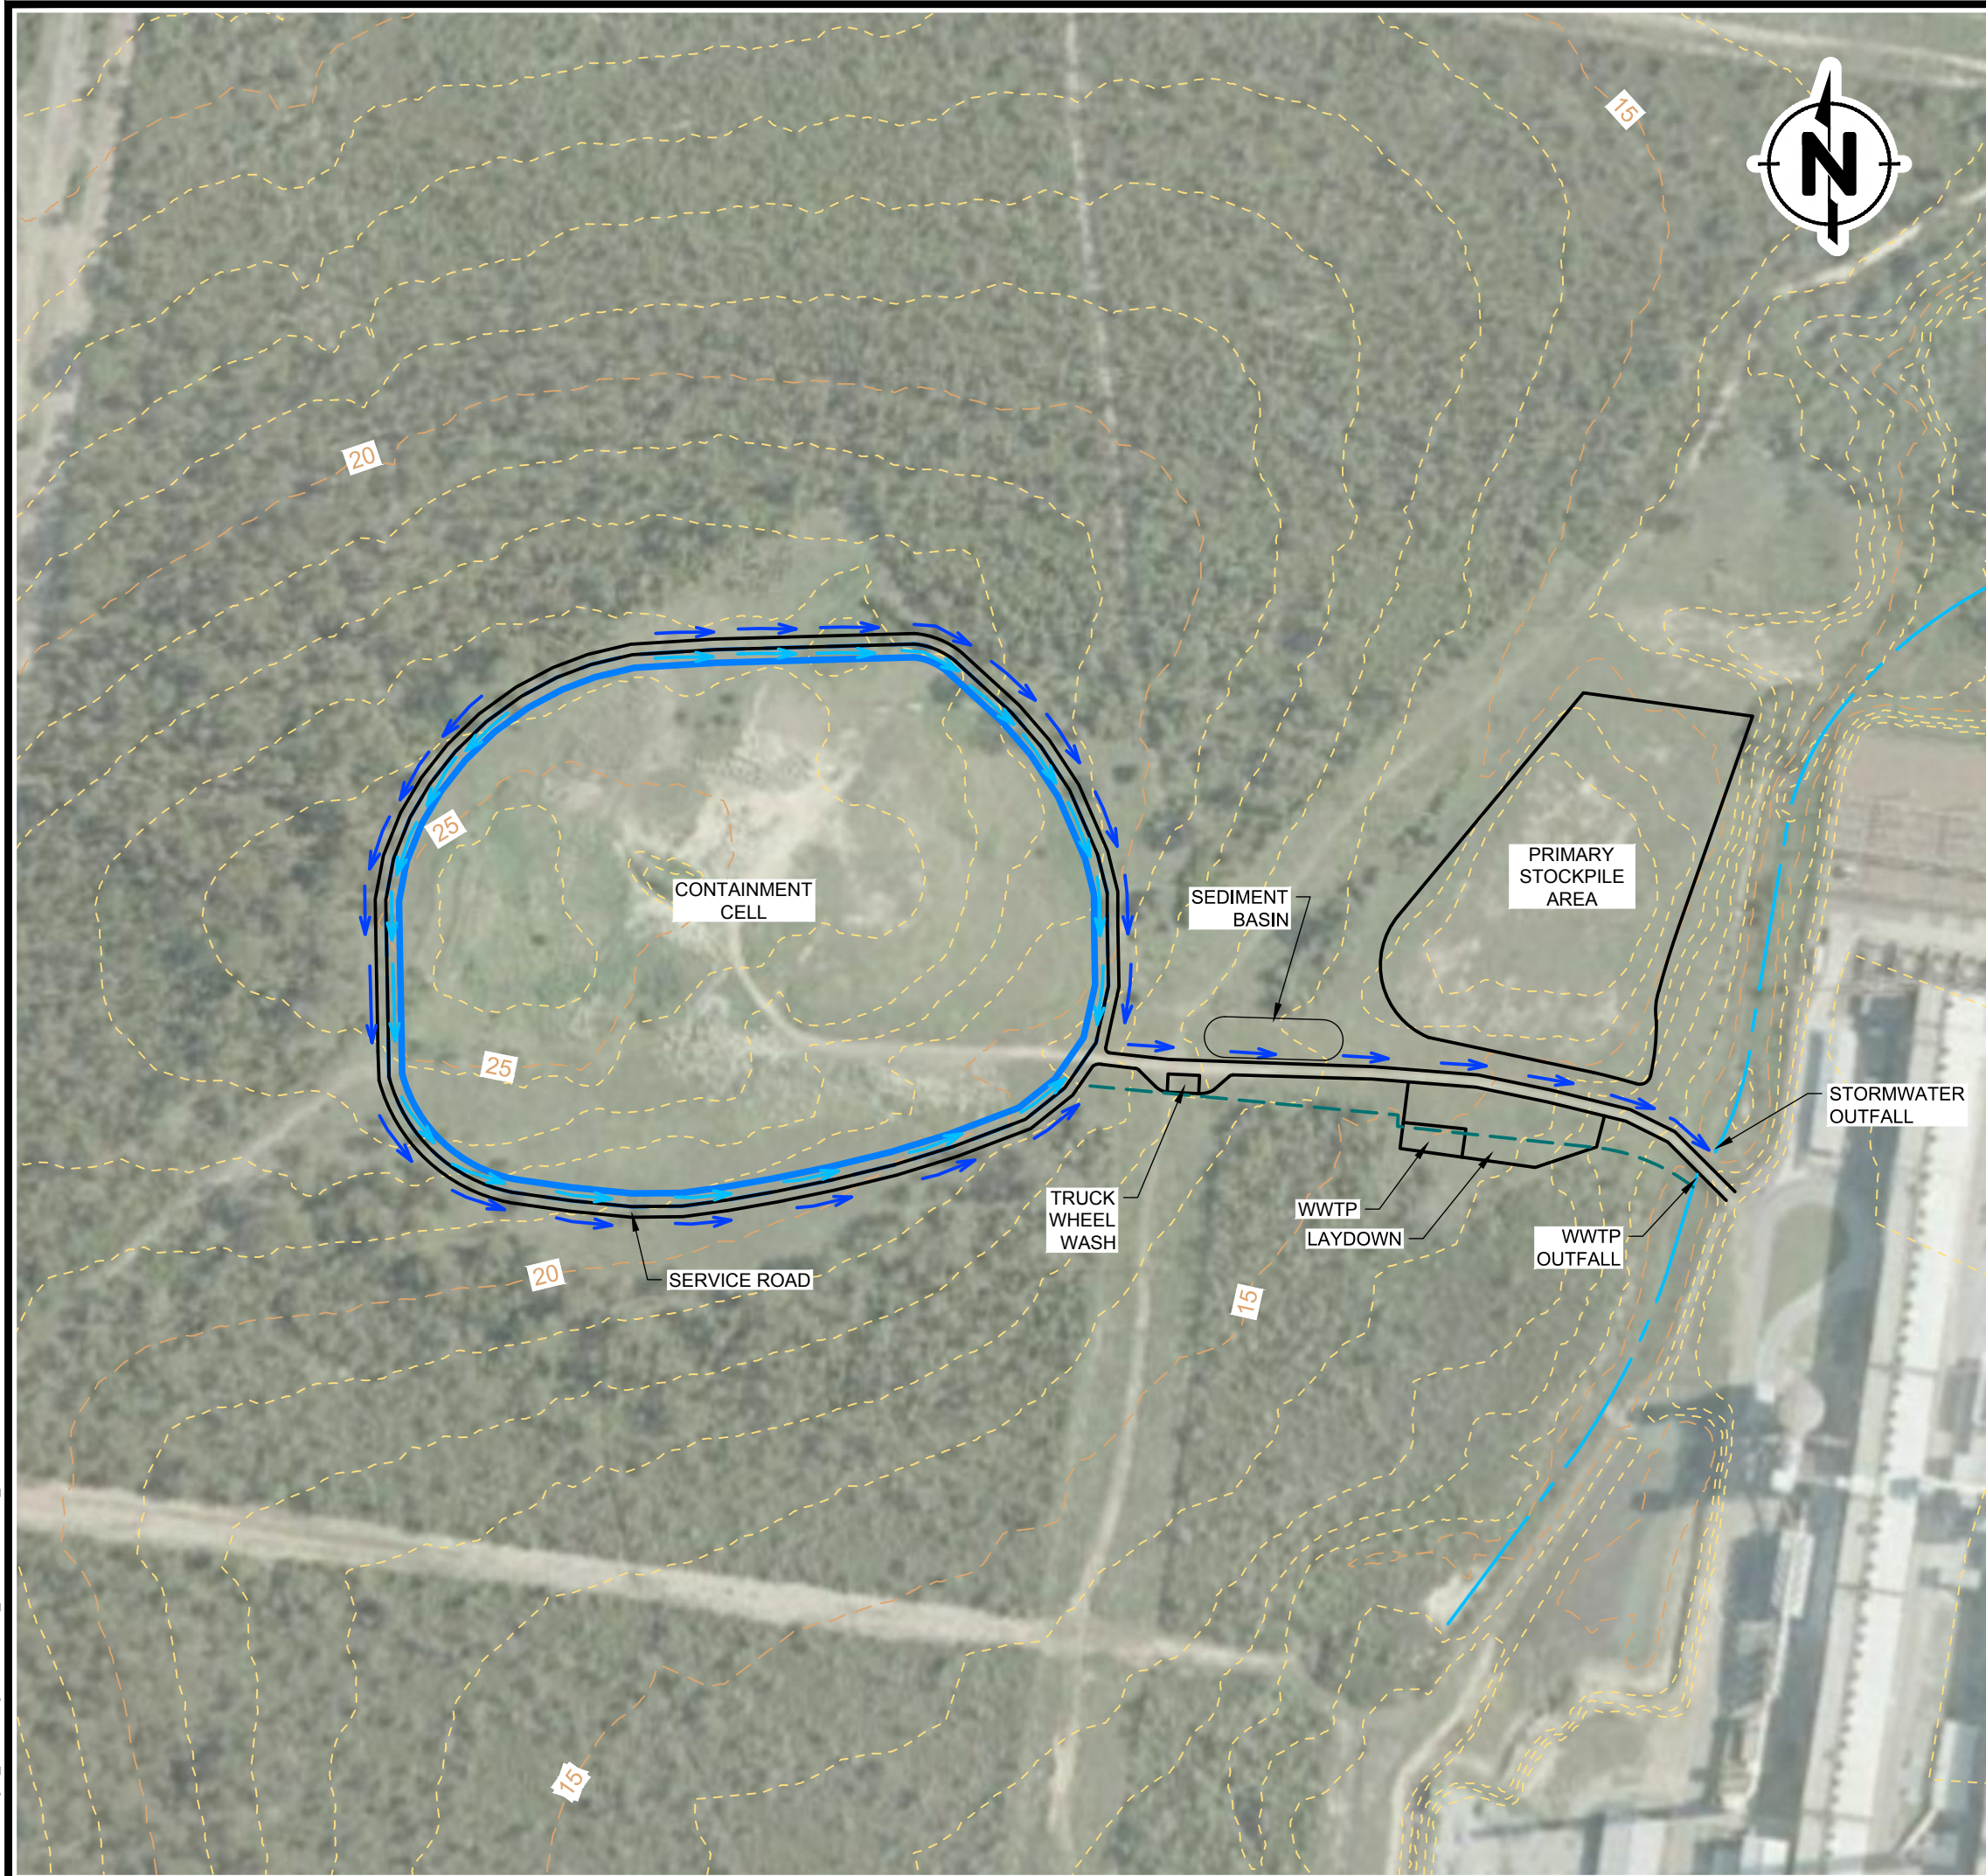
APPENDIX 4 CONTAINMENT CELL CONCEPT DESIGN

- CONTAINMENT CELL LIMIT (CONCEPTUAL)
- - - - - CONTAINMENT CELL CAP LIMIT (CONCEPTUAL)
- - - - - 25 EXISTING CONTOUR MAJOR (5 METRE)
- - - - - 24 EXISTING CONTOUR MINOR (1 METRE)
- → → STORMWATER DRAINAGE CHANNEL
- → → TOE DRAIN
- - - - - UNDERGROUND LEACHATE / WWTP PIPING
- - - - - EPHEMERAL CREEK

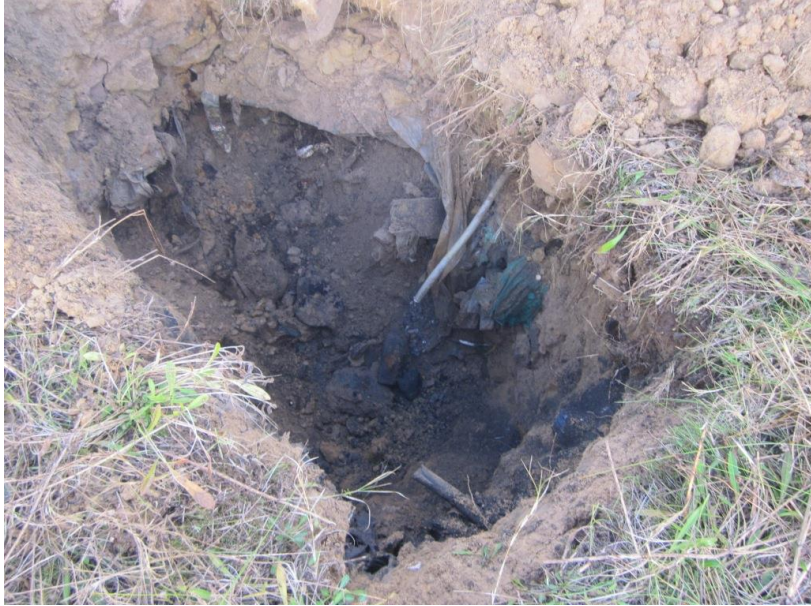
Photograph 2

Test Pit 4, located on the southern edge, showing bulker bags, bricks and metal.

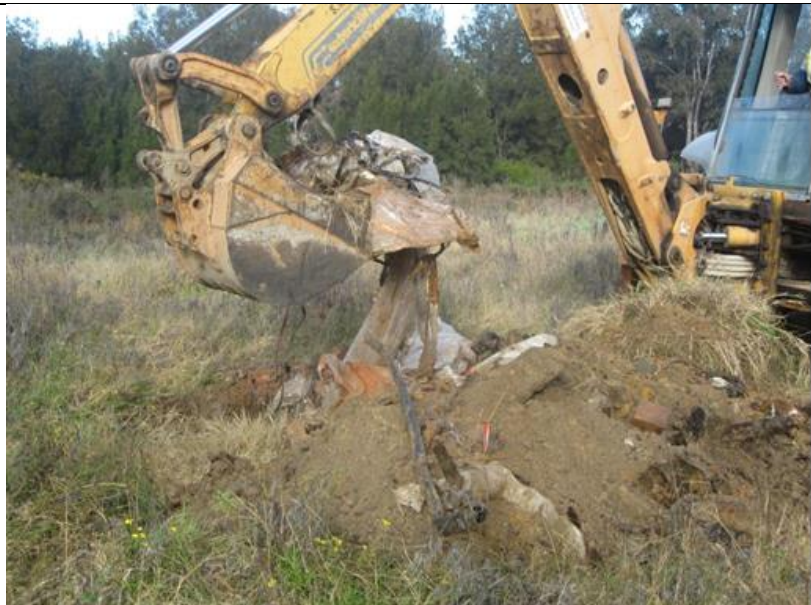
Photograph 3

Test Pit 11, located on the northern edge, showing metal and wood waste.

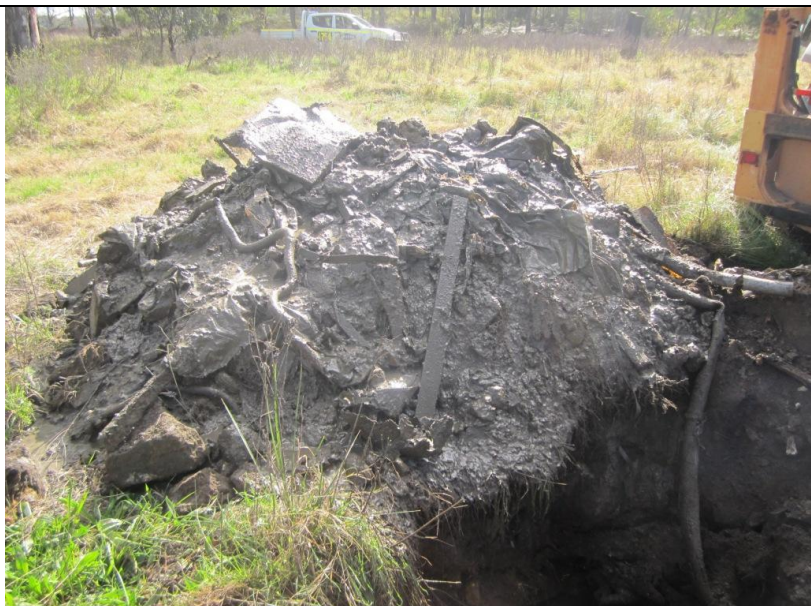
Photograph 4

Test Pit 13, located on the northern edge, showing plastic, brick and concrete.

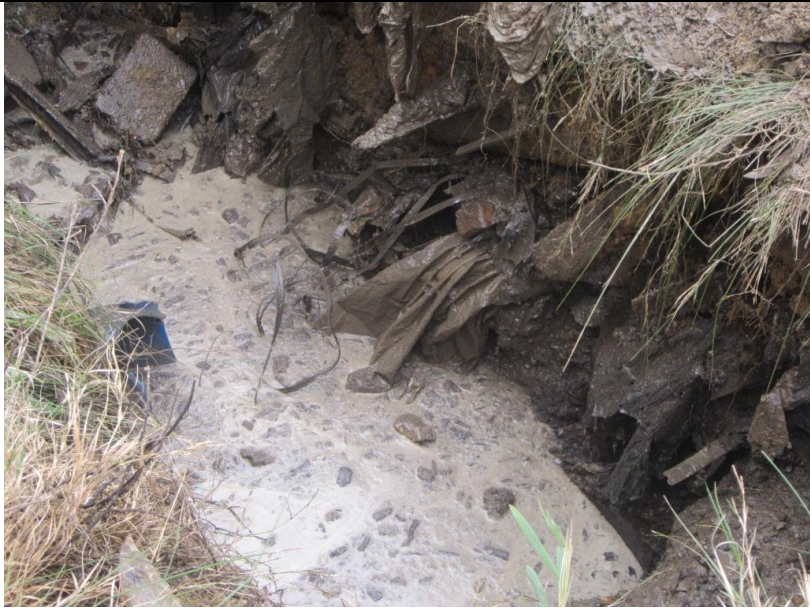
Photograph 5

Test Pit 14, located on the northern edge, showing aluminium, metal and wood waste.
