Document type
Revised Plan

Date
August, 2023

KURRI KURRI ALUMINIUM SMELTER DECOMMISSIONING, DEMOLITION AND REMEDIATION ABORIGINAL HERITAGE MANAGEMENT PLAN

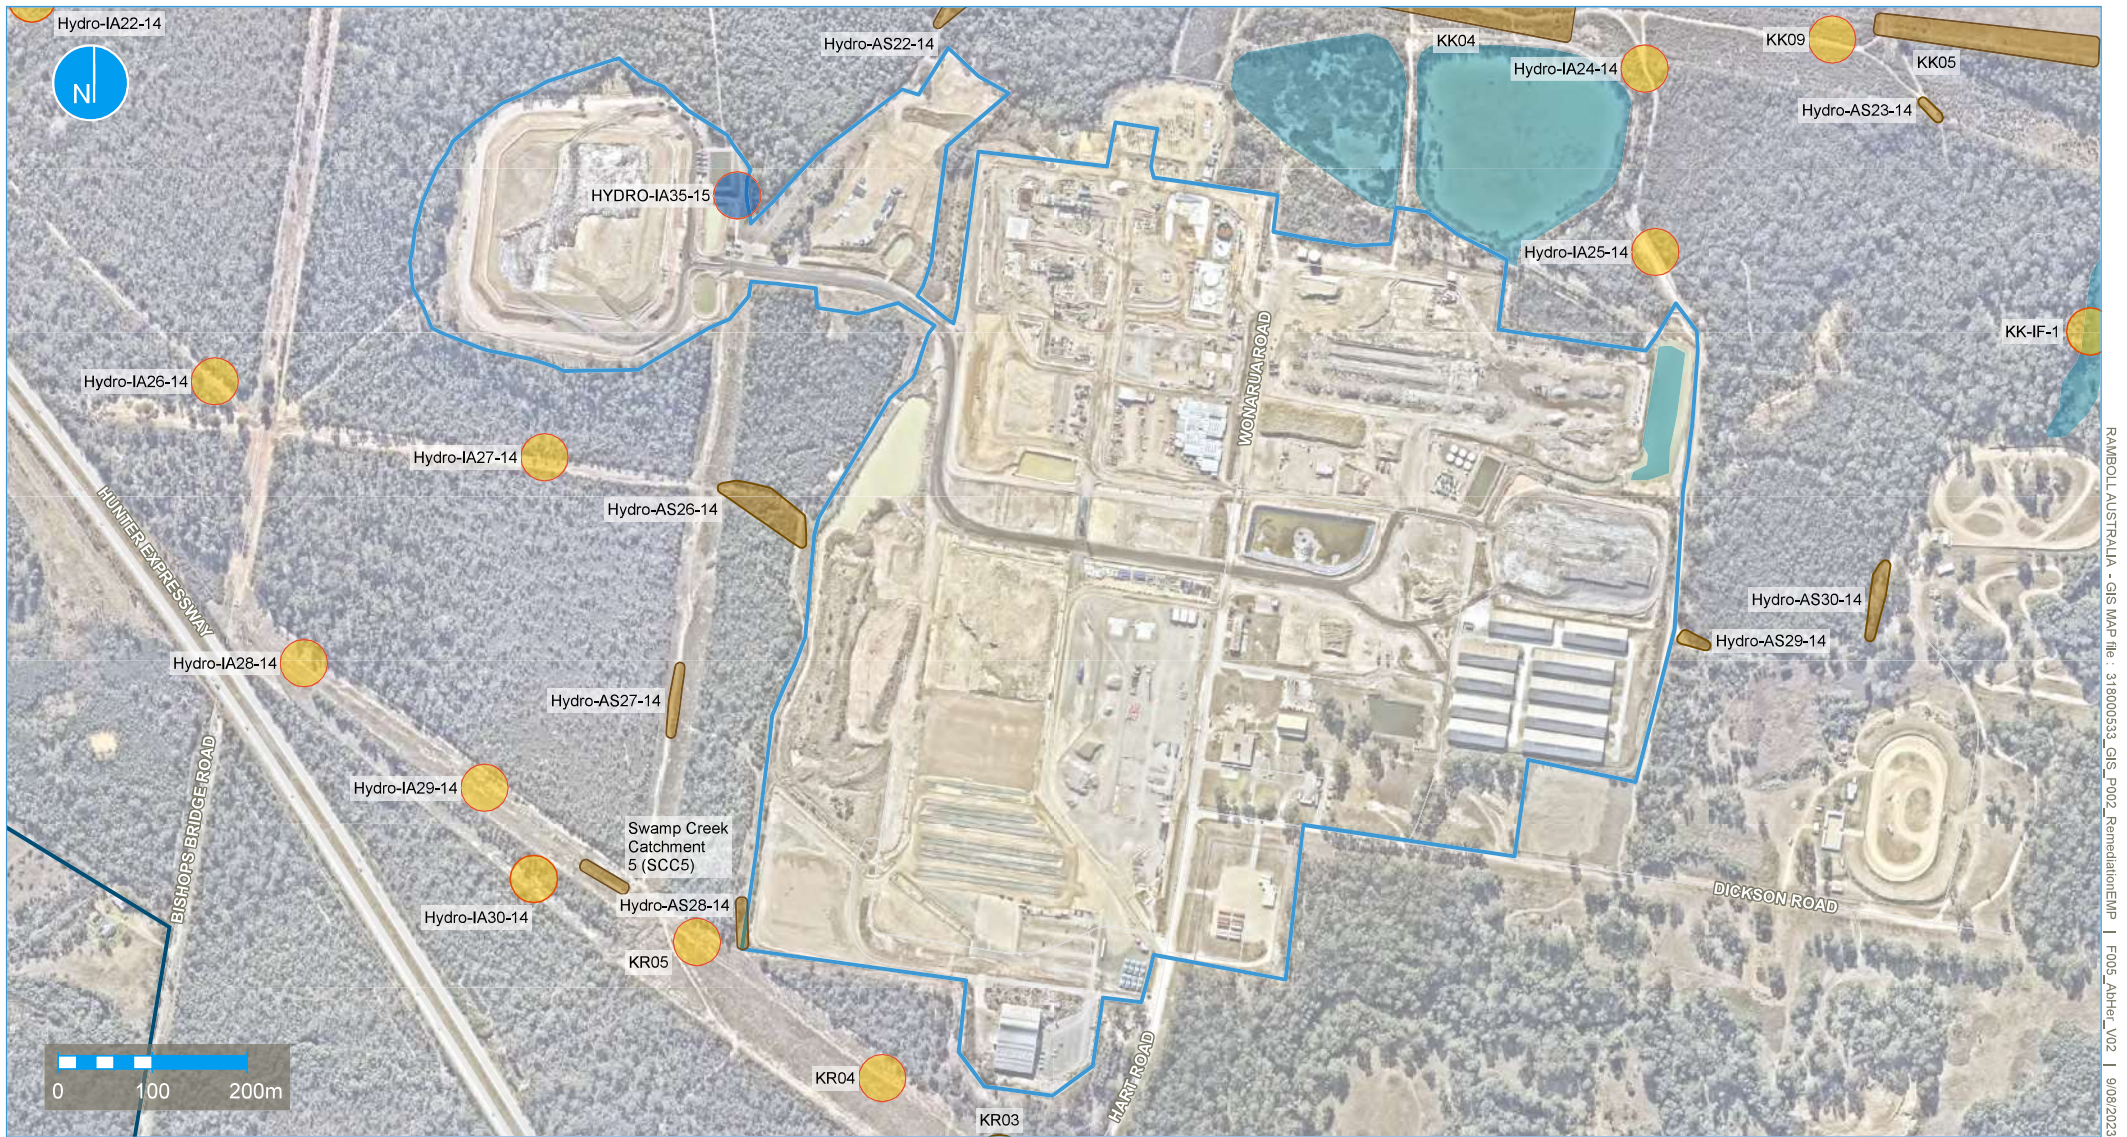
Figure 2-1 | Aboriginal Archaeological Sites - Smelter Site and Surrounds

Figure 2-1 shows the locations of recorded Aboriginal relics and areas of potential archaeological deposits within the Smelter and surrounds.

| Management Measures | Action | Timing / Frequency | Responsibility | Further Detail |
|--|---|---|--|---|
| Prior to undertaking activities within the Hydro Land, the potential impacts on known Aboriginal heritage relics are to be considered. | Figure 2-1 will be reviewed to identify if any mapped Aboriginal heritage sites are within or adjoining the proposed activity location. | Prior to activities | Environment Officer | Figure 2-1 |

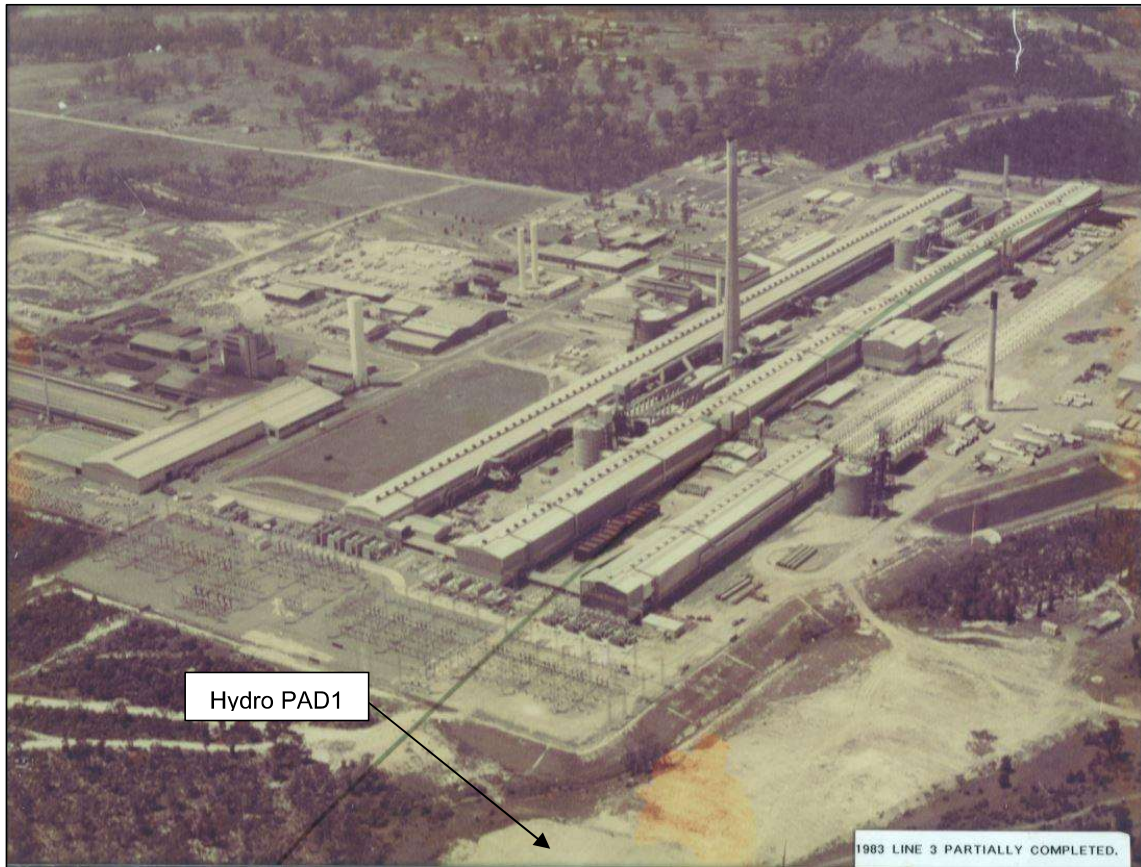
Figure 7 Oblique 1983 aerial of the Smelter site with location of Hydro PAD1 indicated.

- An updated analysis of 13 historical aerial photographs of Hydro PAD1. In particular, a 1983 aerial photograph of the then partially completed pot line of the Smelter, showing part of Hydro PAD1. Significant ground disturbance (excavation and filling) is clearly evident on the 1983 and 1984 historical aerials for Hydro PAD1 and its environs (refer to Figure 7 and 8 in **Appendix 2**).

- Prior to c.1983, ground disturbance within Hydro PAD1 appears to have been limited to native vegetation removal;
- In or around 1983, land within and to the south of Hydro PAD1 was extensively stripped and/or filled. This disturbance, ostensibly associated with the construction of the Smelter's third potline, is clearly visible on the 1983 (Figure 7) and 1984 (Figure 8) aerials;
- Post-1984, no major, additional ground disturbance phenomena are evident within Hydro PAD1. Land within the site appears to have been left vacant and unused; and
- Aerials examined for this assessment suggest that, contra AECOM's 2015 assessment, land within Hydro PAD1 has been severely disturbed. Natural soil profiles within bounds of the PAD are likely to have been radically modified via heavy earthworks.

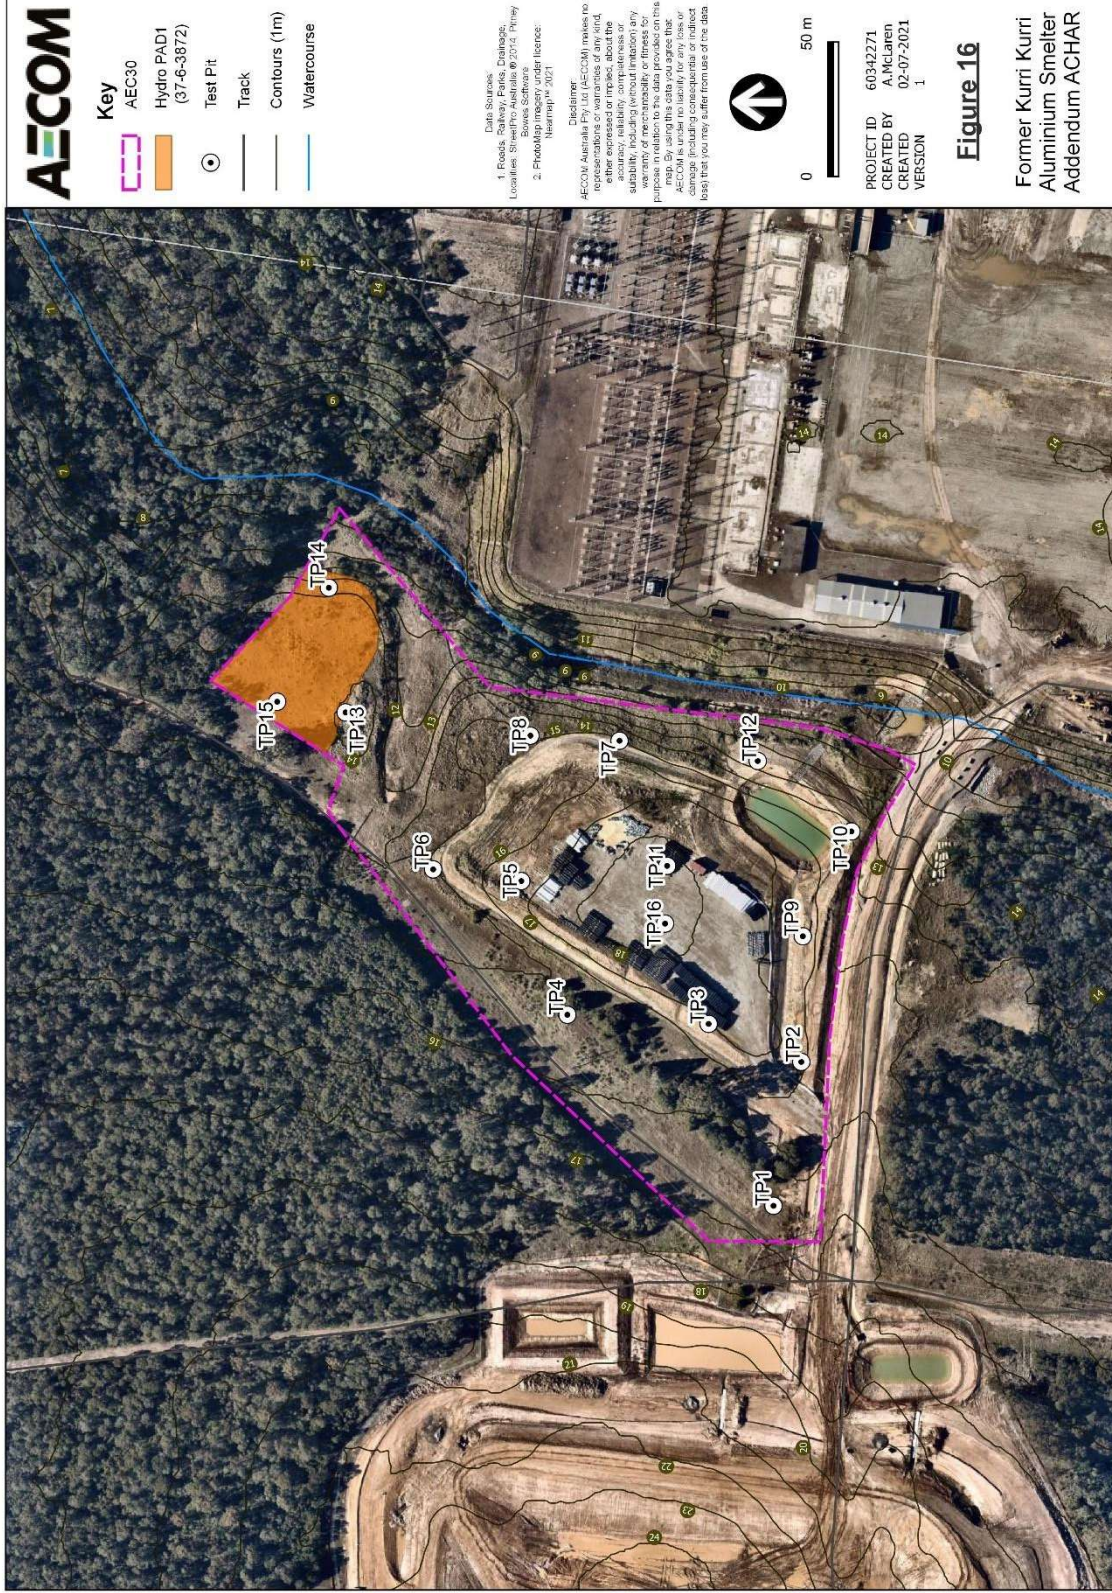
Figure 16 Map showing location of AEC30 and associated test pits relative to Hydro PAD1

Of particular relevance to the current assessment are Ramboll's (2020) observations for TPs 13, 14 and 15. As indicated in Table 2, soil profiles in all three of these pits were found to contain fill deposits from the surface, with those in TPs 13 and 14, located within the boundary of Hydro PAD1, extending to depths of 0.7 m and 2.5 m b.g.l respectively. In TP13, fill materials extended to a depth of 2.2 m b.g.l. Fill deposits in TPs 13 and 14 included foreign materials, while that in TP15 did not.

- Natural soil profiles across AEC30, including Hydro PAD1, were severely disturbed as a result of the ground disturbance works evident on the 1983 and 1984 historical aerials for this area; and
- Logs for TPs 13, 14 and 15 suggest that natural topsoils within Hydro PAD1 have been removed, with fill deposits overlying high plasticity sandy clays consistent with locally occurring subsoils.
