FORMER HYDRO ALUMINIUM SMELTER CAPPED WASTE STOCKPILE, 2024 ANNUAL GROUNDWATER MONITORING REPORT

Reference
 318000344-003

Description 2024 Annual Groundwater Monitoring Report for the leachate plume

associated with the Capped Waste Stockpile at the former Hydro

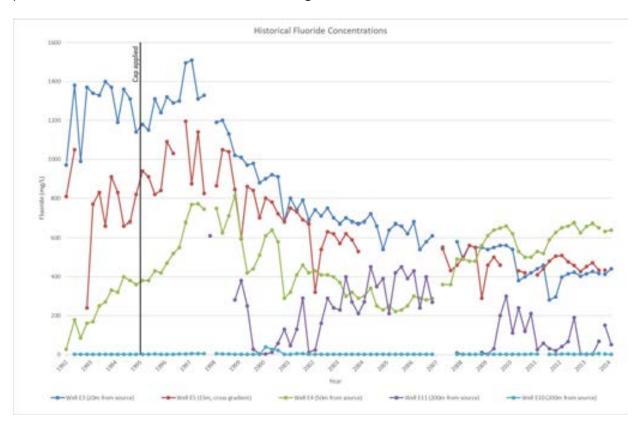
Figure 2-1: Historical Fluoride Concentrations Along the Plume 1992 - 2014

The semi-continuous shallow sand aquifer that is impacted with leachate is characterised by high pH (pH >9), electrical conductivity (>5,000 μ S/cm), fluoride (>200 mg/L) and total cyanide (>6 mg/L) concentrations and is brown in colour. Historical data from 1992 to 2014 indicates fluoride concentrations within the leachate plume decreased after the CWS was capped in 1995. Fluoride concentrations near the CWS, the source of the plume, peaked in 1997. Mid-way along the plume, fluoride concentrations peaked around 2000 and at the leading edge, fluoride concentrations peaked between 2004 and 2006, as shown in **Figure 2-1**.

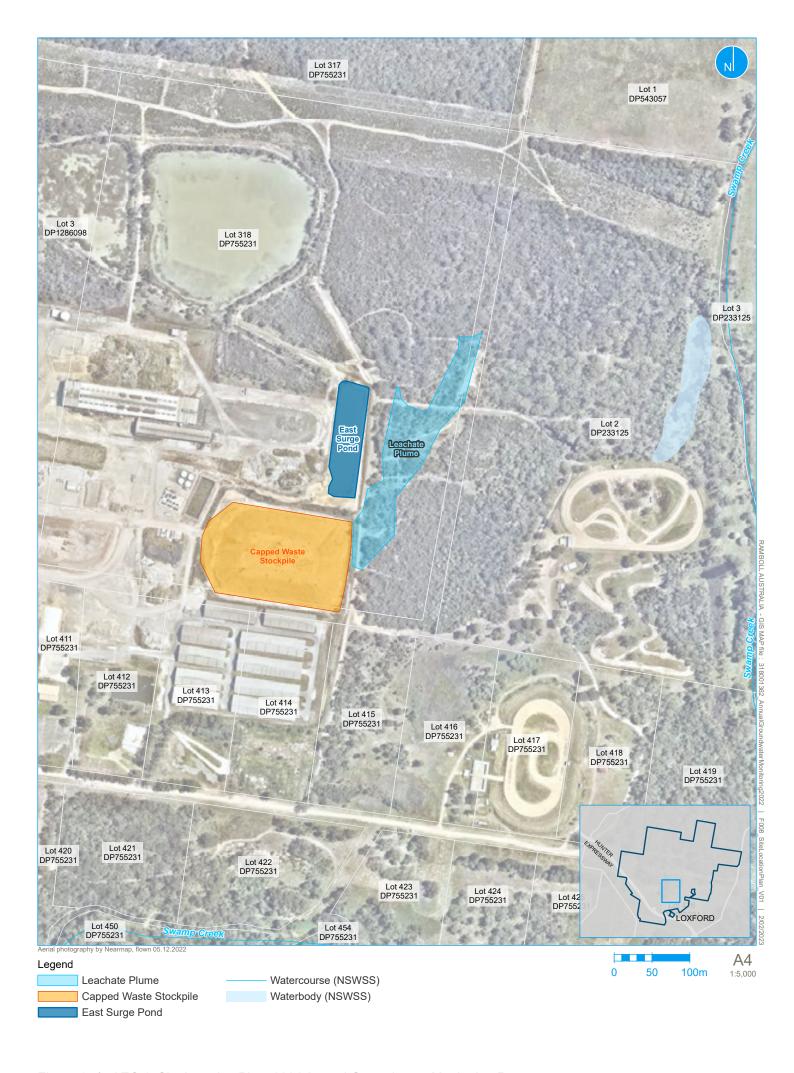
Figure 1 | AEC 1: Site Location Plan, 2024 Annual Groundwater Monitoring Report

The CWS was maintained as an uncapped bunded waste repository prior to being capped with clay under development consent in the mid-1990s. At this time, impacts to vegetation in the buffer zone downgradient of the CWS were observed. Leachate from the CWS, caused by rainwater and groundwater coming into contact with the CWS contents, was also known to have impacted on groundwater and investigations commenced to explore the extent of groundwater impact. These investigations identified that leachate impacted groundwater likely originated from the northeast corner of the CWS and extended approximately 300 meters (m) northeast. The CWS and associated leachate impacted groundwater were identified as AEC 1 in the Phase 2 Environmental Site Assessment completed by Environ (now Ramboll) in 2012. The location of AEC 1 is shown in **Figure 1, Appendix 1**.

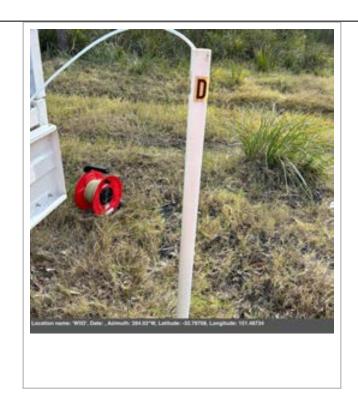
Date	06/17/2024	Time	13:49
Did Well Dewater?	No	Sample Date	06/17/2024
Sample Time	13:52	Sample ID	W5D
QC Sample ID		Analysis	
Sample Preservation		Bottles	
Remarks	Kink in well, tubing una	ble to move past
