REGROWTH
KURRI KURRI

Project	Hydro Kurri Kurri site redevelopment project	From	Emma Heaton
Subject	Community Reference Group Meeting	Tel	1800 066 243
Venue/Date/Time	Thursday 15 February 2018 Hydro Aluminium 6.00pm – 6:50pm	Job No	2218982
Copies to	All committee members		
Attendees	<p>Mr Andrew Walker – Hydro Kurri Kurri Project Manager (AW)</p> <p>Mr Richard Brown – Managing Director, Hydro Kurri Kurri (RB)</p> <p>Mrs Kerry Hallett – Hunter BEC (KH)</p> <p>Mr Kerry McNaughton – Environmental Officer, Hydro Kurri Kurri (KM)</p> <p>Mr Toby Thomas – Community representative, Towns with Heart (TT)</p> <p>Mr Brad Wood – Community representative (BW)</p> <p>Clr Darrin Gray – Cessnock City Council (DG)</p> <p>Mr Rod Doherty – Kurri Kurri Business Chamber (RD)</p> <p>Ms Debra Ford - Community representative (DF)</p> <p>Mr Michael Ulph – CRG Chair, GHD (MU)</p> <p>Emma Heaton – GHD (Minutes)</p>		
Guests/observers			
Apologies	<p>Clr Robert Aitchison – Maitland City Council (RA)</p> <p>Mr Allan Gray – Community representative - Retired Mineworkers (AG)</p> <p>Mr Gareth Curtis – Cessnock City Council (alternating with Martin Johnston)</p> <p>Mr Bill Metcalfe – Community representative (BM)

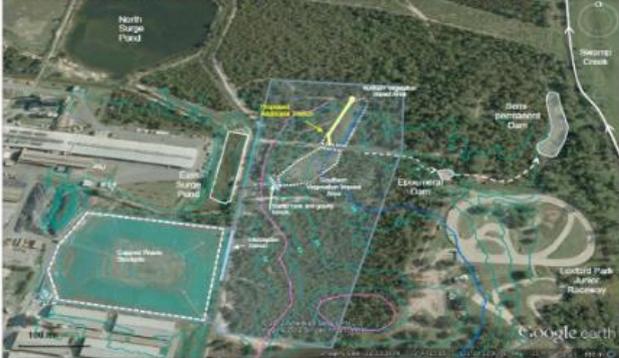
Leachate Interception Trench

Additional (third) leachate interception trench to be installed during Q1'18. Will go into northern veg impact area. Work to commence 19/2/18.

We are about to start the third interception trench on Monday – the job was awarded to Les Edwards Plumbing. They also installed an isolation valve (Dec 18th) so water can be supplied to these three buildings and can shut the water off on the main water tower. Done because tracking big machines on the west side of the site, demolishing pot lines and felling structures, and if there was any damage to the ring main, water needs to be turned off in a hurry and not lose water to our building.

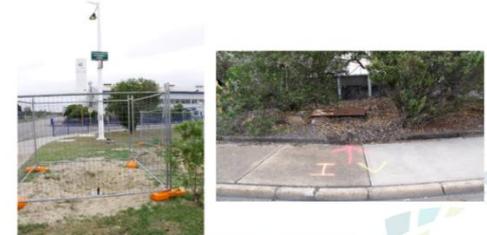
Potable Water Isolations

Valve installed in Dec 18 so that water leaving the main tower can be isolated in the event of a major failure of the fire & domestic ring main

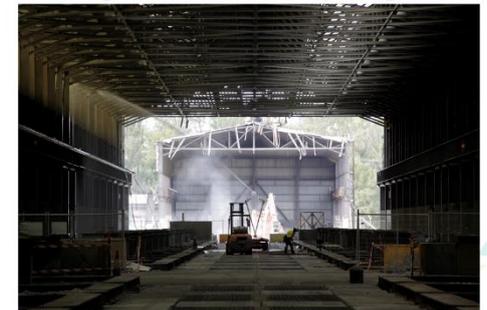
Stage 1 Demolition Progress

Washing the inside of Line 3 building to remove dust (photo taken 25/1/18)

Line 3 is almost to the half way point of demolition. Images shown washing inside line 3. Firehose to remove dust out of the roof. A water truck also being used on site to keep dust levels down for vehicles around site roads.

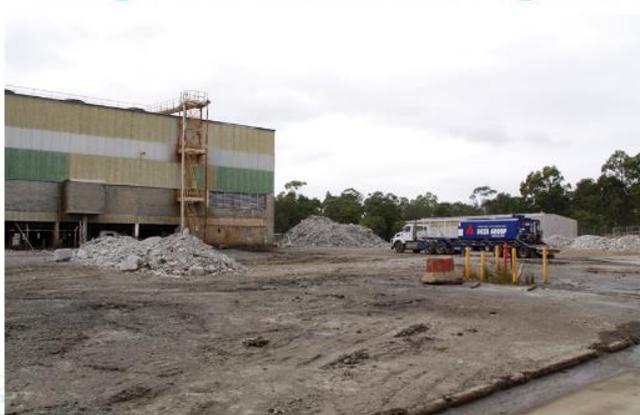
Stage 1 Demolition Progress

Water truck in use to wash down roads to suppress dust (photo taken 25/1/18)

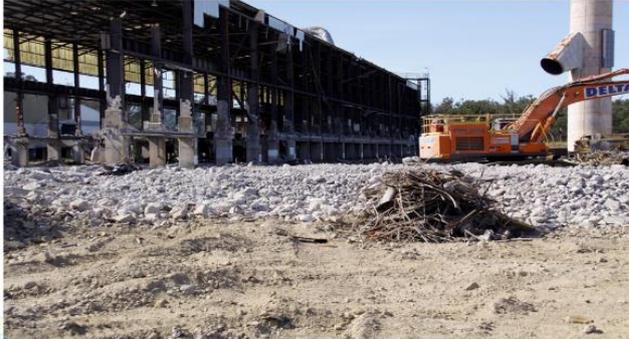
Stage 1 Demolition Progress

Line 3 South demolition area with concrete stockpile in foreground (photo taken 18/1/18). Concrete is being progressively analysed for contaminants.

Here we have been stockpiling concrete from the floor slabs and pot columns. We are going to use that concrete to backfill some of the voids. We've been getting it tested and samples taken just to check for fluoride before it gets used. Last few bays of line 3, being demolished in February.

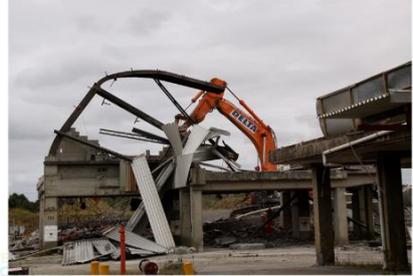
Stage 1 Demolition Progress

Last few bays at Line 3 south being demolished (photo taken 1/2/18)

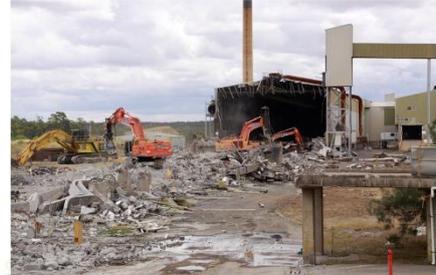
Stage 1 Demolition Progress

Sorting scrap steel and aluminium busbar & pulverising concrete at Line 3 south (photo taken 2/2/18)

Barricading on the bridge between line 2 & 3 at the southern end, after it was demolished. Image looking towards southern end of line 3, the other end of the building is gone. Here machines are pulverising concrete separating steel from aluminium. A few bays are demolished, they tidy up the site, scrap is segregated, then they load out and move on.

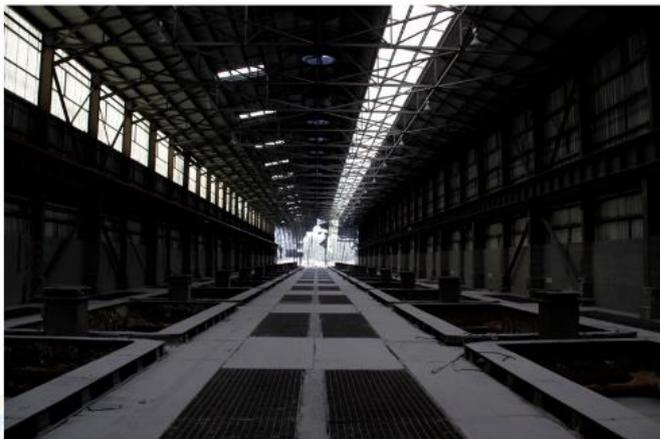
Stage 1 Demolition Progress

View of the inside of Line 3 (photo taken 1/2/2018)

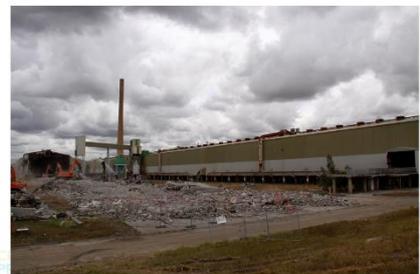
Stage 1 Demolition Progress

Line 3 south (photo taken 2/2/18)

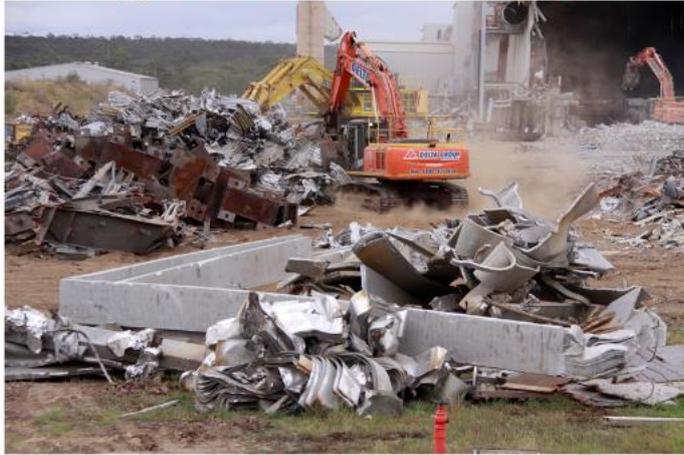
Stage 1 Demolition Progress

Sorting scrap steel and aluminium (photo taken 2/2/18)

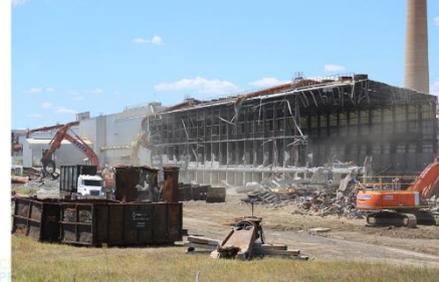
Stage 1 Demolition Progress

Progressing north towards the centre of Line 3 (photo taken 5/2/18)

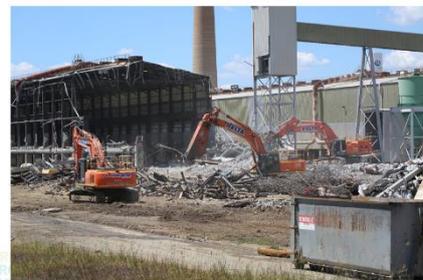
Stage 1 Demolition Progress

L3 demolition area showing south bath station, which is to be demolished in late February once L3S area is cleared (photo taken 5/2/18)

This is the south bath station to be pulled down in about two weeks – once far enough past that point they will attach cables and pull to the west to make sure it falls away from line 2.

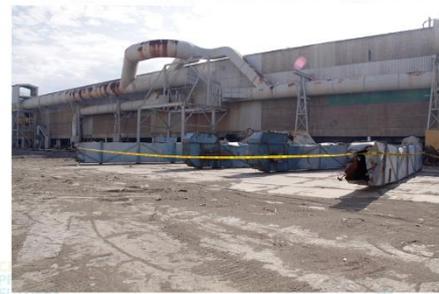
Stage 1 Demolition Progress

Bucket elevators from L1/2N on hold for asbestos gasket removal (photo taken 25/1/18)

Bucket elevators between lines 1 and 2. They found asbestos in gaskets. The demolition contractor found asbestos and plan to cut those flanges out before the steel is scrapped. They have been checking for asbestos and marking with florescent paint.

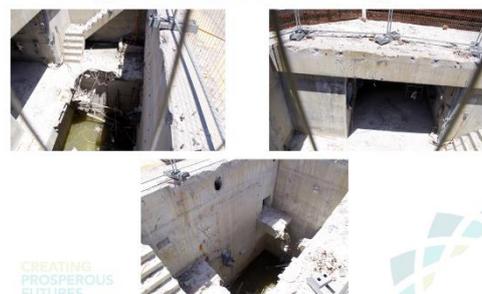
Stage 1 Demolition Progress

Line 3 south alumina dump station prior to backfilling

This is one of the voids - line 3 south dump station. They removed all the steel structure, the bucket elevator and dump hopper. The bucket elevator to convey the alumina into the silo. Here is an image of the slab that the silo was sitting on and in that void there was an air slide. Steel equipment has been removed and ready to be back filled with clean concrete.

AW: 8m deep. Some of the pits in casting are actually 13m deep.

AW: In stage 2 the top 1.5m will be removed again. So that slab's going to get broken up. They are going to dig 1.5m back out and knock in all these walls, pick the big pieces out and back fill with minus 40mm crushed concrete. It needs to be temporarily filled – for safety.

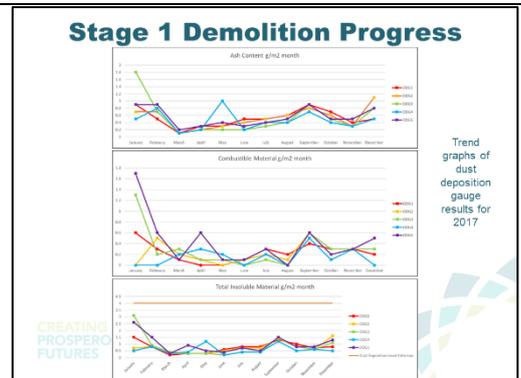
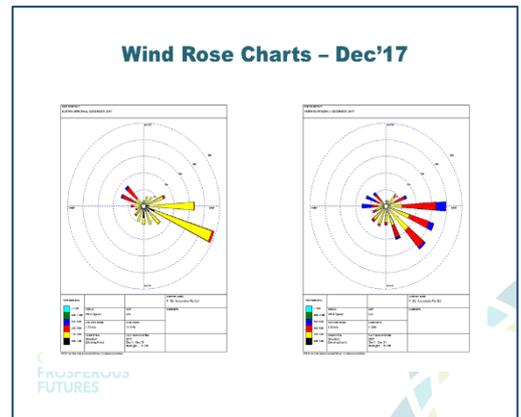
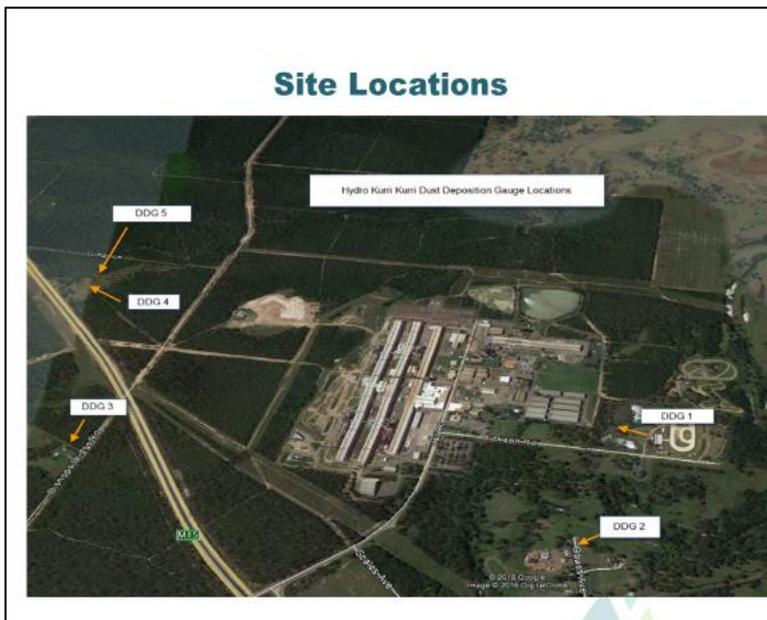
Dust Monitoring During Demolition - Dec'17

CMA tested for two types of dust – inhalable dust (100 micron particle size) and respirable dust (below 10 microns). A small increase on the day recorded for demolition to the day with no demolition. (0.15 milligram per cubic metre)

Respirable dust results (same dates) shown no difference. (Less than 1 milligram per cubic metre).

5.2.2 Respirable Dust
The airborne respirable dust results for background monitoring at active demolition site boundaries are shown in Table 6 and Table 7.

Graph – dust deposition gauges – 2017 data. Ash, combustible material and total insoluble dust. There is an allowable limit of 4g/sqm per month. The highest result for December was at dust deposition gauge number 2. Prevailing winds for December were southeast. Some fluoride was detected in dust (1.5)
