Project	Hydro Kurri Kurri site redevelopment project	From	Alysia Norris
Subject	Community Reference Group Meeting	Tel	1800 066 243
Venue/Date/Time	Thursday 13 December 2018 Hydro Aluminium 6.00pm – 7.10pm	Job No	2218982
Copies to	All committee members		
Attendees	<p>Mr Andrew Walker – Hydro Kurri Kurri Project Manager (AW)</p> <p>Mr Kerry McNaughton – Environmental Officer, Hydro Kurri Kurri (KM)</p> <p>Mrs Kerry Hallett – Hunter BEC (KH)</p> <p>Mr Allan Gray – Community representative - Retired Mineworkers (AG)</p> <p>Mr Ian Rush – Cessnock City Council (attending for Martin Johnson) (IR)</p> <p>Cr Darrin Gray – Cessnock City Council (DG)</p> <p>Mr Brad Wood – Community representative (BW)</p> <p>Mr Toby Thomas – Community representative, Towns with Heart (TT)</p> <p>Cr Robert Aitchison – Maitland City Council (RA)</p> <p>Mr Andrew Neil – Manager Strategic Planning, Maitland City Council (AN)</p> <p>Mr Michael Ulph – CRG Chair, GHD (MU)</p> <p>Ms Alysia Norris – Minutes, GHD (ANo)</p>

## Demolition Progress – CMA Contracting

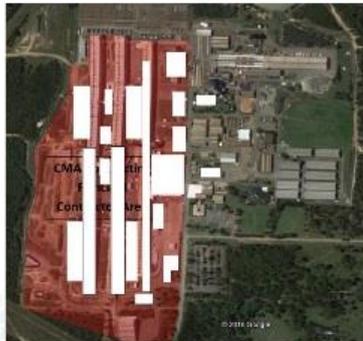
White boxes indicate areas which have been demolished.

- Contract awarded 11/16/2017
- Site meeting to discuss the demolition methodology and detail for Risk Assessment (November 16/17) process with SafeWork NSW on 11/20/17
- DRAW 1.1 – also called interim, full on 11/20/17
- Handover of certain part of the site to CMA on 16/10/2018
- DRAW 1.2 – plan for the demolition of the structure mid on 10/20/18
- Stage 1 management plans approved on 20/12/17 and demolition commenced thereafter
- DRAW 1.3 Structures between Line 1 and 2 held on 1/1/18
- DRAW 1.4 Pot line 3 demolition held on 14/1/2018
- DRAW 1.5 Casting demolition held 20/2/2018
- Stage 2 demolition approved by LCC on 16/03/18 & LCC needed management plans approved on 20/3/18
- DRAW 1.6 Curtain Plant demolition 25/3/18
- Stage 2 demolition work commenced 17/10/2018
- DRAW 1.7 stack demolition risk assessment workshop on 4/12/18

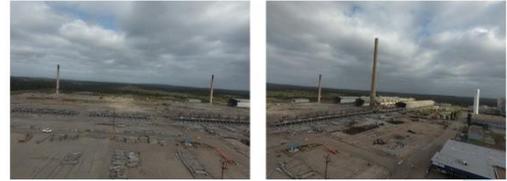
Aerial view of site taken on 24/10/2018

These are just a few aerial shots taken in October. As you can see line 1 demolition is progressing, and they're only focused on demolishing the roof, section by section. These gaps are where there's no fume duct trench in the basement, so they're able to drive through with their machines.

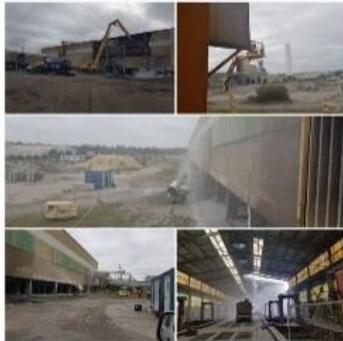
### Actions to Minimise Dust Emissions

**AW:** Yeah, I actually came in that day and I saw a lot of dust so I actually got them to shut down early that day. I think it was when they started in line 1. If it was the same day that I was here, you're talking about, I think it was when they first started in line 1. They had tried their best to clean inside, spraying inside the roof but it obviously wasn't good enough so we made them go back and do it again and do the rest of the pot line, washing it from the inside.

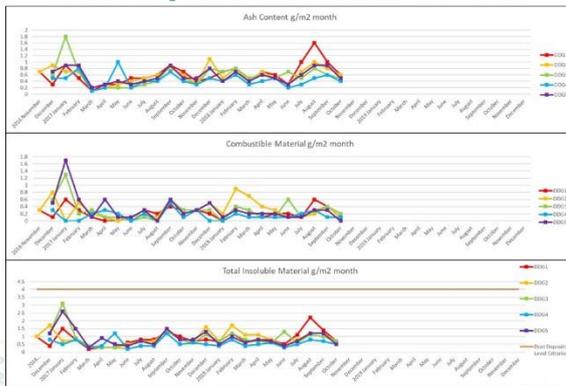
### Dust Deposition Results – Oct'18

These are the latest dust deposition results from October so you can see we did have some issues in August, I think that's about when we started line 1. We had a lot of westerly winds blowing, so that's sampling point 1, which was quite high. It has come down again but we did have some bad days in November where we had that red dust so I think all the locations might be higher, I'm not sure. We haven't seen the November results yet have we?

Trend graphs of dust deposition gauge results for 2017/2018

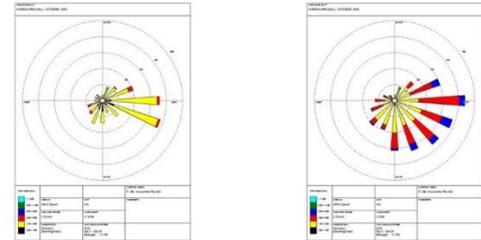
### Wind Rose Charts – Oct'18

**AW:** The wind's now coming from the south east and the east as opposed to the west so we need to keep an eye on these locations over this side with the wind blowing towards those (sampling points) four and five.

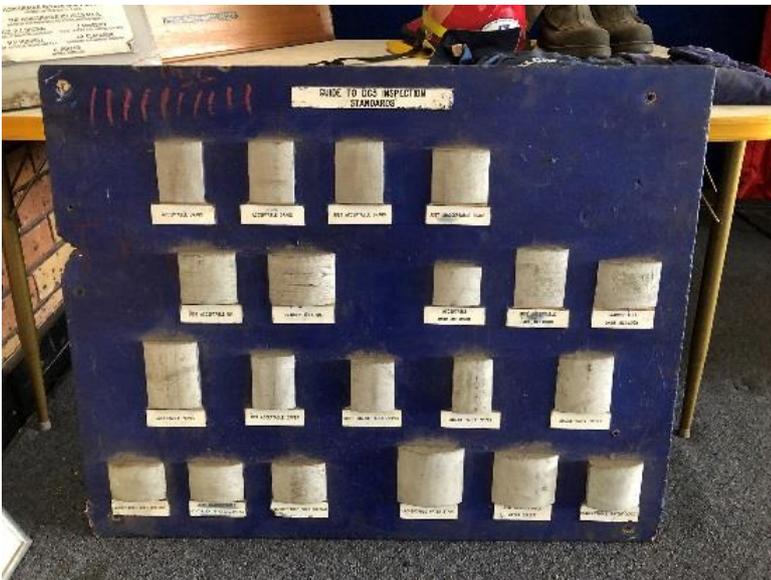
This is just an example, this was used at the DC3 inspection station so the operators had like a visual guide for just acceptable, acceptable and unacceptable defects on extrusion ingots. That might be of interest.
