2018 ANNUAL WASTE MANAGEMENT REPORT HYDRO ALUMINIUM KURRI KURRI SMELTER

Prepared By: Kerry McNaughton Environment Manager

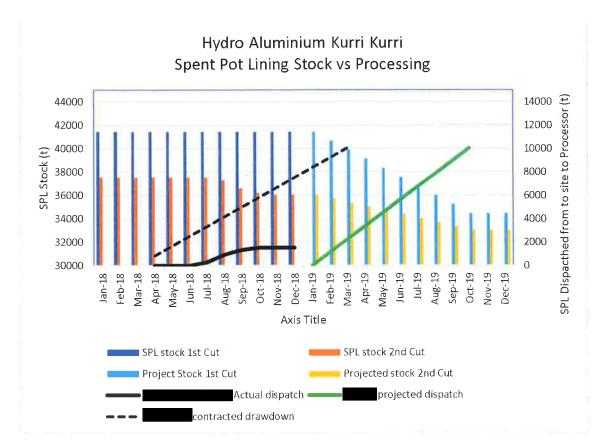
Figure 1: SPL Recycling status

At the beginning of 2018, the SPL stock at Hydro totalled 79000t. During 2018, 1509t have moved off site for processing resulting in a final stock level at the end of 2018 of 77491t.

As can be seen in Figure 1, by the end of 2018, 1509t of 2 nd cut SPL had been dispatched to for processing and subsequent export as compared with a contractual expectation that ~7500t should have been dispatched from Hydro in this period. Of this amount, 1217t had been exported to the Chinese end consumer during 2018.
There are a number of explanations for this shortfall:
 was not sufficiently prepared to transport and process the SPL at their facility which resulted in delayed and slow start to material movement. Corrective actions required from the facility audits have not been implemented and thus only the trial allotment of 1500t has been released to
Hydro has been following up regularly with regarding the status of actions required to correct the deficiencies identified in the audits. To date there has been no evidence from that anything has been done. Until there is acceptable progress made, Hydro considers the risk for further processing too great and will not release the remaining 8500t to Hydro is awaiting further action from It is hoped that the required actions will be completed during 2019 and the 8500t residual of the contract will be processed.
