Project	Hydro Kurri Kurri Site Redevelopment Project	From	Sonya Pascoe
Subject	Community Reference Group Meeting	Tel	1800 066 243
Venue/Date/Time	Thursday 19 August 2021 MS Teams video conference 6.05pm – 7.14pm	Job No	2218982
Copies to	All committee members		
Attendees	Mr Richard Brown – Managing Director, Hydro Kurri Kurri (RB) Mr Andrew Walker – Hydro Kurri Kurri Project Manager (AW) Mr Kerry McNaughton – Environmental Officer, Hydro Kurri Kurri (KM) Mrs Kerry Hallett – Hunter BEC (KH) Mr Andrew Neil – Manager Strategic Planning, Maitland City Council (AN) Mr Toby Thomas – Community representative, Towns with Heart (TT) Mr Iain Rush – Cessnock City Council (attending for Martin Johnson) (IR) Cr Robert Aitchison – Maitland City Council (RA) Mr Rod Doherty – Kurri Kurri Business Chamber (RD) Mr Alan Gray – Community representative - Retired Mineworkers (AG) Mr Michael Ulph – CRG Chair, GHD (MU) Ms Sonya Pascoe – Minutes, GHD (SP)

5 Project Update

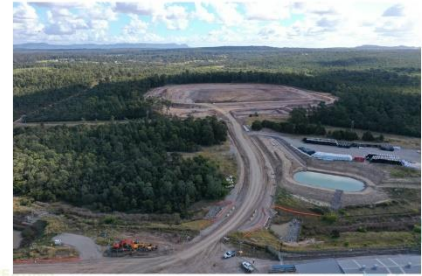
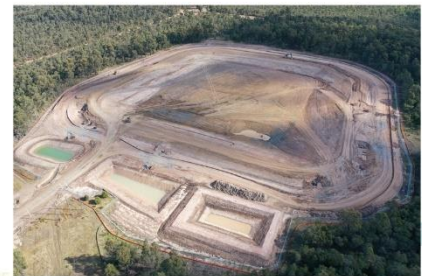
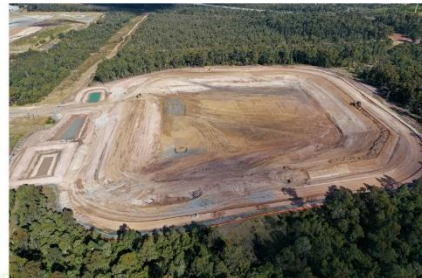
At this point, Daracon are just finishing off trimming the base of the cell to the design levels for the sub-grade and you can see in this photo they have dug in one sump, which is in the northeast corner and the other one still hasn't been done.

I've got the same photos two months later. You can see the progress that's been made.

CRP PROSPERITY FUTURE • ECC Works – Overall Site Layout (21/6/21)

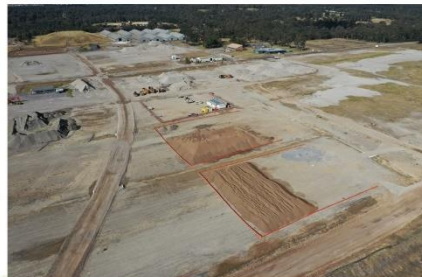
The drainage aggregate has continued to come in from Denman, and that's all on site. There's about 16 thousand tonnes and that goes in the base of the cell and that's where any leachate that forms as a result of rain while we're transporting waste from the capped waste stockpile to the cell. We collect it in that drainage aggregate and make its way to the sumps where it will be extracted and treated on site. I'll talk about the water treatment plant a bit later.

CRP PROSPERITY FUTURE • Leachate drainage aggregate stockpiles (21/6/21)

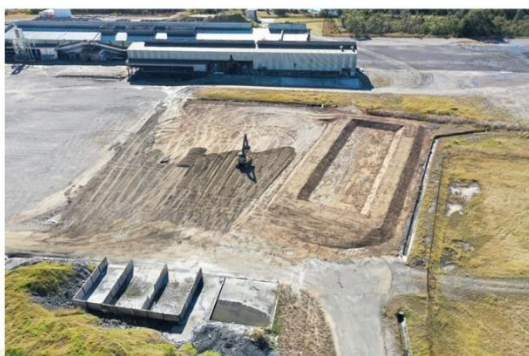
CRP PROSPERITY FUTURE • AEC2 – construction of Leachate Buffer Storage Pond and level pad for TWTP concrete slab adjacent to the Capped Waste Stockpile (5/7/21)

In this photo you can see what we call AEC2 – area of environmental concern, which is where the anode butts used to be

stored. That's been remediated and this is where we were going to locate the water treatment plant. The excavator there is just making a level pad and a concrete slab is going to be poured there within the next few weeks and there will be four, 100,000 litre tanks of treated leachate will be stored there, and tested, and once the results come in it will be discharged to the storm water system. To the right of the excavator is the leachate buffer storage pond. There is one of those at the cell and one down there at the capped waste stockpile, in the right of that photo, and leachate will be pumped across into this pond and from there it will go through the water treatment plant and get treated.

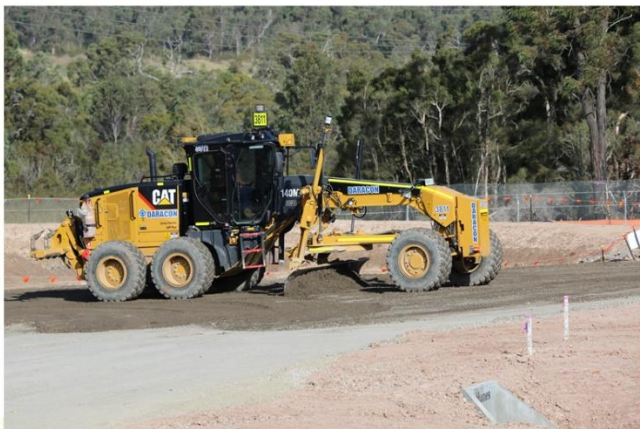
PRC • ECC Works – Grader trimming the sub-base layer on the ECC perimeter road (19/7/21)

This is a grader laying the sub-base layer at the perimeter road.

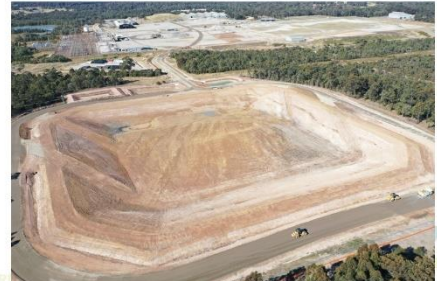
This is a bit later on, in early July. You can see all the ramps are formed and the two sumps were dug in. We've also been building the roads. The perimeter road and the access road to the cell and this is testing of the pavement using a HILF density meter.

PRC • ECC Works – Perimeter Road Construction (5/7/21)

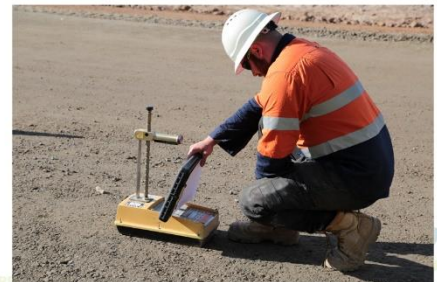
PRC • ECC Works – Compaction testing of perimeter road select fill layer by HILF density measurement (6/7/21)

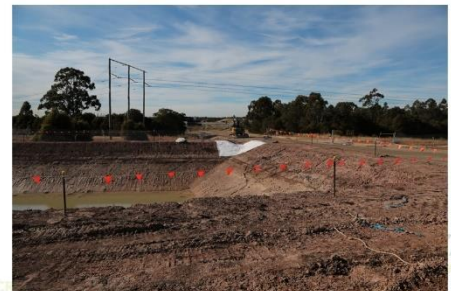
Daracon have also been finishing off the drainage works. Last meeting, I showed a number of photographs showing all the drains going in under the four ramps that go into the cell. All that water leads into the sed (sediment) basins near the cell, sed basin 1 and sed basin 2, they've been putting the rip rap and rock on the outlets, which feed into two swale drains.

PRC • ECC Works – Sed Basin 1 Rip Rap Outlet (6/7/21)

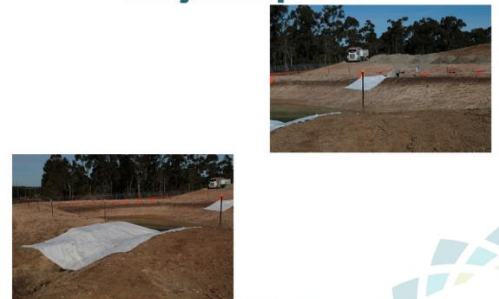
So, the previous photo was sed basin 1, this is sed basin 2. You can see rip rap on the inlet side and the outlet side.

PRC • ECC Works – Sed Basin 2 Rip Rap Inlet and Outlet (6/7/21)

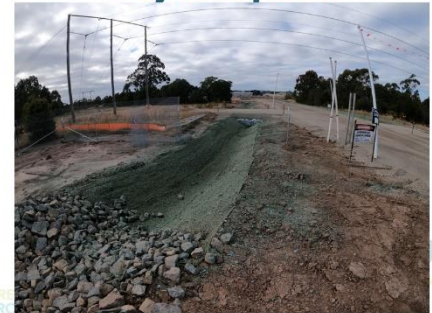
This is the other swale drain on the northern side of the access road, and Daracon sprayed that with hydro mulch to try and get some vegetation growing.

CREATING PROSPERITY FUTURES
• ECC Works – Swale Drain 02 (21/7/21)

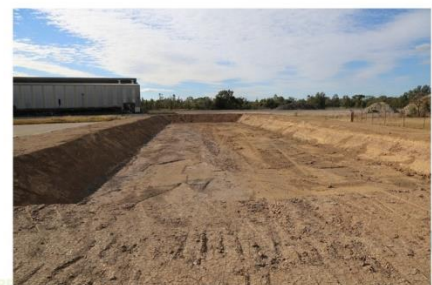
This is just another photo of the leachate buffer storage pond. So, these two ponds they have to be lined with 600 mm thick clay-rich fill which has to be tested and has to conform to tech spec from GHD. And once the clay rich fill is installed, then it's lined with 2 mm HDPE liner, high density polyethylene, it's like a black plastic. And all that gets welded together, that's so that no leachate can escape from the pond. And that will be happening next week.

CREATING PROSPERITY FUTURES
• ECC Works – Leachate Buffer Storage Pond (19/7/21)

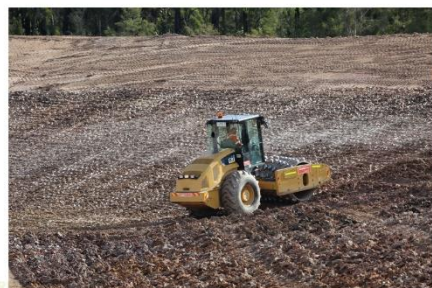
The other thing that Daracon has been doing is the rip and recompact of the sub-grade in the cell and last meeting I showed a number of photographs of the scrapers that did the excavation of the cell, and you will see them in the video that I'm going to show later. On the berms around the perimeter of the cell, about two-thirds of it is in-cut, so excavated, and the top third is in-fill. So that top one third has already been tested, it was compacted in 150 mm lifts, compacted and then the density was all tested and it was fine, so we don't have to rip and recompact the area that's in-fill. So, that's why you can see that line there. So, they go through with the ripper, they drop the tines on a grader and they rip the surface, and they compact it with a pad foot roller which is what you can see here.

CREATING PROSPERITY FUTURES
• ECC Rip & Recompact – Compaction Works (19/7/21)

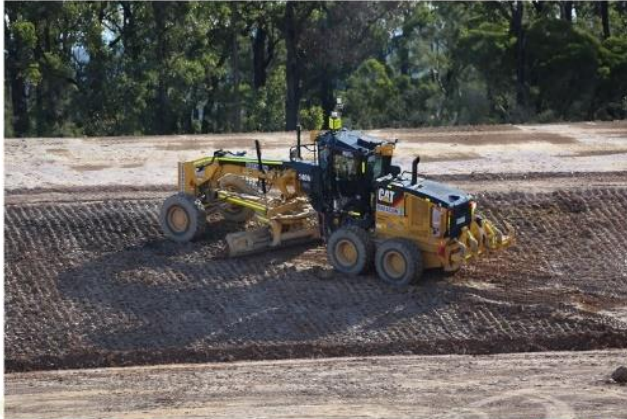
Then they trim it with the grader to get it to the level that's in the 12D model, which is software inside the machine. It uses GPS

and it can trim to the exact contours that were designed as part of the detailed design.

• ECC Rip & Recompact – Trimming Works (19/7/21)

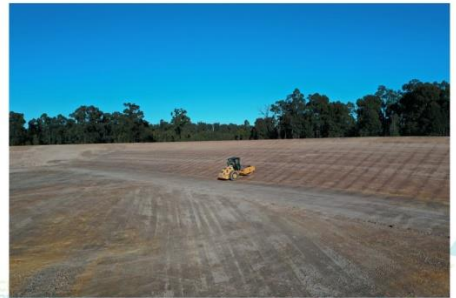
• ECC Rip & Recompact - Smooth Drum Rolling (20/7/21)

And finally, they do a final roll with a smooth drum roller.

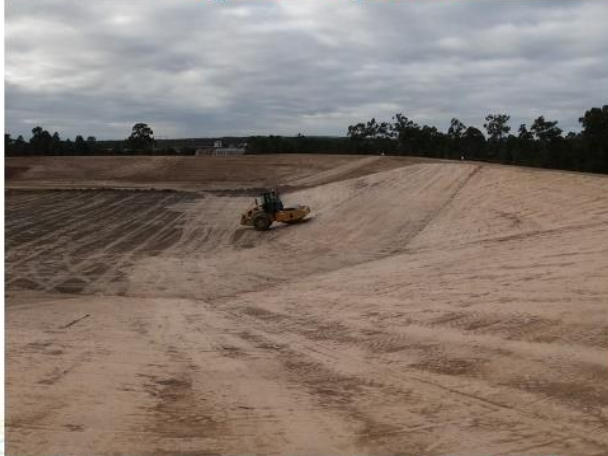
• ECC Rip & Recompact – Smooth Drum Rolling (21/7/21)

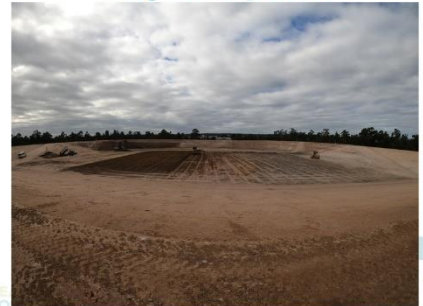
• ECC Rip & Recompaction of Base (21/7/21)

It was at this point that my team was involved with the proof roll test, so that's a hold point and we had to inspect the proof rolling of the whole cell. And we did find one or two soft spots, so that had to be boxed out, they dug down about 200 mm, removed that unsuitable material, replaced it with good clay and recompact it. So that proof roll – it was explaining that last time as well – if there is any sinking of the roller, it doesn't hold up properly, you've got to replace it. So anyway, we've been over the whole cell, and the independent engineers inspected it and its all ready now, everyone is happy with it. And walking around inside of it now is

like a ballroom dance floor, it's so smooth. And that's now ready to be lined, and lining works should be starting next week.

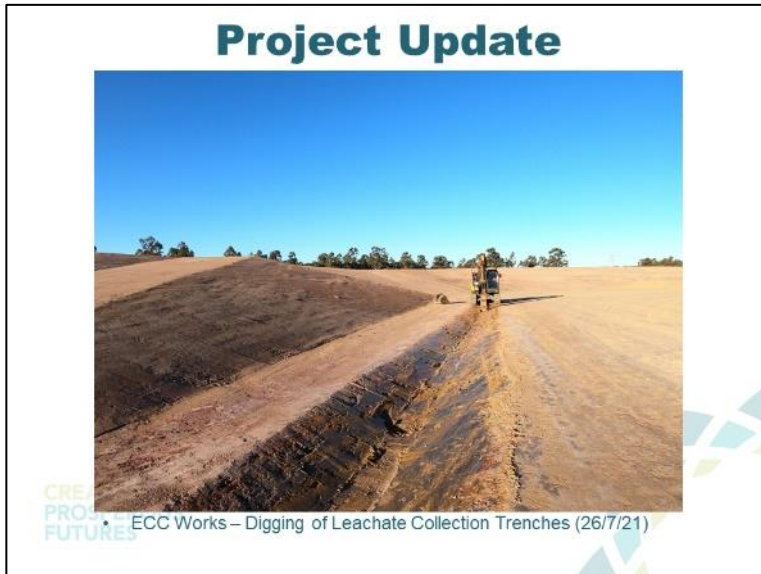
This is a little bit later, ripping and recompacting the base of the cell, the grader working there trimming it

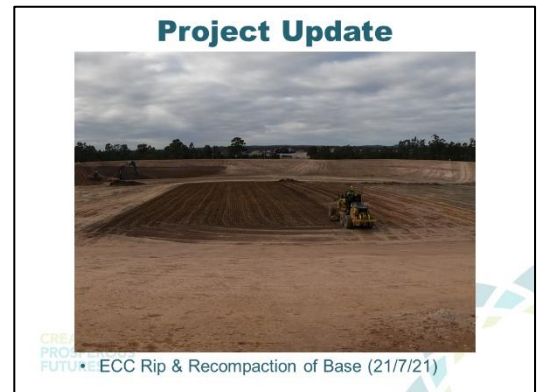
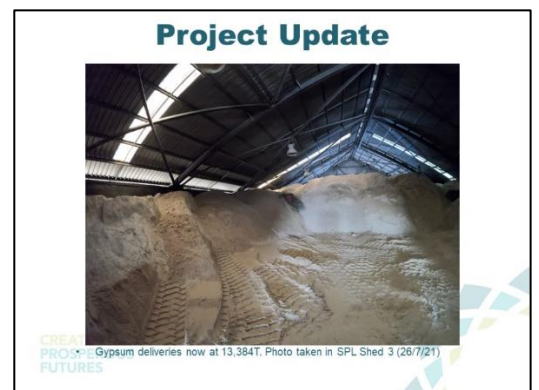
Daracon have been digging the leachate collection trenches. So, these trenches will be lined the same as the rest of the cell, with the nine different layers of material. And the leachate pipes will be installed after all the liners have gone in and they will lead to the two sumps. And the cell actually drains towards the sumps, so it drains from the centre to the north and the south and then to the east.

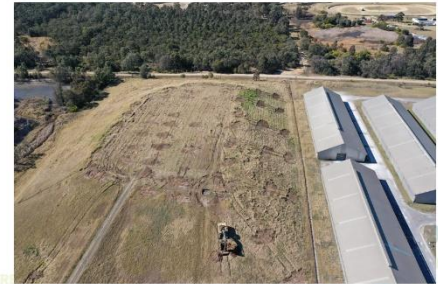
AW: About 1.5 metres, that's through the topsoil and the clay and down to the to 200 mm thick gravel gas drainage layer.

AW: Yeah, it was getting an accurate fix on the volume of the waste and measuring how consistent is the clay cap and the topsoil. But they are building that into their models how they are going to move their waste. And we are going to have a workshop within the next eight weeks to go into detail on how this waste will be relocated, because it does contain friable asbestos, and it will be Enviro Pacific Services that will moving the waste, they are Daracon's sub-contractor, and we want to have a workshop with them and they are going to present their methodology to us, and we will critique it and we will bring along some of our consultants who have worked on this in the past, looking at various options on how we were going to remediate the site. We looked at about half a dozen different options and were going to revisit some of that

• Test pitting of the CWS cap (6/8/21)

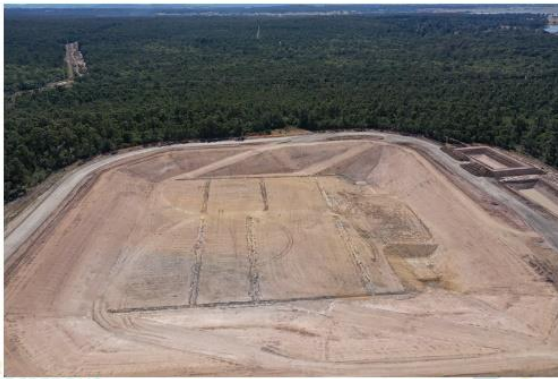
So there, you can see this is looking from the south you can see the leachate drainage trenches, you can see the two sumps at the north-east and south-east corner, you can see the four ramps leading into the cell.

• ECC Works – Overall Site Layout (6/8/21)

You can see the perimeter roads and the access road.

It's pretty much as per the drawing now and ready to start lining.

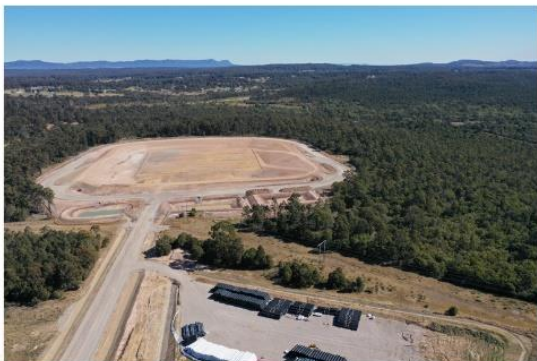
• ECC Works – Overall Site Layout (6/8/21)

Just on the liner materials – all those rolls of liner materials you can see in the foreground, there has been a lot of work happening

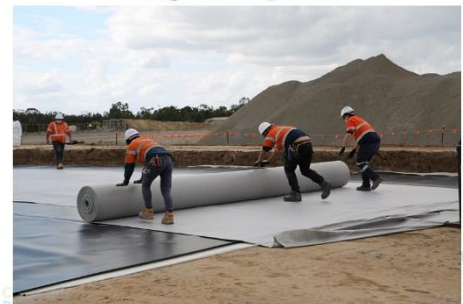
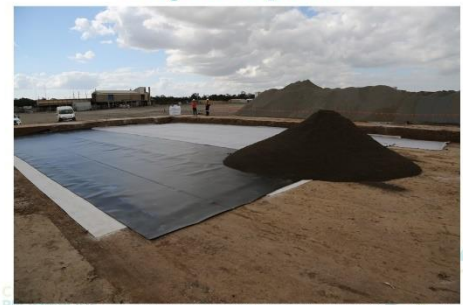
The last two days on site, we have actually been doing something quite interesting. It's a trial pad, and what this involves is taking the clay that was excavated from the clay borrow pit for the cell, and actually making a pad to simulate the sub-grade. And Eco Line have been lining the cells, they have put down the GCD, which is the geo-composite drainage layer then the separation geotextile, geosynthetic clay liner, which is the bentonite, then the first layer of 2 mm HDPE, which is what you can see here in this photo. And that's what you call a secondary barrier. It's the lower one.

And onto that, they... we did a trial, the contractor raised this, it's not part of the design but they suggested that we should have an extra layer of separation geotextile to end the HDPE and the sand. So, we're doing a trial within a trial. We have done half with and half without this separation geotextile.

Then they have started putting down the sand, I spoke about the sand last time, the sand is coming from Metromix quarry at Teralba, and its sand that has come from crushing of conglomerate rock. So it's not beach sand, it's more like a river sand.

So that was pushed out and they had the sand in four different thicknesses, so one metre thick, 700 mm thick, 500 mm thick and 300 mm thick, which is the design thickness. And they wanted to test their work method of driving a 40 tonne moxie on the one metre thick sand layer, 700 mm thick sand layer. They had a smaller dump truck, which has less ground pressure, and they ran that backwards and forwards on the 500 mm layer. They drive the machines across it about ten times. And on the 300 mm they just use the positrack and the swamp dozer, which are the two machines you can see there. They ran them east-west, and today they actually removed all that sand, and they were looking for scratches in the east-west direction, which is perpendicular to the direction of the machines are going in there for filling. We were

PK • Trial Pad to assess any damage to the HDPE caused by materials handling equipment and procedures (18/8/21)

looking for any damage caused by those machines, tracking east-west. If the scratches were north-south, that would suggest they were caused by this operation, which is pushing the sand out in the first instance. What we did find, though, is that the separation geotextile is a good idea because it did... although the scratches were quite small there was nothing more than 20 to 40 microns, and were allowed up to 200 microns, the side that had the protection geotextile had no scratches at all.

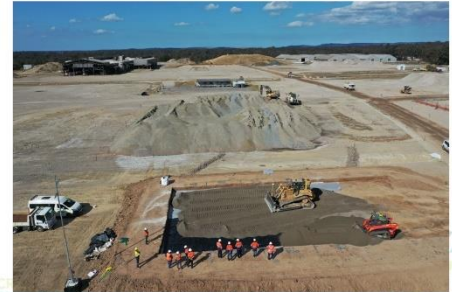
And tomorrow, they are going to build the primary barrier, that's another layer of geosynthetic clay, 2 mm HDPE. Then they'll put down protection geotextile and then the drainage aggregate, again in different thicknesses, to simulate what is going to happen in the cell. And we had two different types of drainage aggregate, one is 20 to 14, the finer one, and the other one is 50 to 20, the coarser one. And we'll put half the cell with the finer gravel and half the cell with the coarser, and we'll do the same tests, running the machines over the test pad and then carefully remove the materials and look for any damage caused to the HDPE. It's a very important test, so the contractor can work out what machines they can and can't use, because obviously, you don't want to be causing damage to the liners and putting holes in them. They have to last a long time, they have to last in perpetuity, so we want to do it properly.

• Trial Pad to assess any damage to the HDPE caused by materials handling equipment and procedures (18/8/21)

AW: Just on that, we have got a camera set up, which you can see in the bottom left-hand corner of the screen, and it takes a shot every one minute and we can get time lapse footage of the trial. We could put something together for the next meeting in two months' time to show and explain a little but more what we did. And we'll have the results to show the CRG then as well.

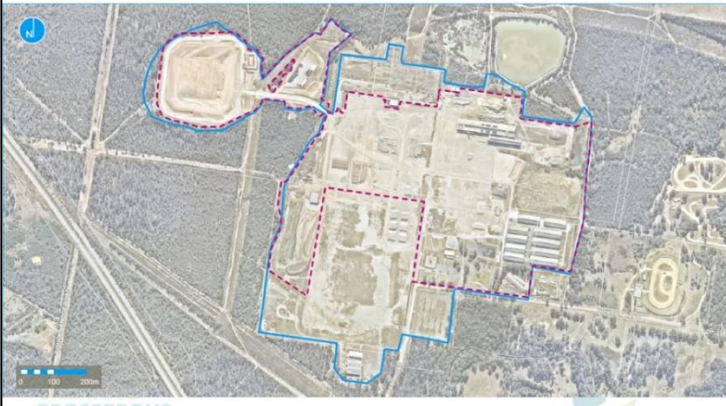
Mod 2 – Project Boundary

So, what it will look like now is now within the dashed line. So, a couple of features that you can see there are a large part of the southern part of the site we are trying to remove from the project, which is being completed, demolition and remediated, so there's no constraints on that from a physical perspective. So, we'd like to have that removed from the project definition to allow potential development activities to occur.

Another part of the site, which you're probably now familiar with, is the switch yard location. So that's actually subject to an independent contract piece of works for the demolition and remediation for the future site owner. So that work is independent, that work is happening independently of our remediation activities. And once completed that will also form the site for the Hunter Power Project. And the other part that I mentioned is removing aspects of the footprint that are not necessary for clearing, so you can see that the red line here sits within the blue line and there are parts of the area in between which we didn't need to clear. And I can demonstrate to you by showing you the next slide. So, if you pay attention to that aerial underneath the slides so that's a bit older, prior to us doing the veg clearing in that area. And when I move that forward...

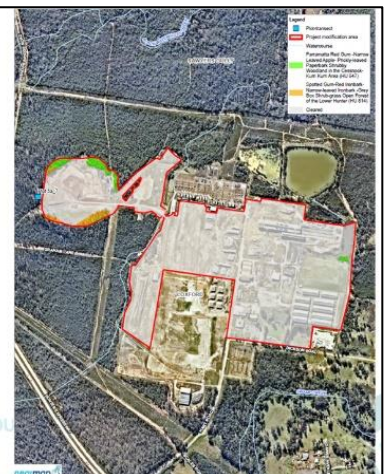
Mod 2 – Reduced Veg Clearing

And further to that – apologise for my title being in the wrong orientation - so, these were the areas that were reassessed for having an actual impact. So, we had to go back and re-evaluate the areas that we were impacting on, the biodiversity, and you can see this is inside what was on the previous slide, the red dashed

lines, the red line here is the same as the red dashed line there, and this shows there are still small impacts on the green, which is the Kurri Sand Swamp Woodland ecosystem, and the orange which is Spotted Gum Ironbark ecosystem. And associated with that are some specific species.

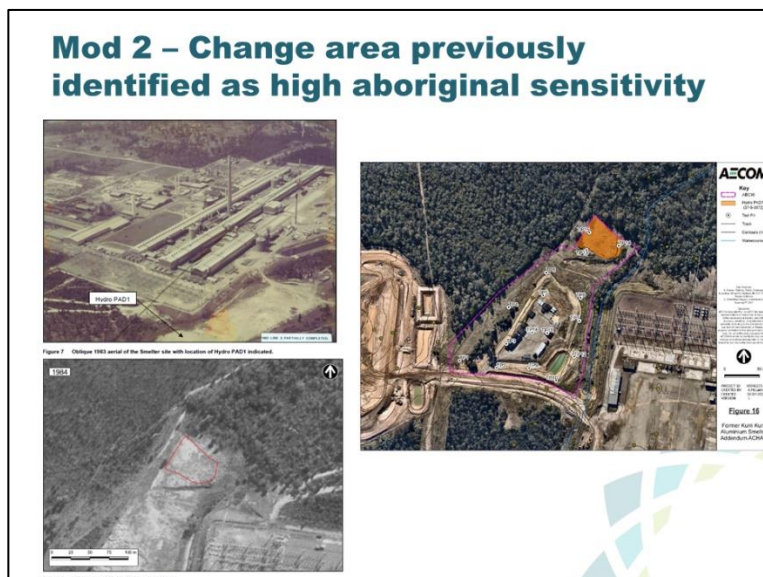
And the other part I mentioned was about the pad that was identified, so on the right-hand side here you will see this area identified in orange was an area previously identified as having potential high Aboriginal sensitivity. Like we said on investigation, and in these photos, you can see from the early eighties this material was suspected to be fill in those locations. So, we went out and just confirmed that with test pitting and we actually identified some fill. In fact, there is one section there with fill that has got high level of contaminants that will likely need that that material will go into the cell. Those contaminants, I think, were chrome and copper, some metals essentially. Not really sure of the source, but they're low levels slightly exceeding the site criteria so it's likely we are going to have some of that material going into the cell. So the process we have needed to go through
