Document type  
**Statement of Environmental Effects**

# **HYDRO REMEDIATION PROJECT MODIFICATION 2 TO SSD 6666 – PROJECT BOUNDARY AND ABORIGINAL HERITAGE AMENDMENTS**

Project name **Modification 2 to SSD 6666 – Project Boundary and Aboriginal Heritage Amendments**  
Project no. **3180001207**  
Recipient **Hydro Aluminium Kurri Kurri Pty Ltd**  
Document type **Statement of Environmental Effects**  
Version **V0**  
Date **07/09/2021**  
Prepared by **Claire Whitehill and Clare Butterfield**  
Checked by **Shaun Taylor**  
Approved by **Fiona Robinson**  
Description **Modification to SSD 6666 to revise the project boundary and vegetation clearance area and remove Condition B38 as the area of high archaeological significance of the northern area east of the Clay Borrow Pit was incorrectly classified.**

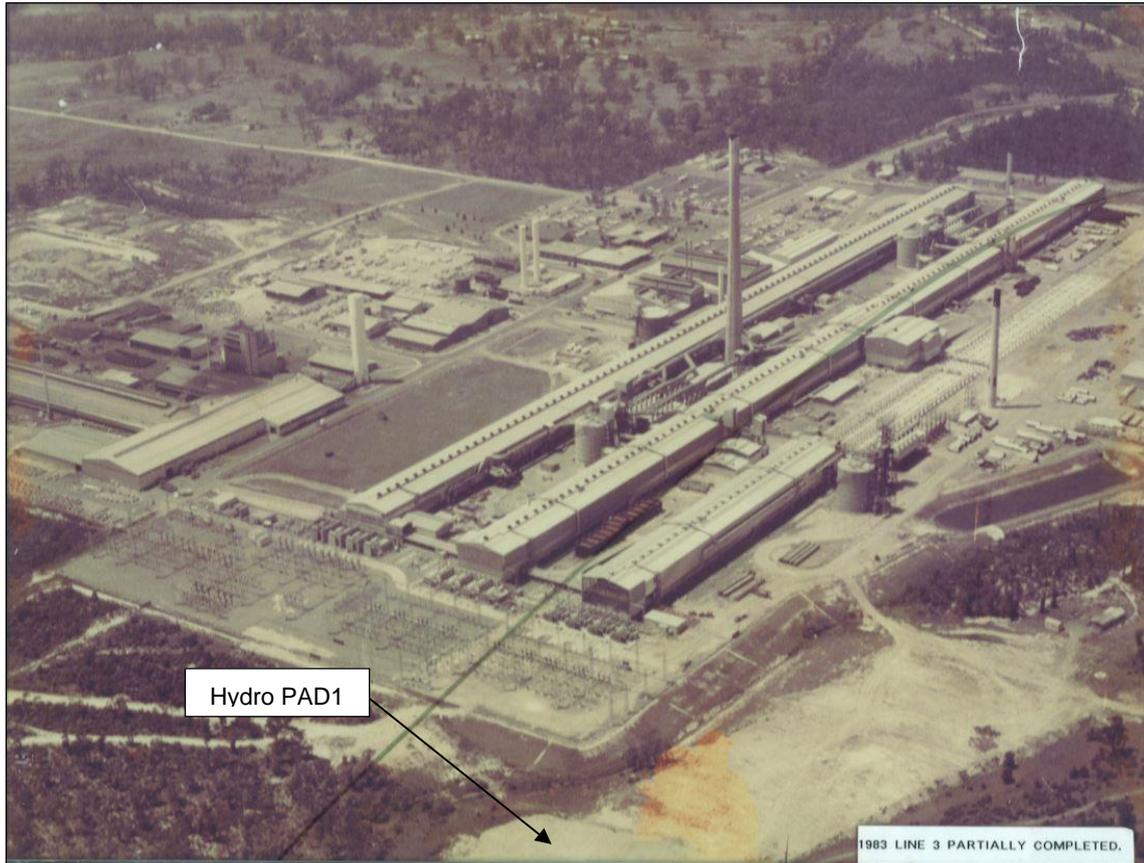
Figure 7 Oblique 1983 aerial of the Smelter site with location of Hydro PAD1 indicated.

- Prior to c.1983, ground disturbance within Hydro PAD1 appears to have been limited to native vegetation removal;
- In or around 1983, land within and to the south of Hydro PAD1 was extensively stripped and/or filled. This disturbance, ostensibly associated with the construction of the Smelter's third potline, is clearly visible on the 1983 (Figure 7) and 1984 (Figure 8) aerials;
- Post-1984, no major, additional ground disturbance phenomena are evident within Hydro PAD1. Land within the site appears to have been left vacant and unused; and
- Aerials examined for this assessment suggest that, contra AECOM's 2015 assessment, land within Hydro PAD1 has been severely disturbed. Natural soil profiles within bounds of the PAD are likely to have been radically modified via heavy earthworks.

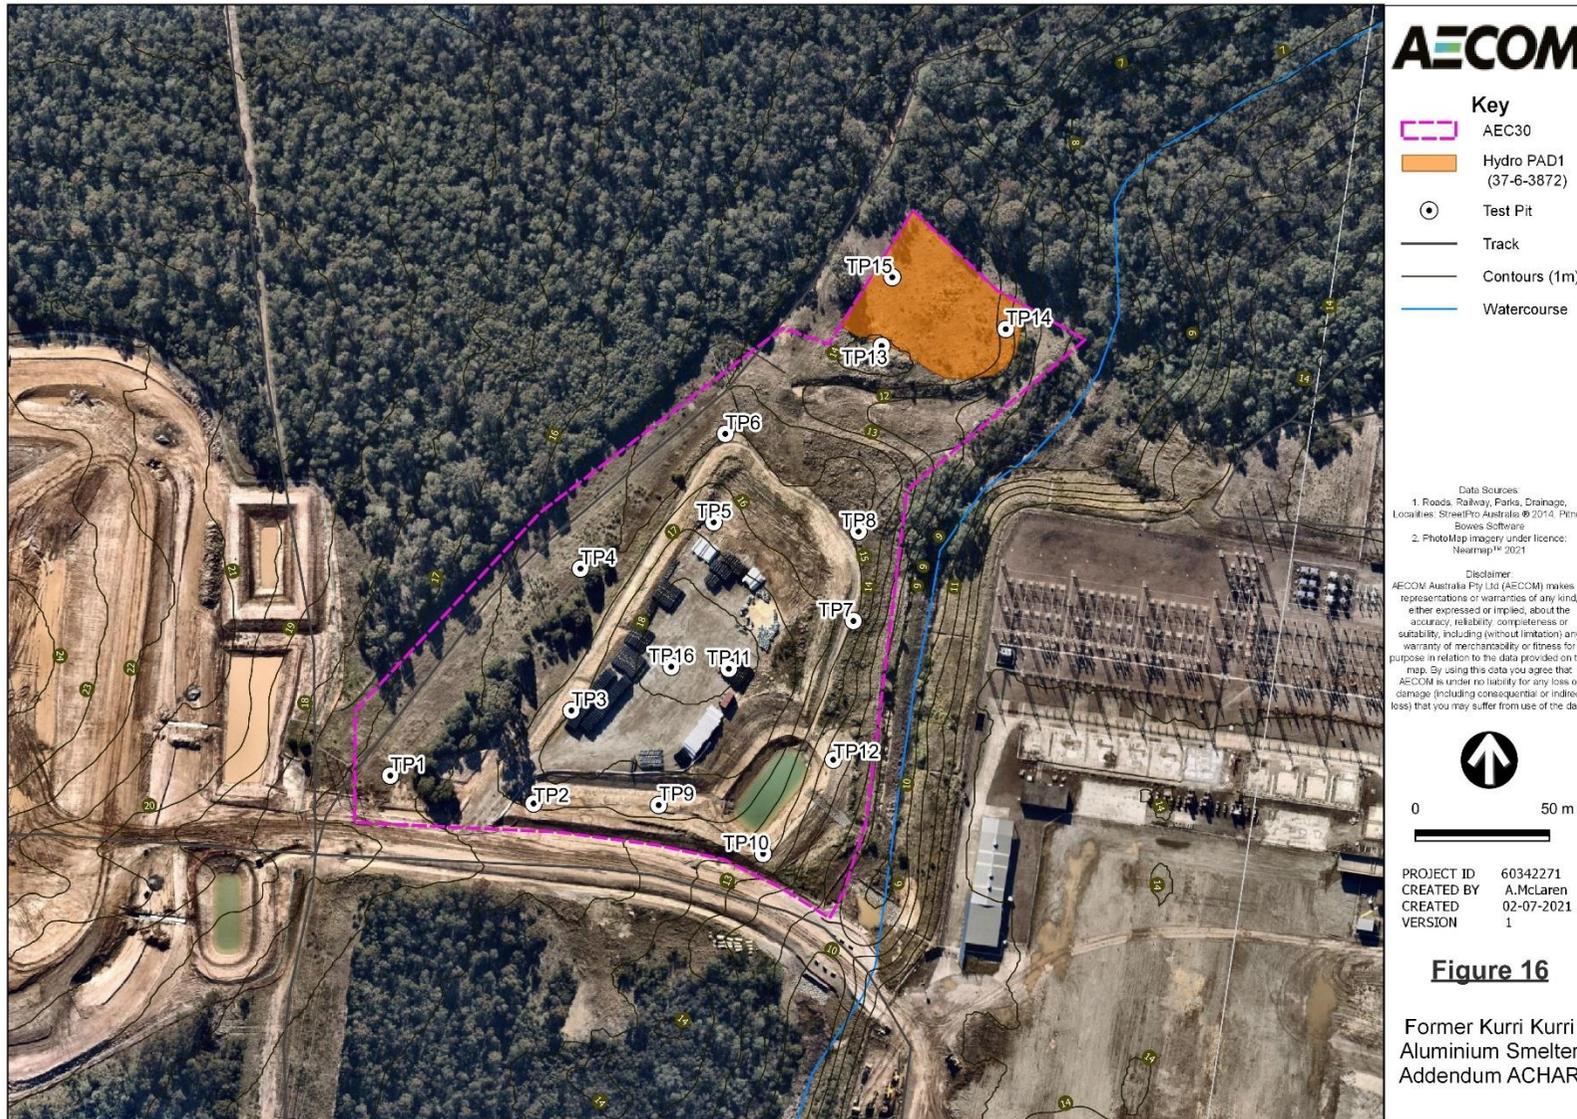
Figure 16 Map showing location of AEC30 and associated test pits relative to Hydro PAD1

- Natural soil profiles across AEC30, including Hydro PAD1, were severely disturbed as a result of the ground disturbance works evident on the 1983 and 1984 historical aerials for this area; and
- Logs for TPs 13, 14 and 15 suggest that natural topsoils within Hydro PAD1 have been removed, with fill deposits overlying high plasticity sandy clays consistent with locally occurring subsoils.

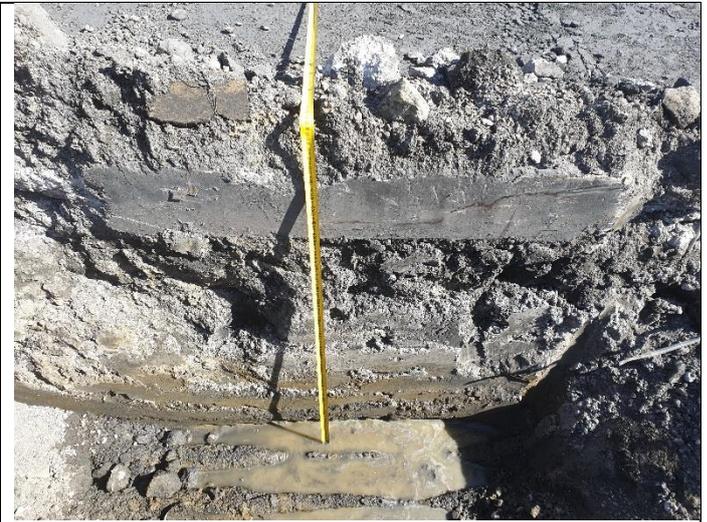
**Photograph 8:** AEC 2 Anode Waste Pile TP206. Water at base of excavation.

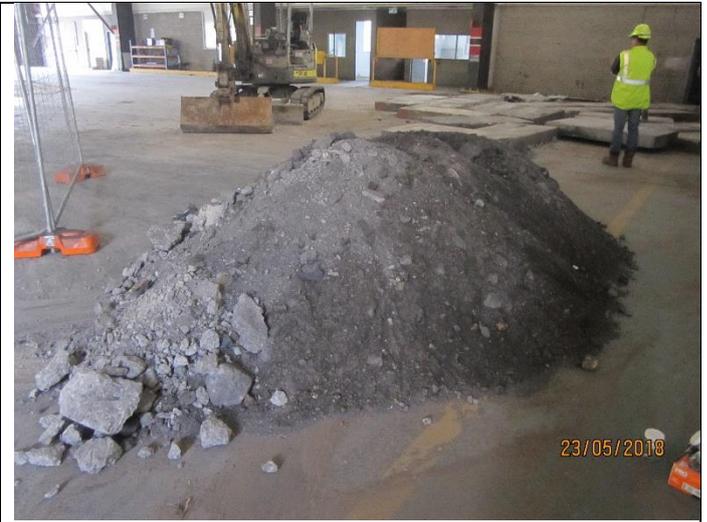
**Photograph 26:** AEC 18 Pot Rebuild Area 77A-Pit 1 backfill material.

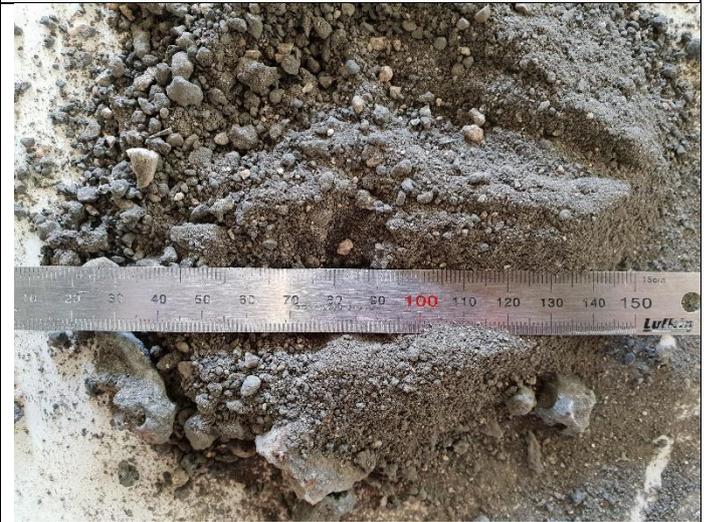
**Photograph 28:** AEC 18 Pot Rebuild Area 77A-Pit 2 slurry from concrete core cutter.

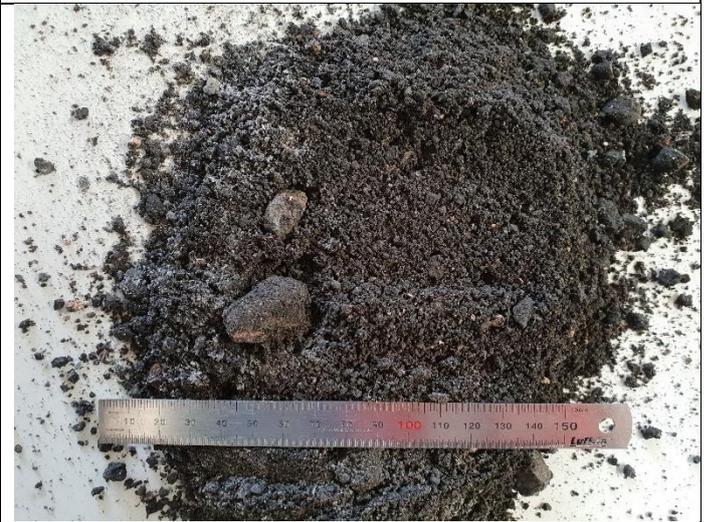
**Photograph 30:** AEC 18 Pot Rebuild Area 77A-Pit 3 slurry from concrete core cutter.

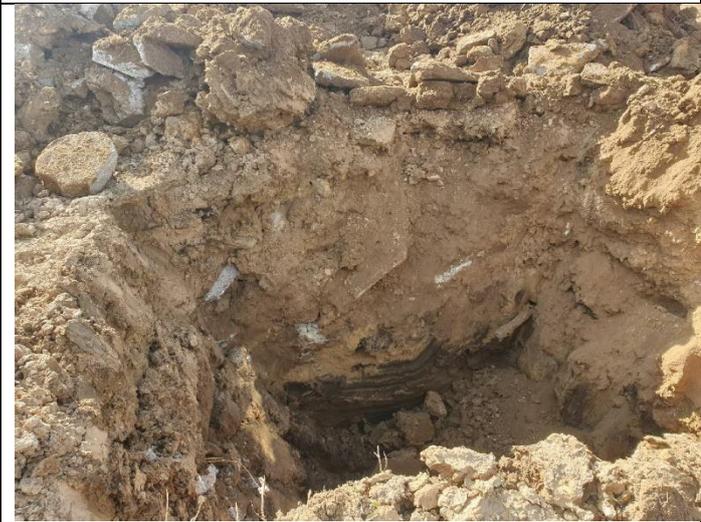
**Photograph 35:** AEC 33 Area East of the Clay Borrow Pit AECBP\_TP3. Foreign material observed.

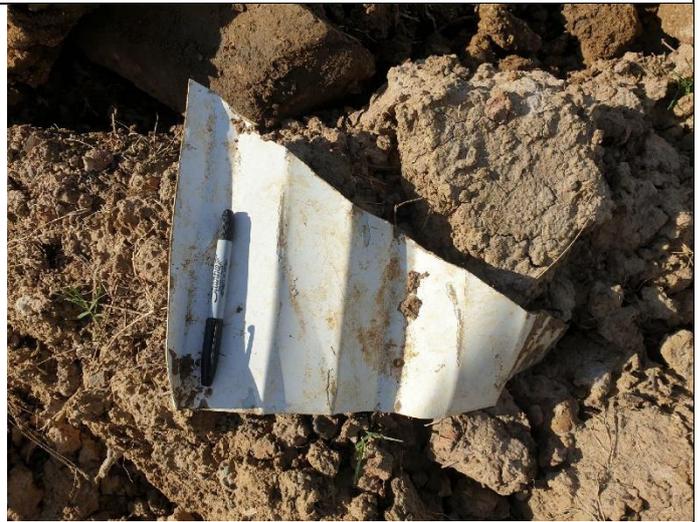
**Photograph 36:** Metal in test pit spoil AECBP\_TP3.

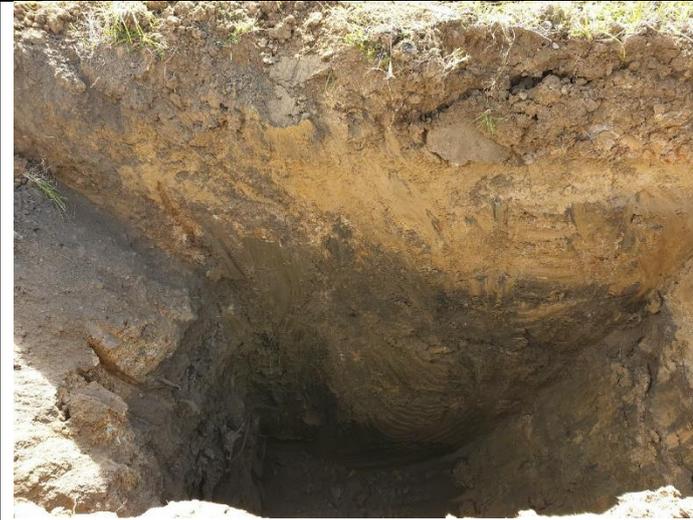
**Photograph 43:** AEC 33 Area East of the Clay Borrow Pit AECBP\_TP8. Foreign material observed.

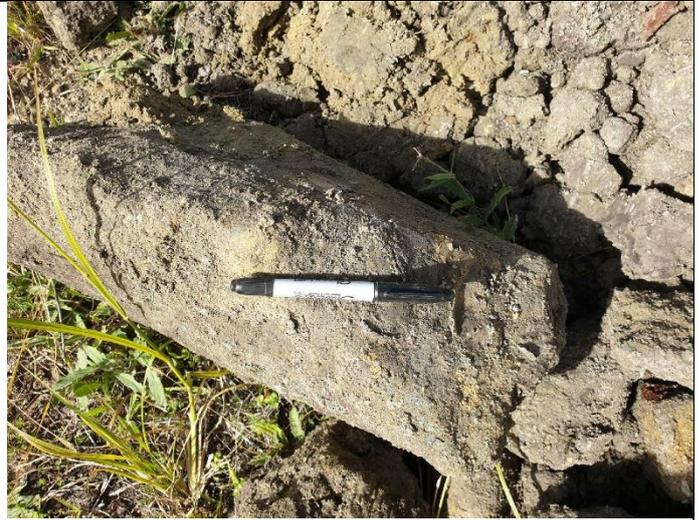
**Photograph 44:** Boulders in test pit spoil AECBP\_TP8.

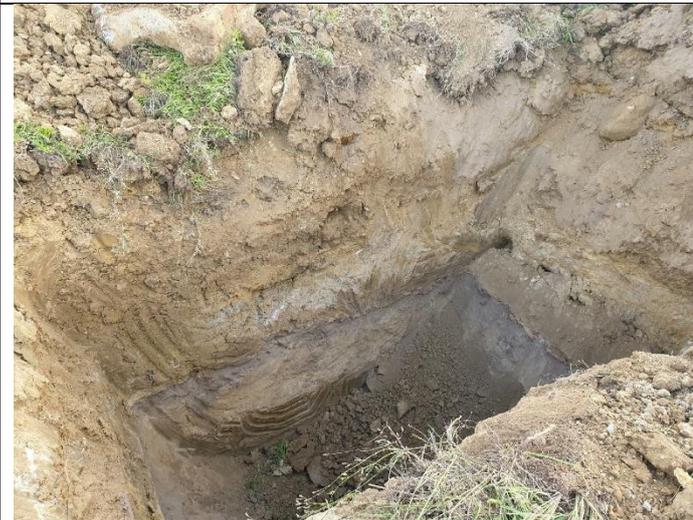
**Photograph 47:** AEC 33 Area East of the Clay Borrow Pit AECBP\_TP10. Foreign material observed.

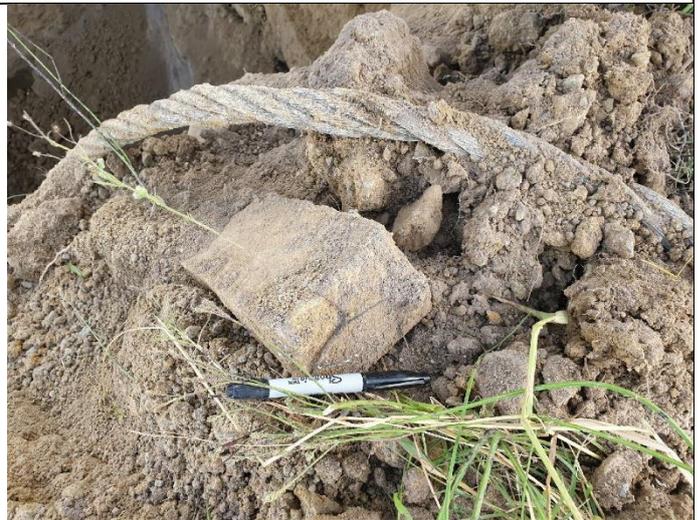
**Photograph 48:** Brick and rope in test pit spoil AECBP\_TP10.

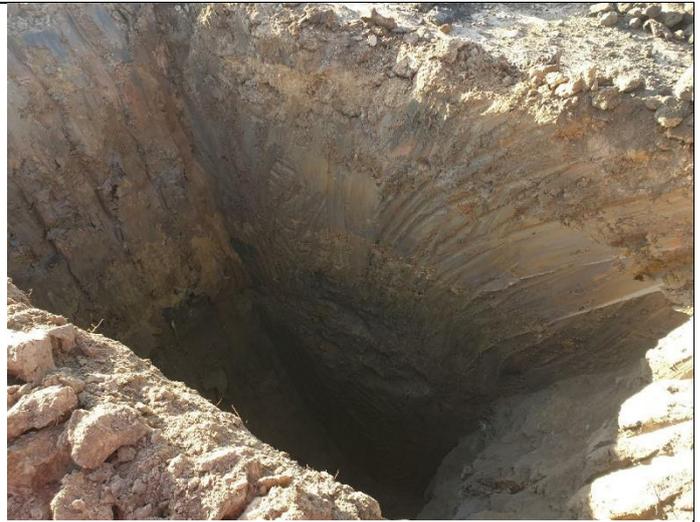
**Photograph 50:** AEC 33 Area East of the Clay Borrow Pit AECBP\_TP11. Foreign material observed.

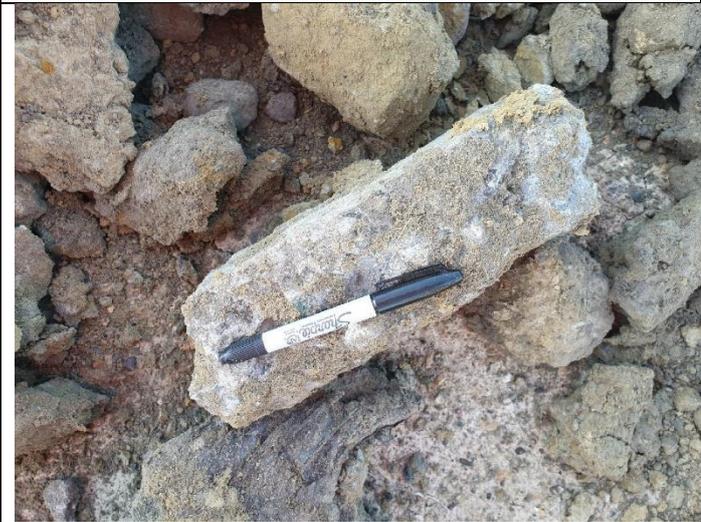
**Photograph 51:** Boulders in test pit spoil AECBP\_TP11.

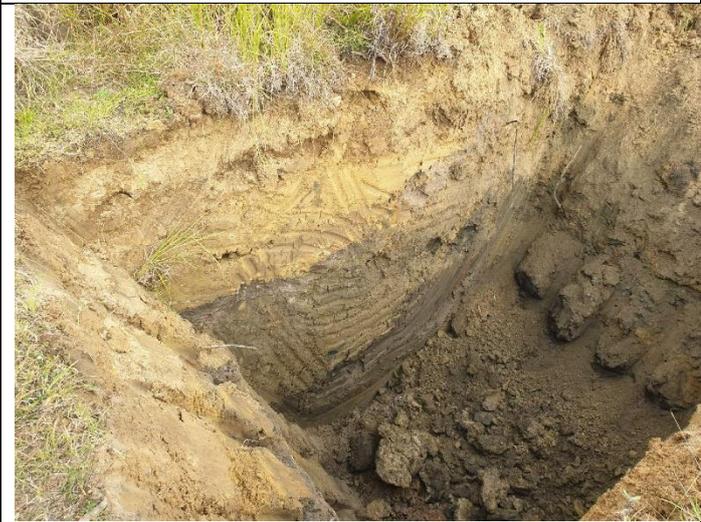
**Photograph 53:** AEC 33 Area East of the Clay Borrow Pit AECBP\_TP13. Foreign material observed.

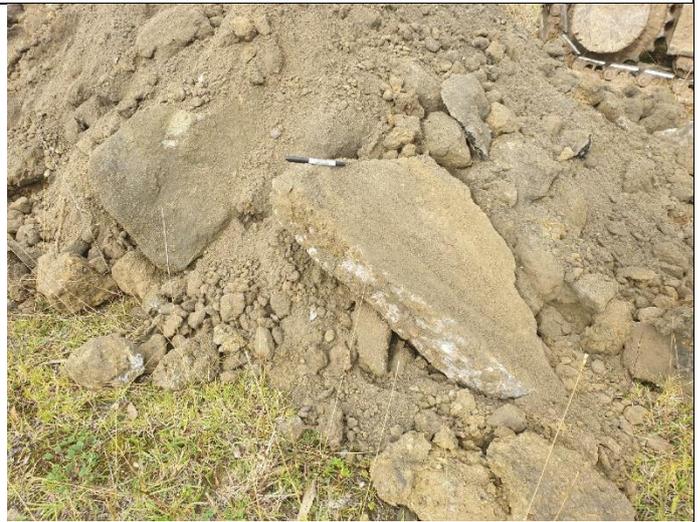
**Photograph 54:** Large Boulders in test pit spoil AECBP\_TP13.

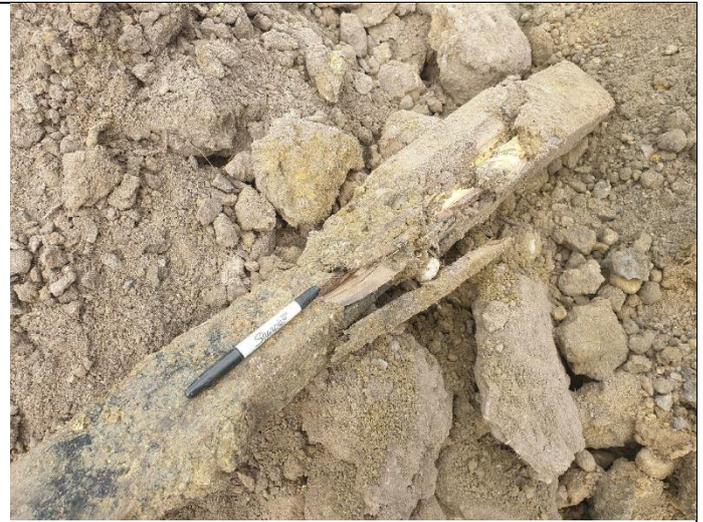
**Photograph 56:** Timber in test pit spoil AECBP\_TP13.

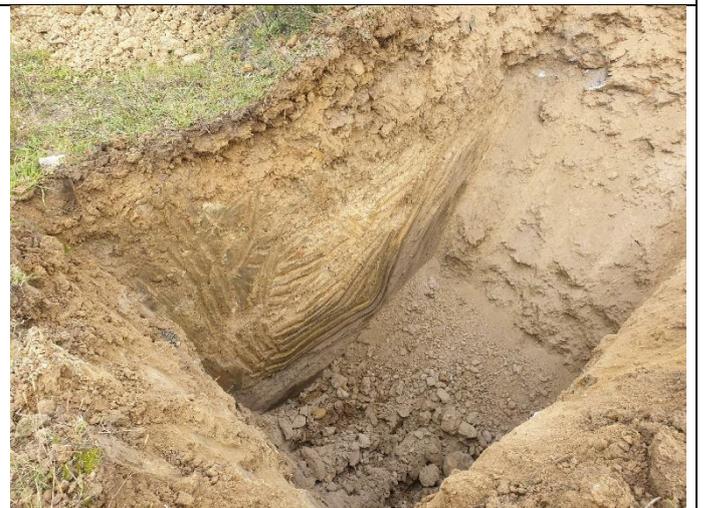
**Photograph 58:** AEC 33 Area East of the Clay Borrow Pit AECBP\_TP14. Foreign material observed.

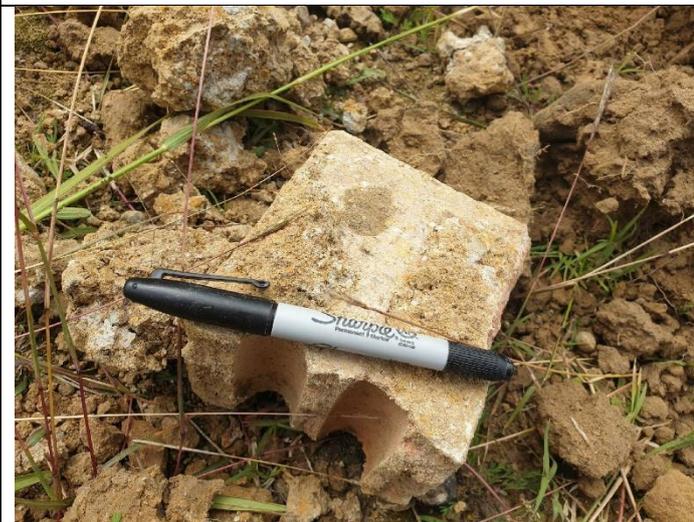
**Photograph 59:** Brick in test pit spoil AECBP\_TP14.

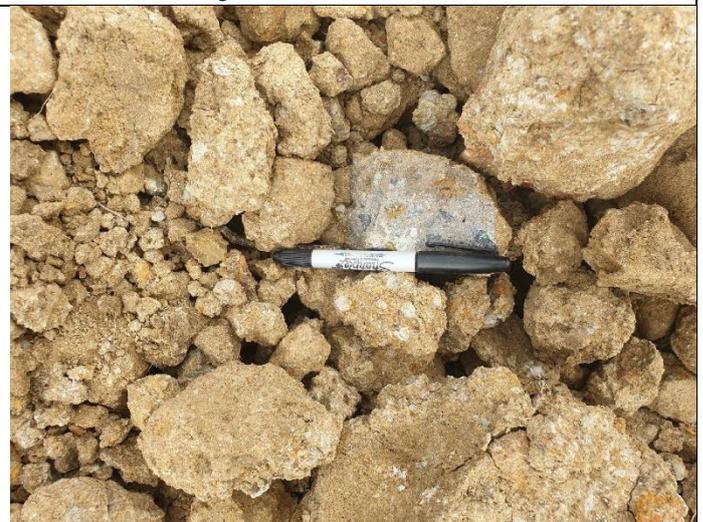
**Photograph 60:** Concrete boulders in test pit spoil AECBP\_TP14.

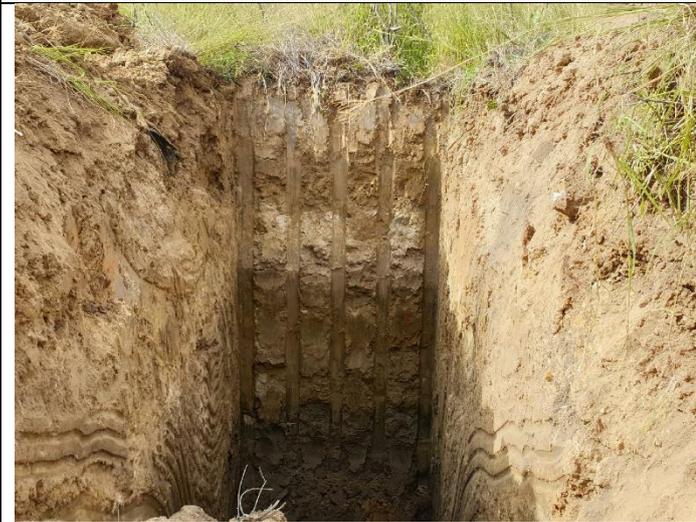
**Photograph 63:** AEC 33 Area East of the Clay Borrow Pit AECBP\_TP16. Foreign material observed.

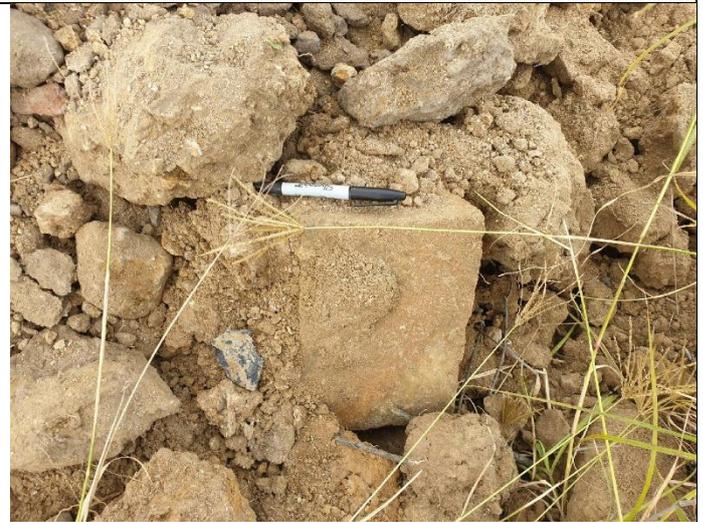
**TP64:** Brick in test pit spoil AECBP\_TP16.
