Validation Report

Clay Borrow Pit Area
Hart Road, Loxford
New South Wales, Australia, 2326

Hydro Aluminium Kurri Kurri Pty Limited

DLH1155_H000638

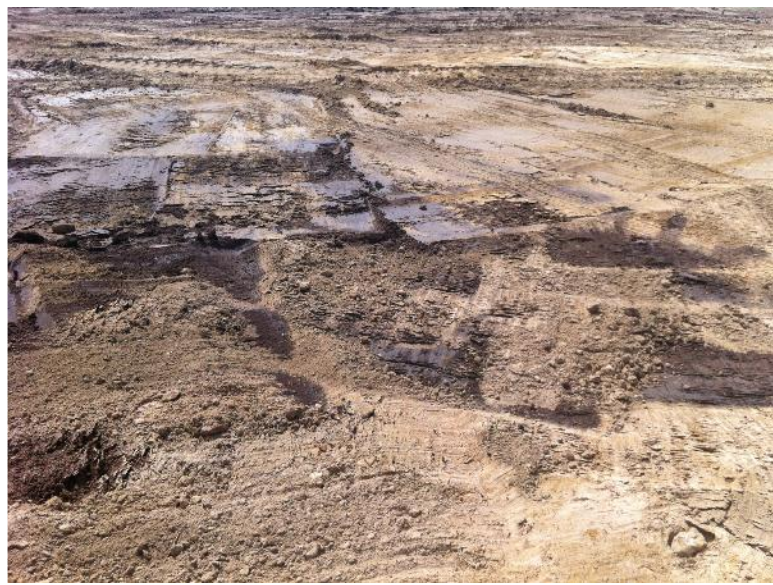
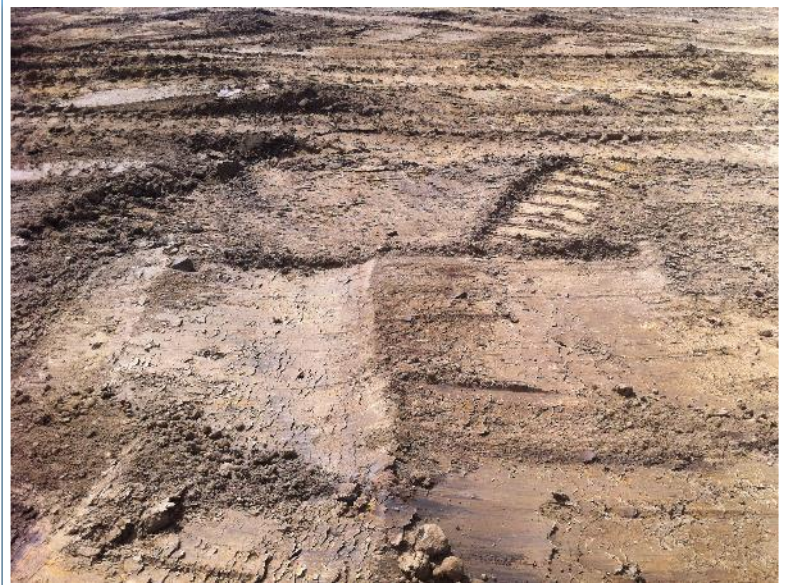
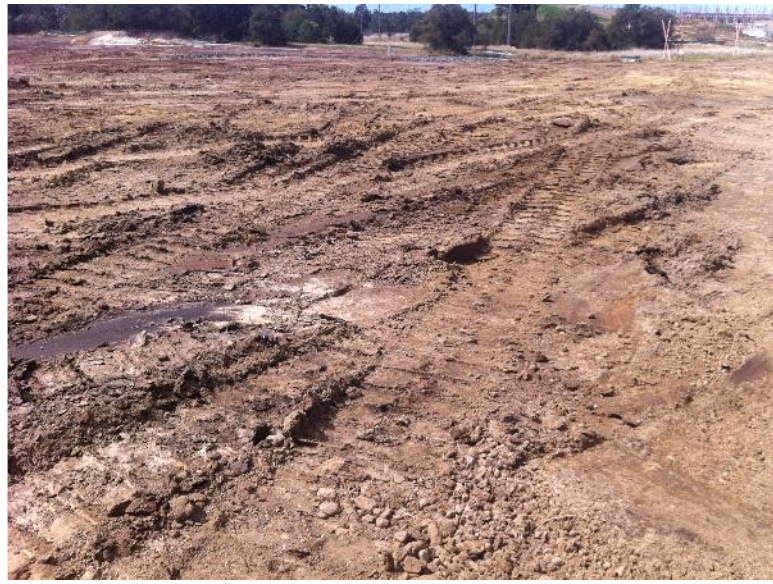
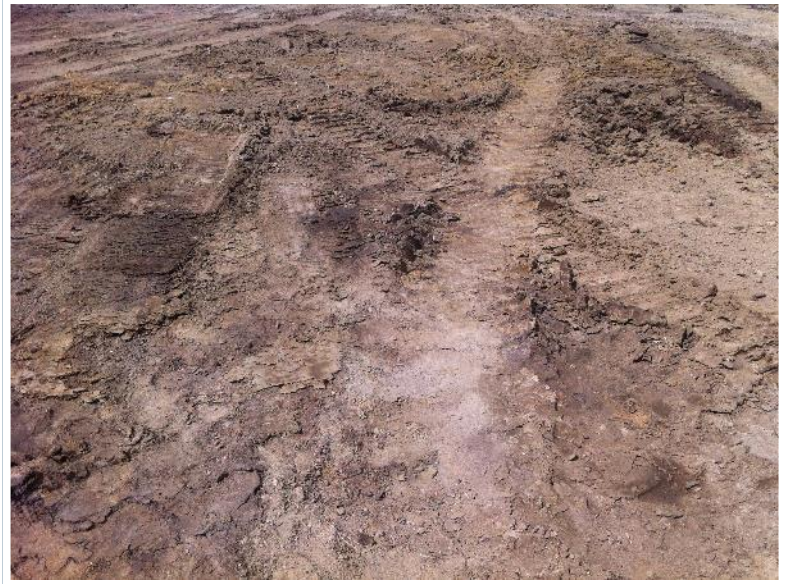
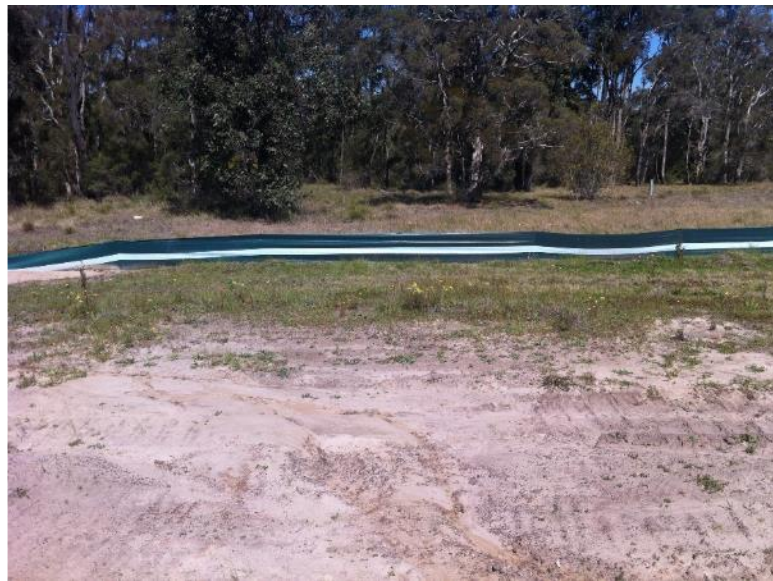
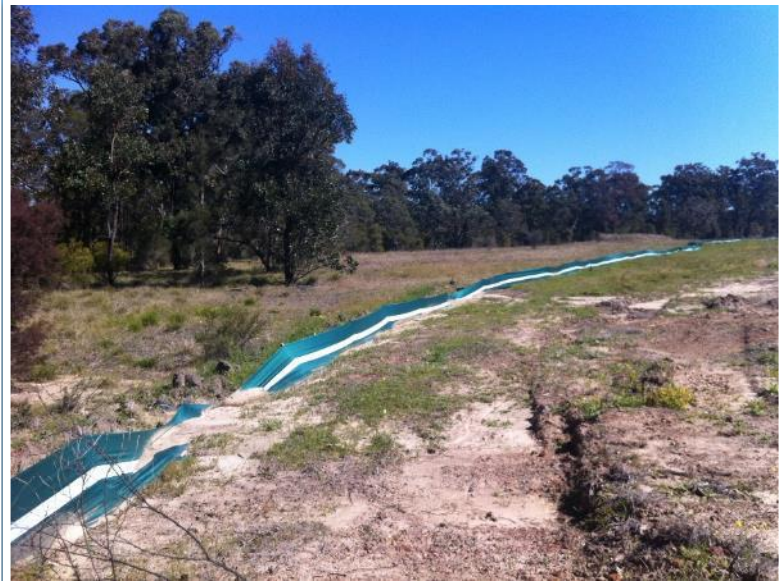
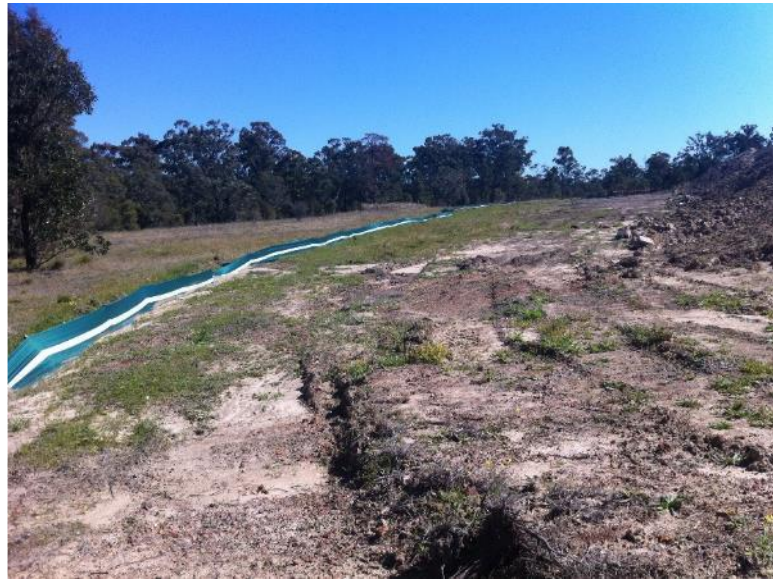
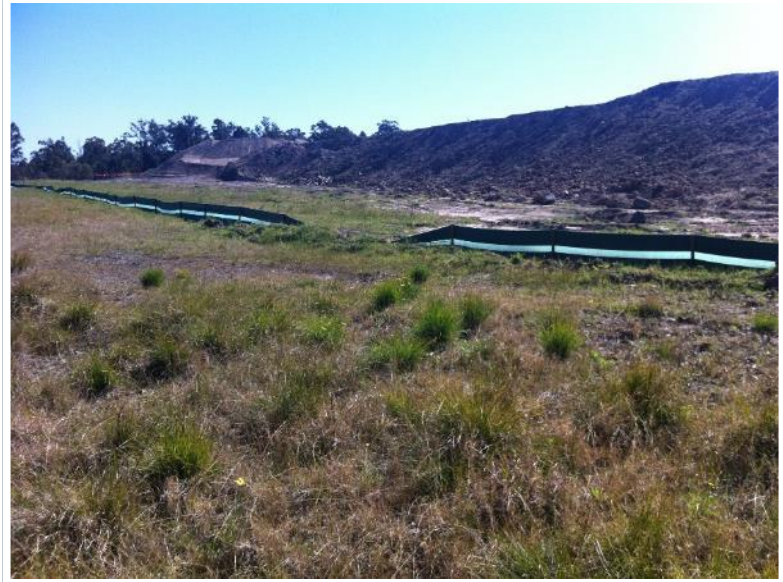
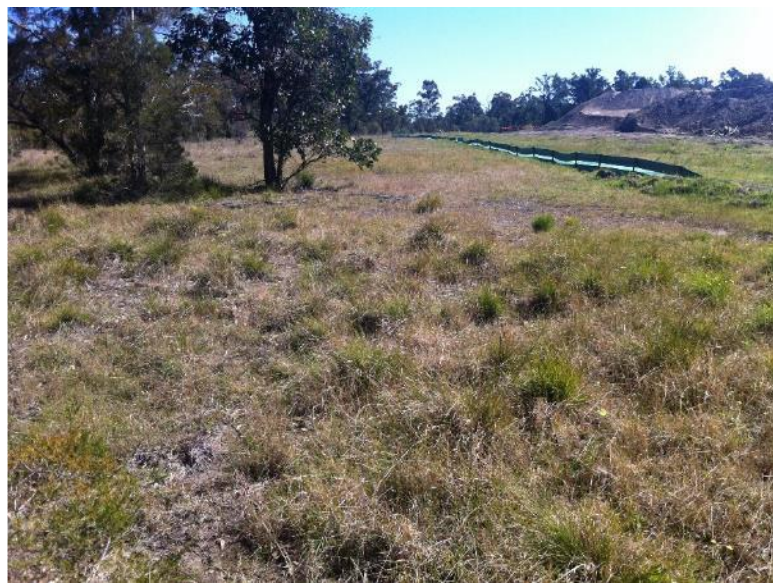
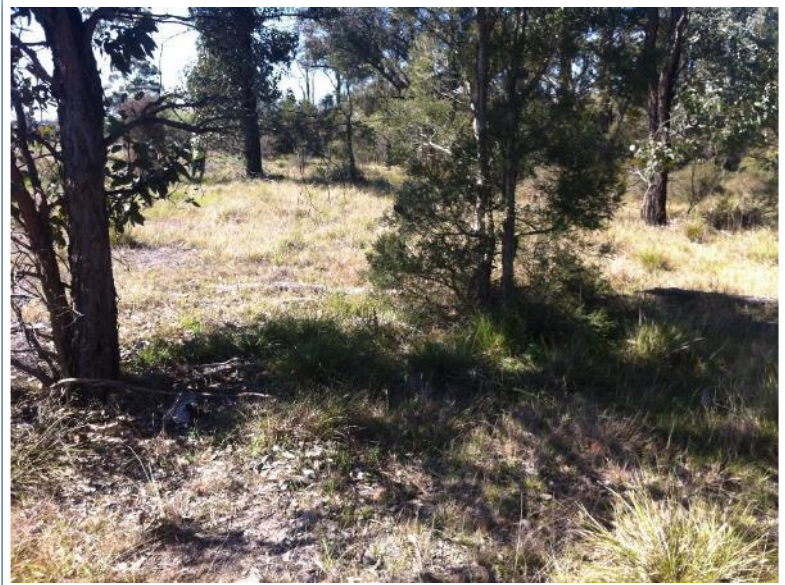
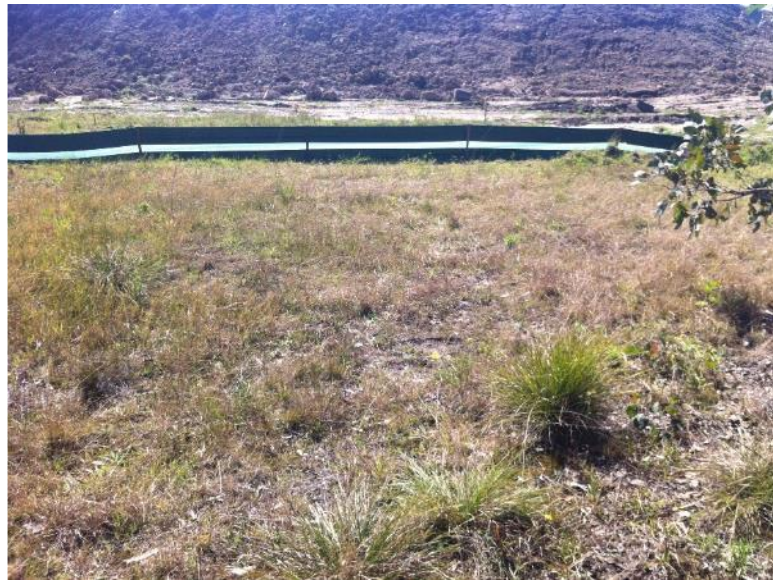
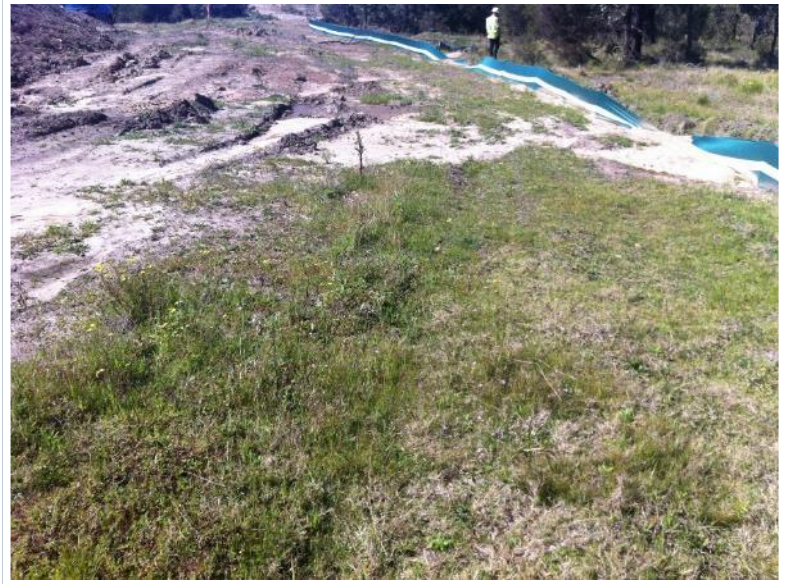
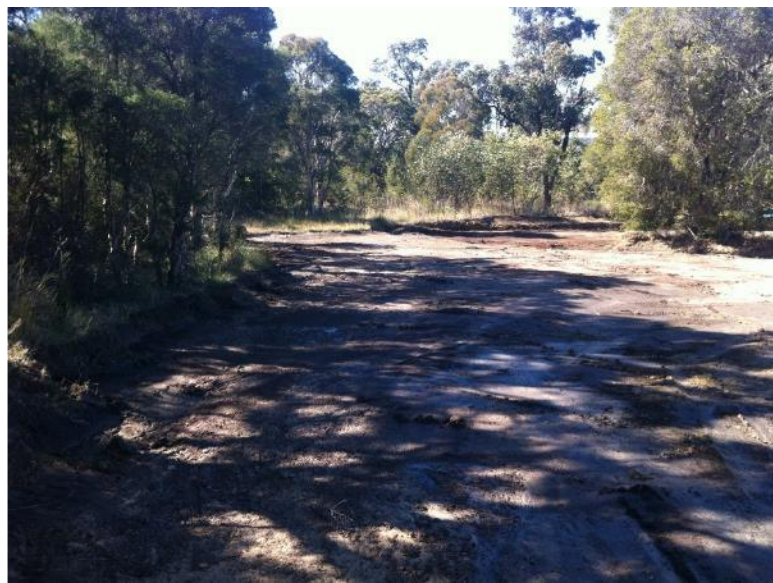
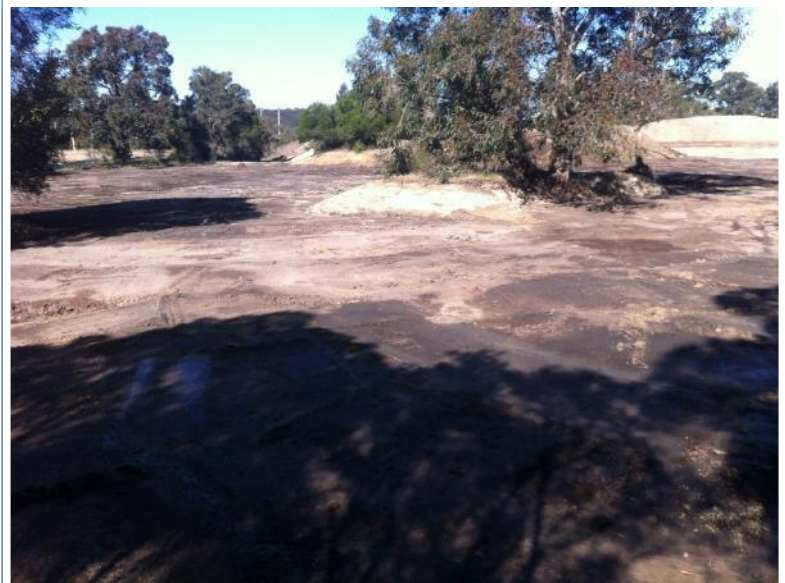
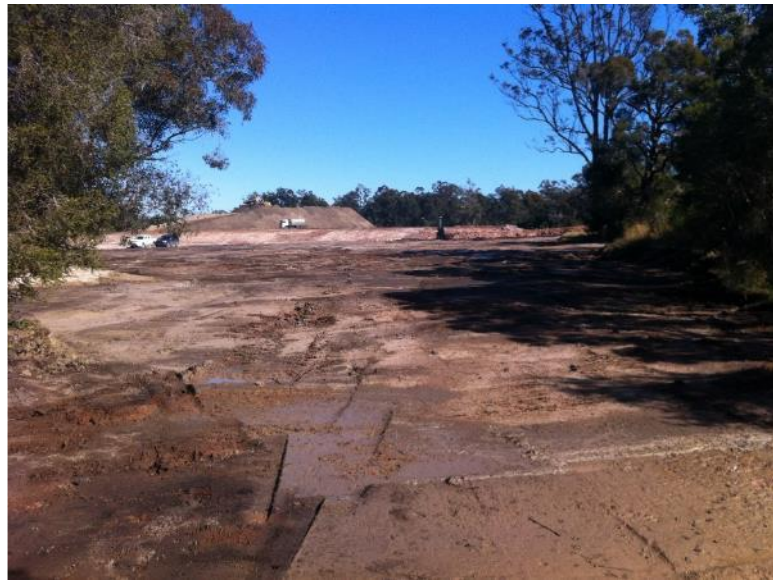
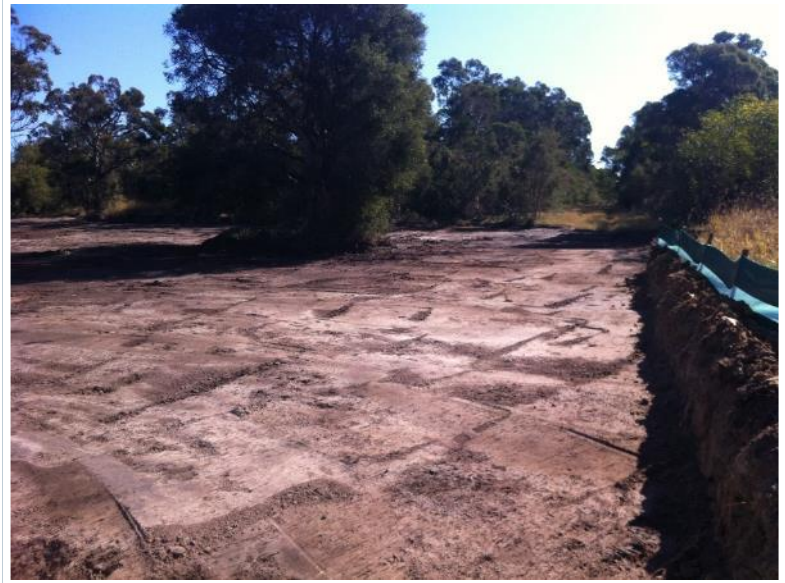
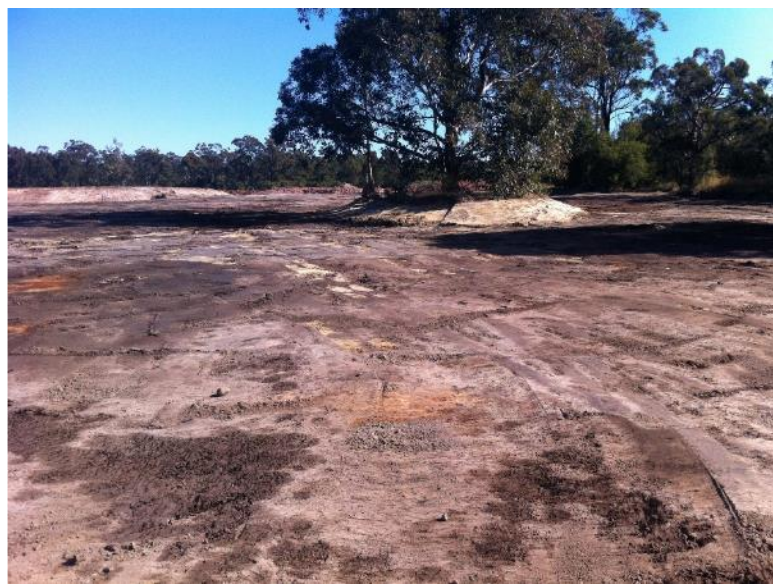
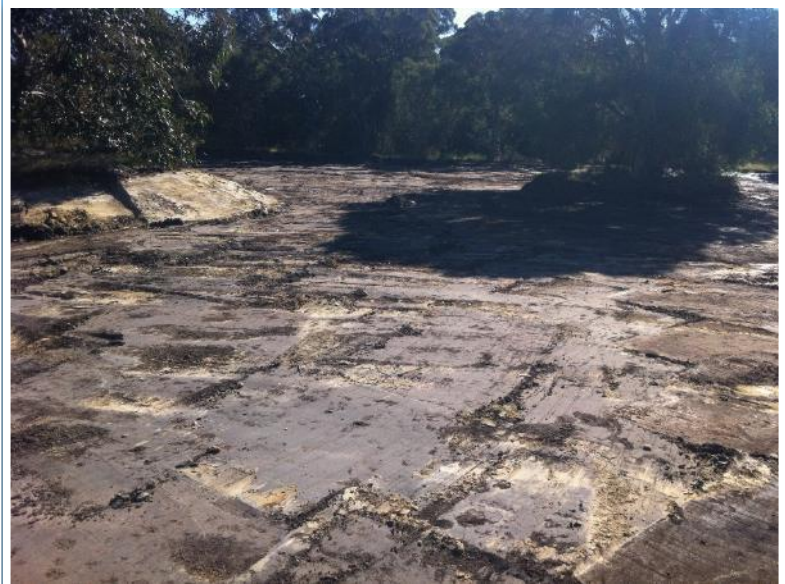
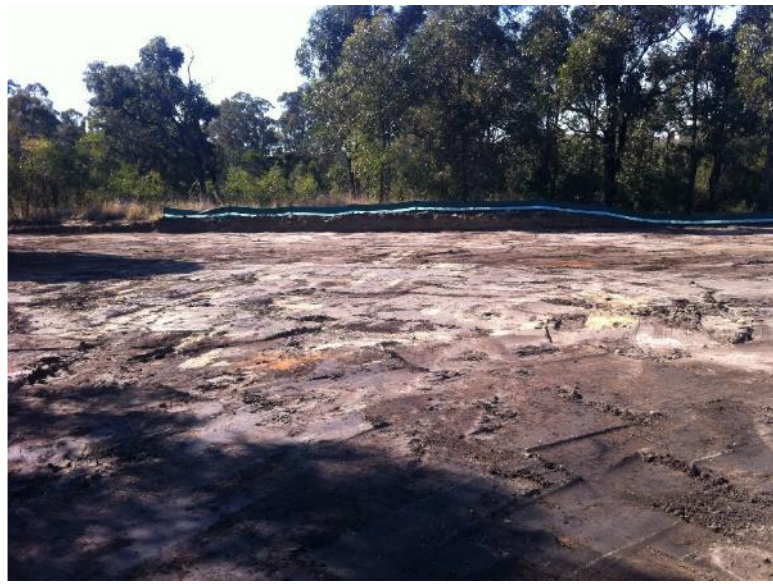
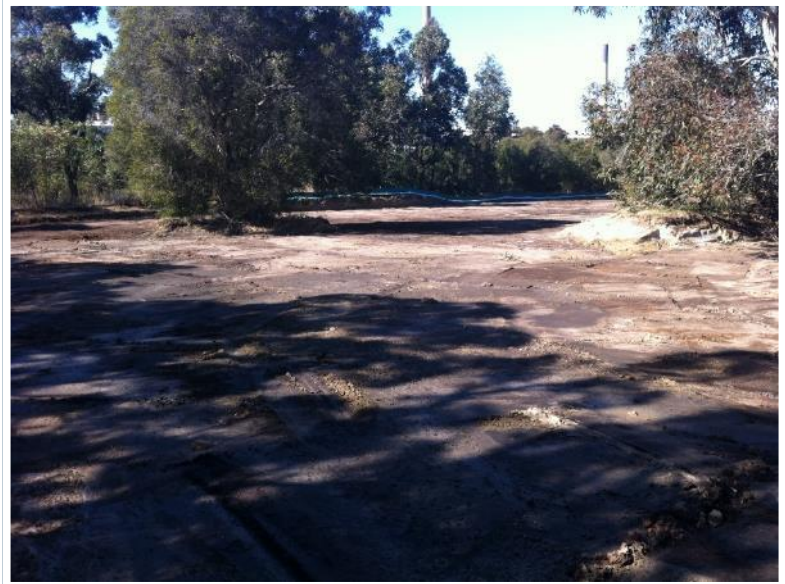
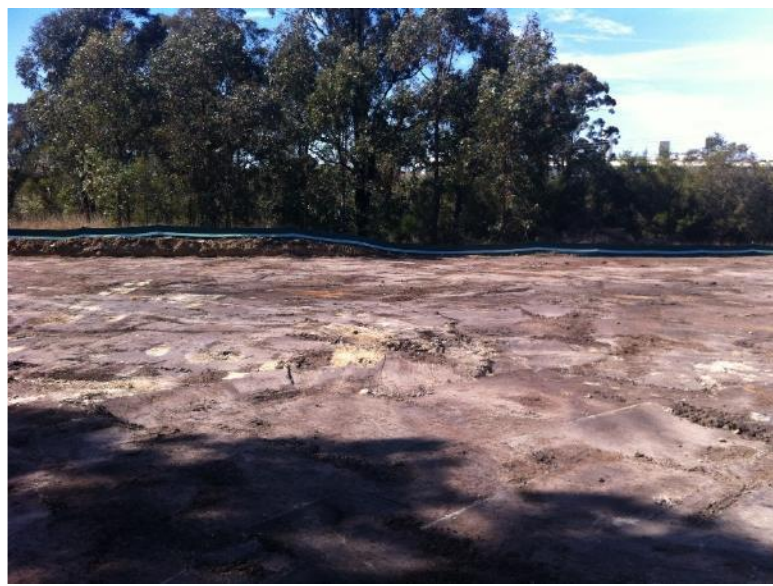
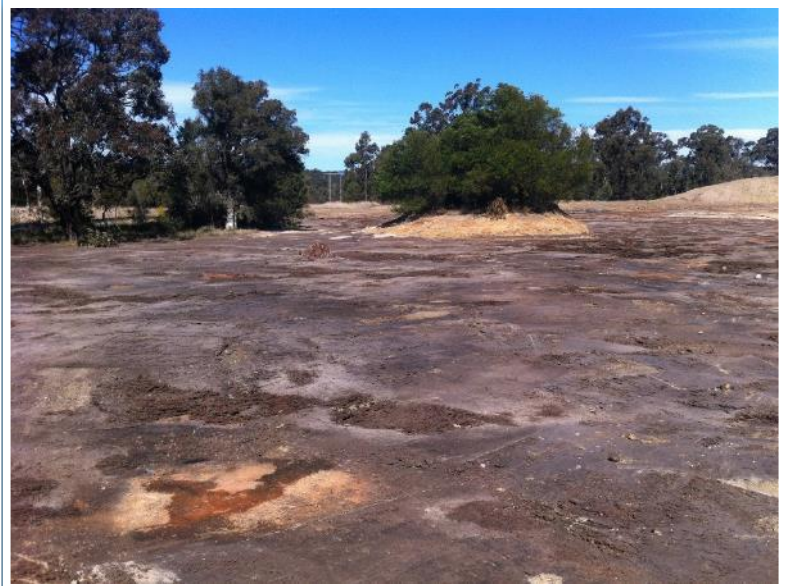
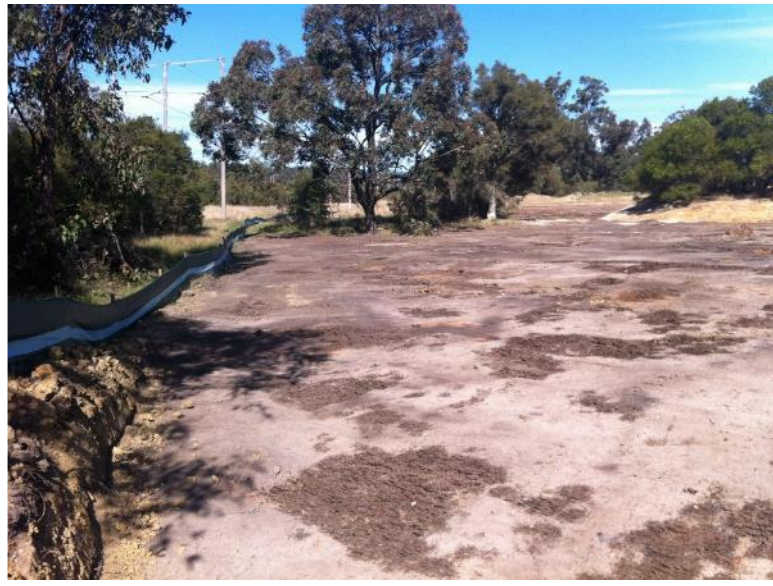
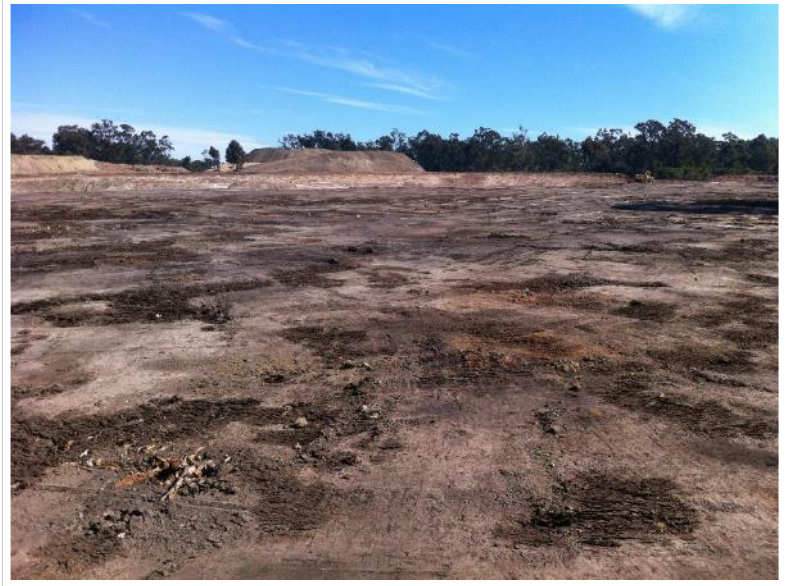
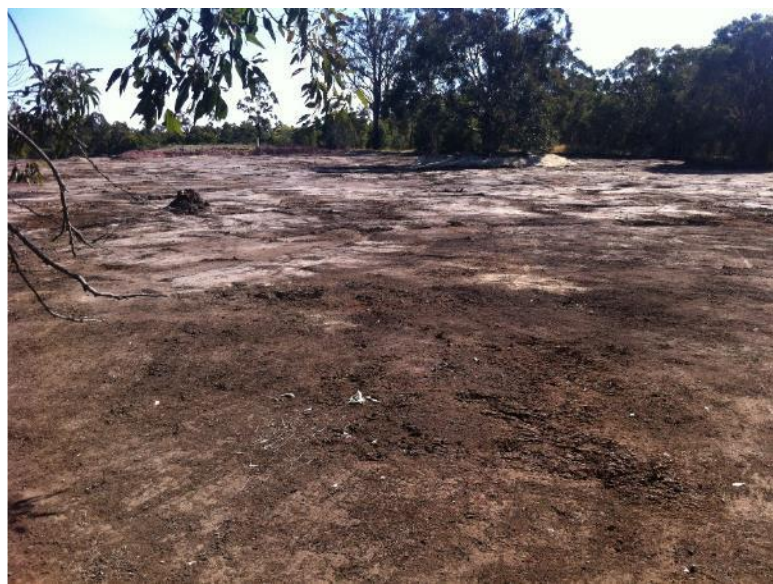
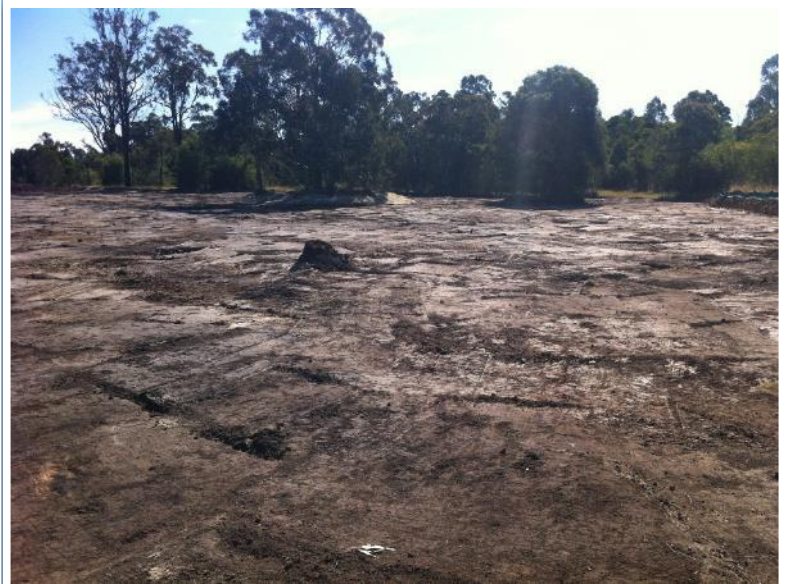
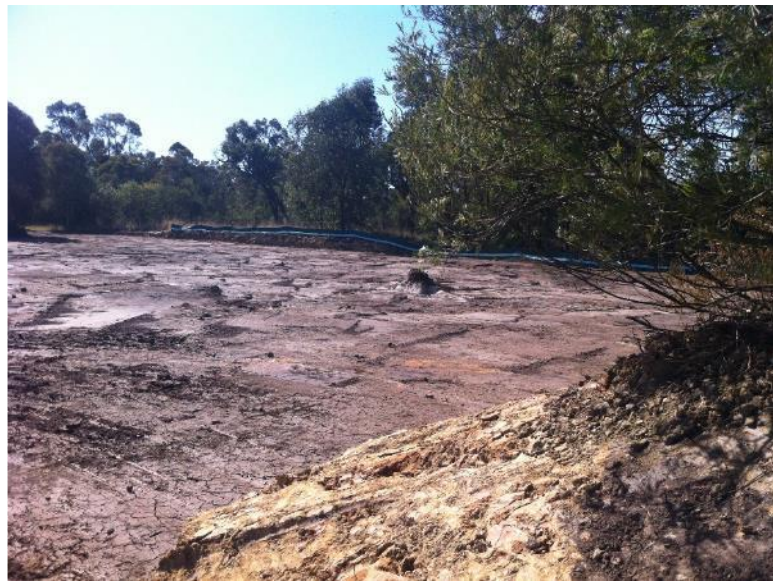
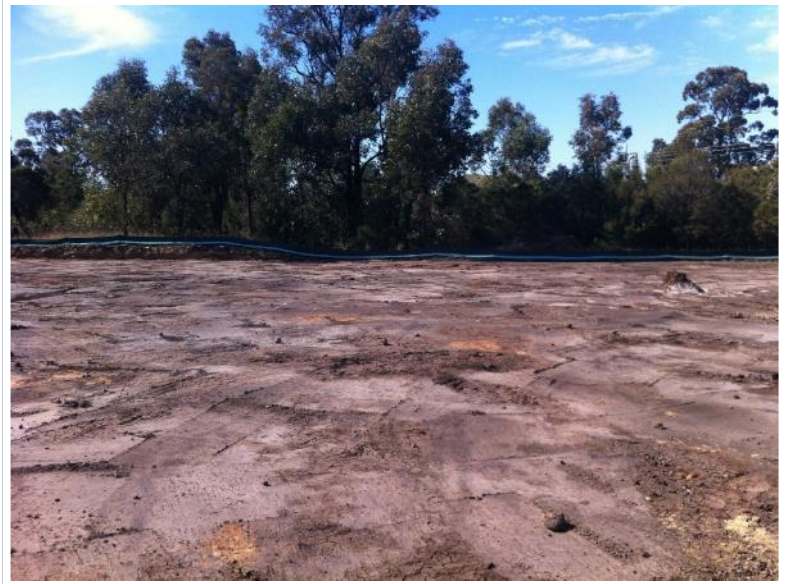
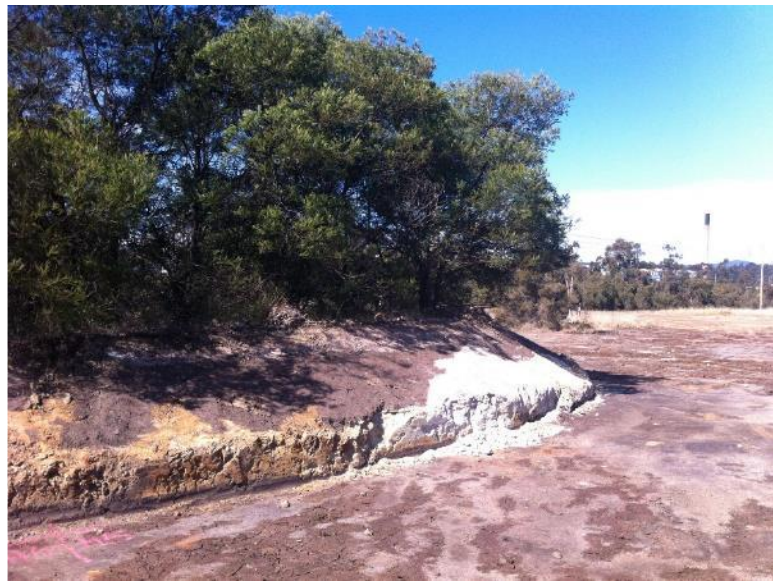
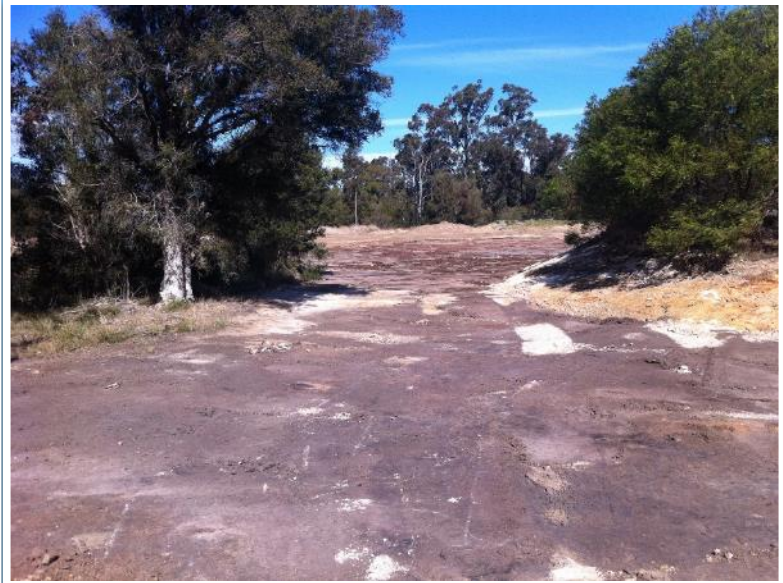
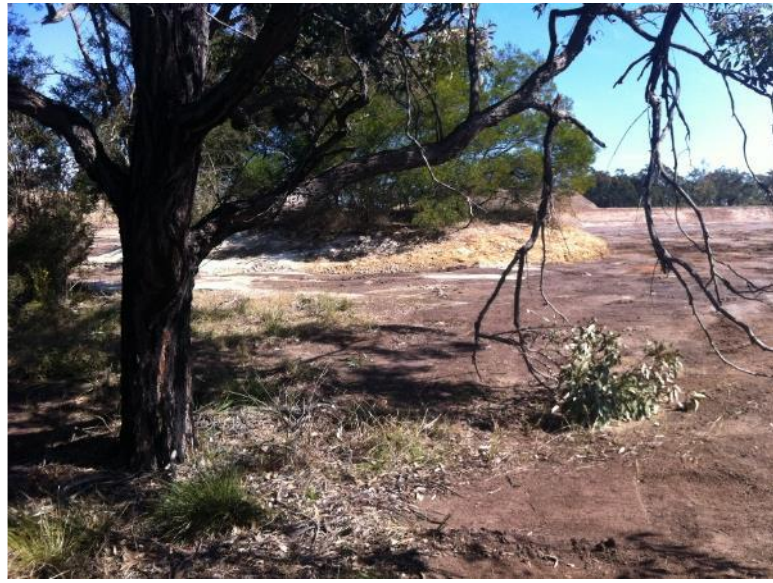
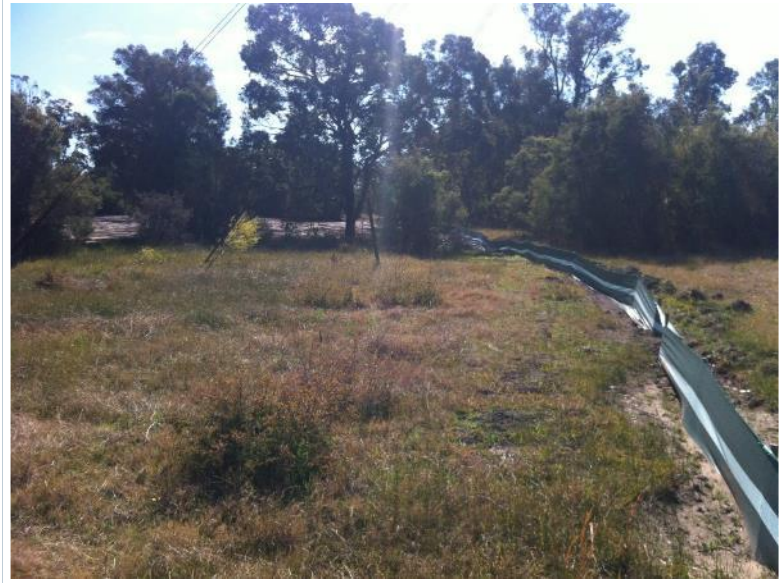
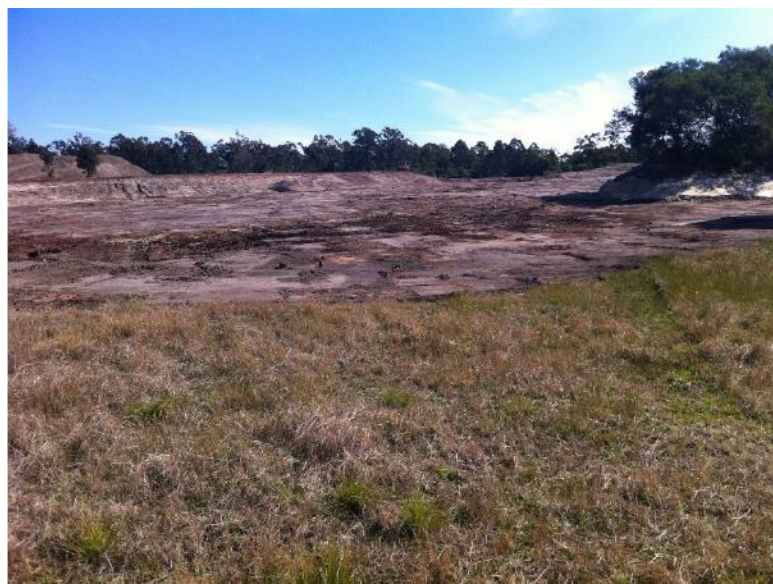
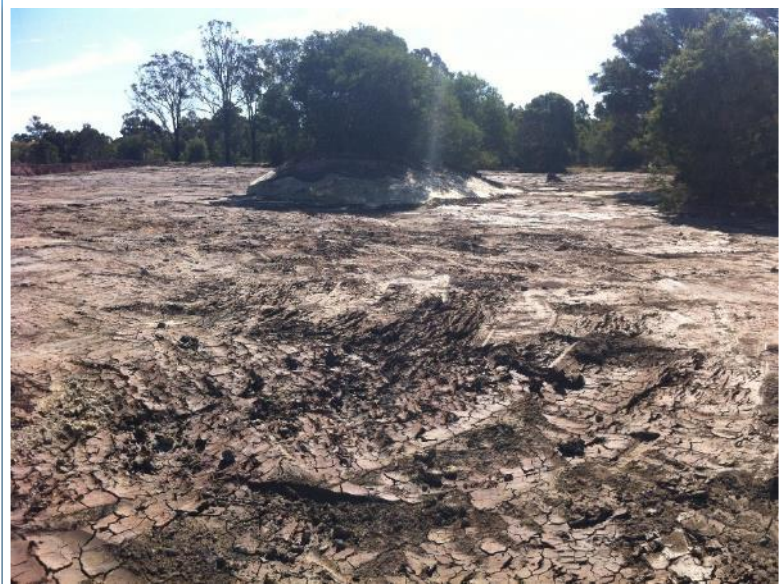
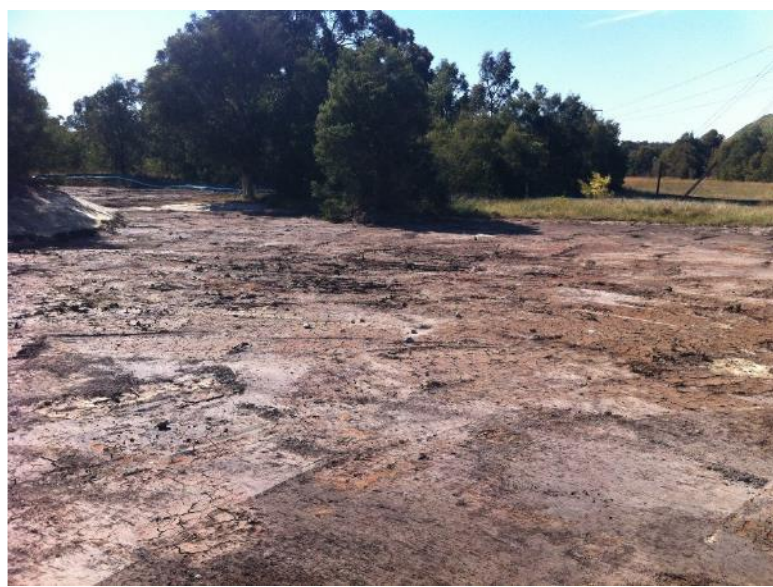
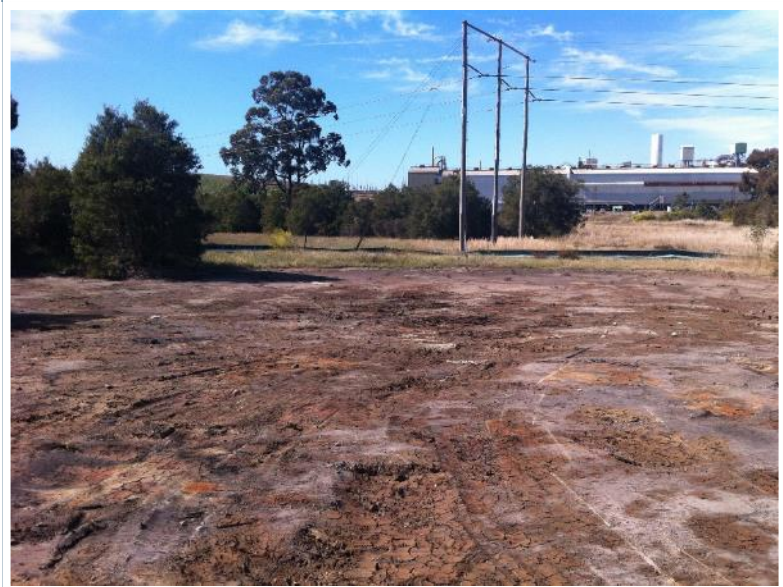
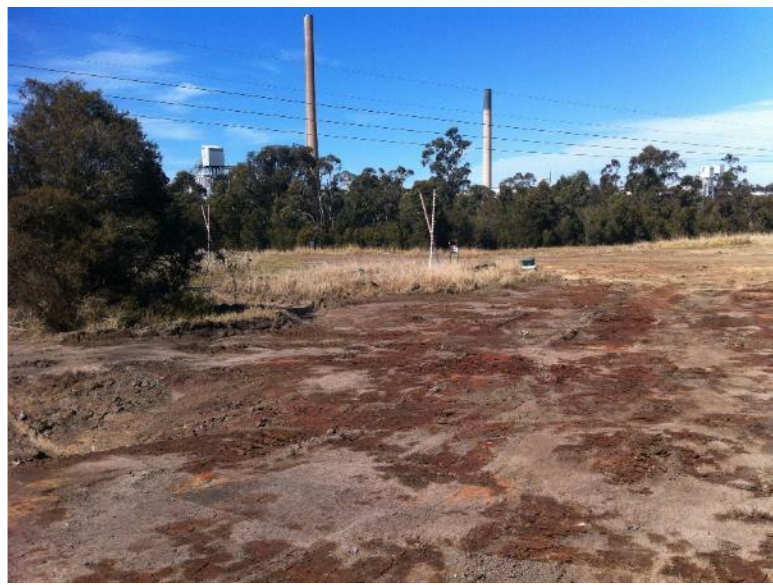
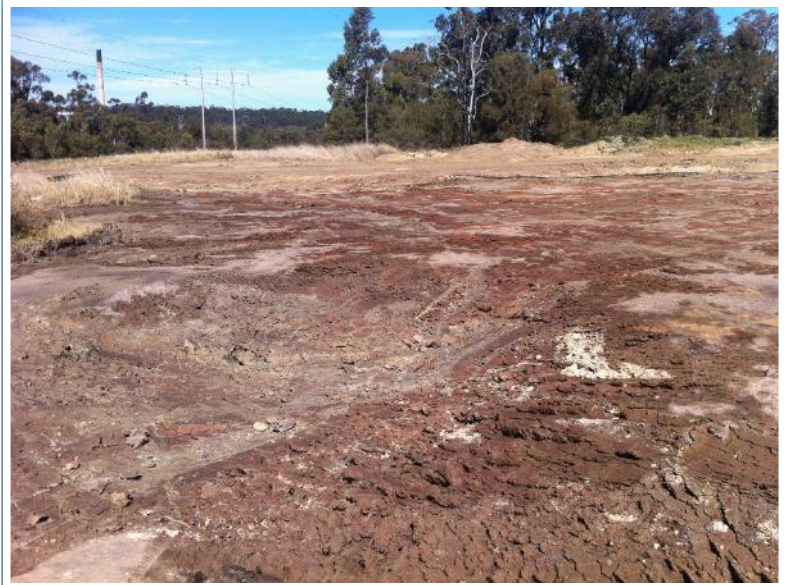
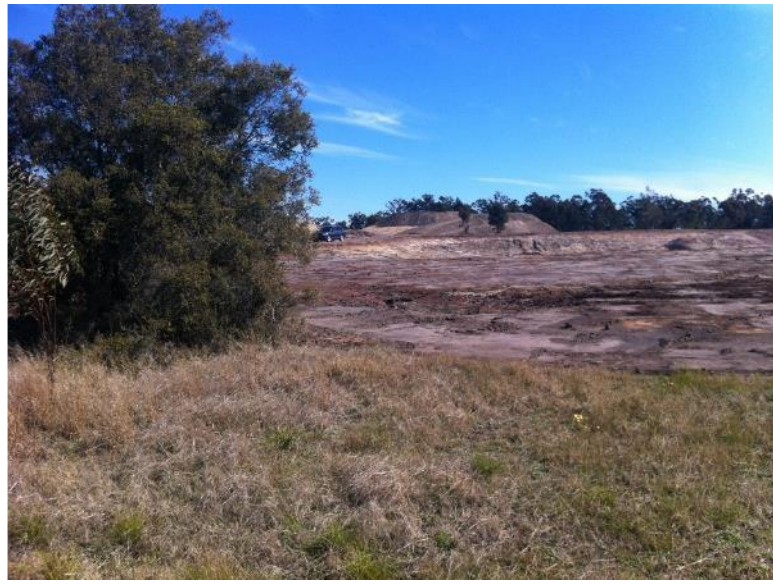
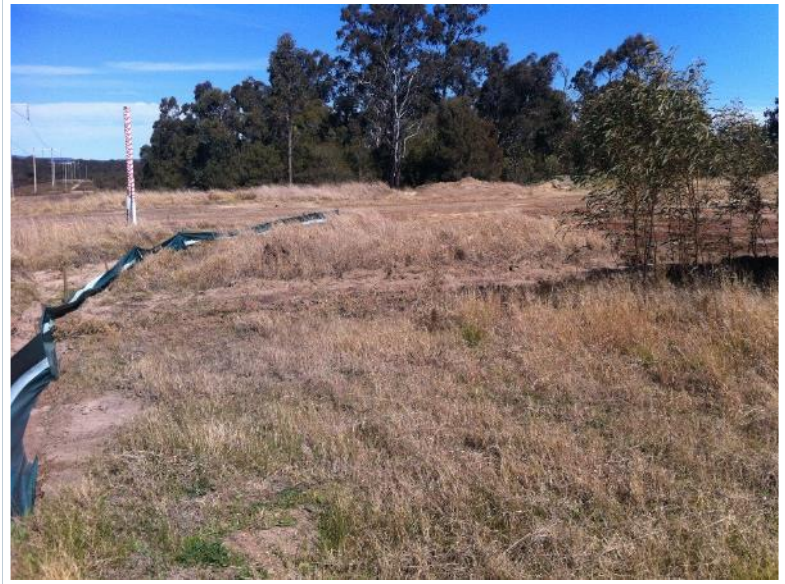
- All grid squares found on this map have photographic evidence provided in the following gallery except for those completely vegetated and considered to be outside of the required scope of works.

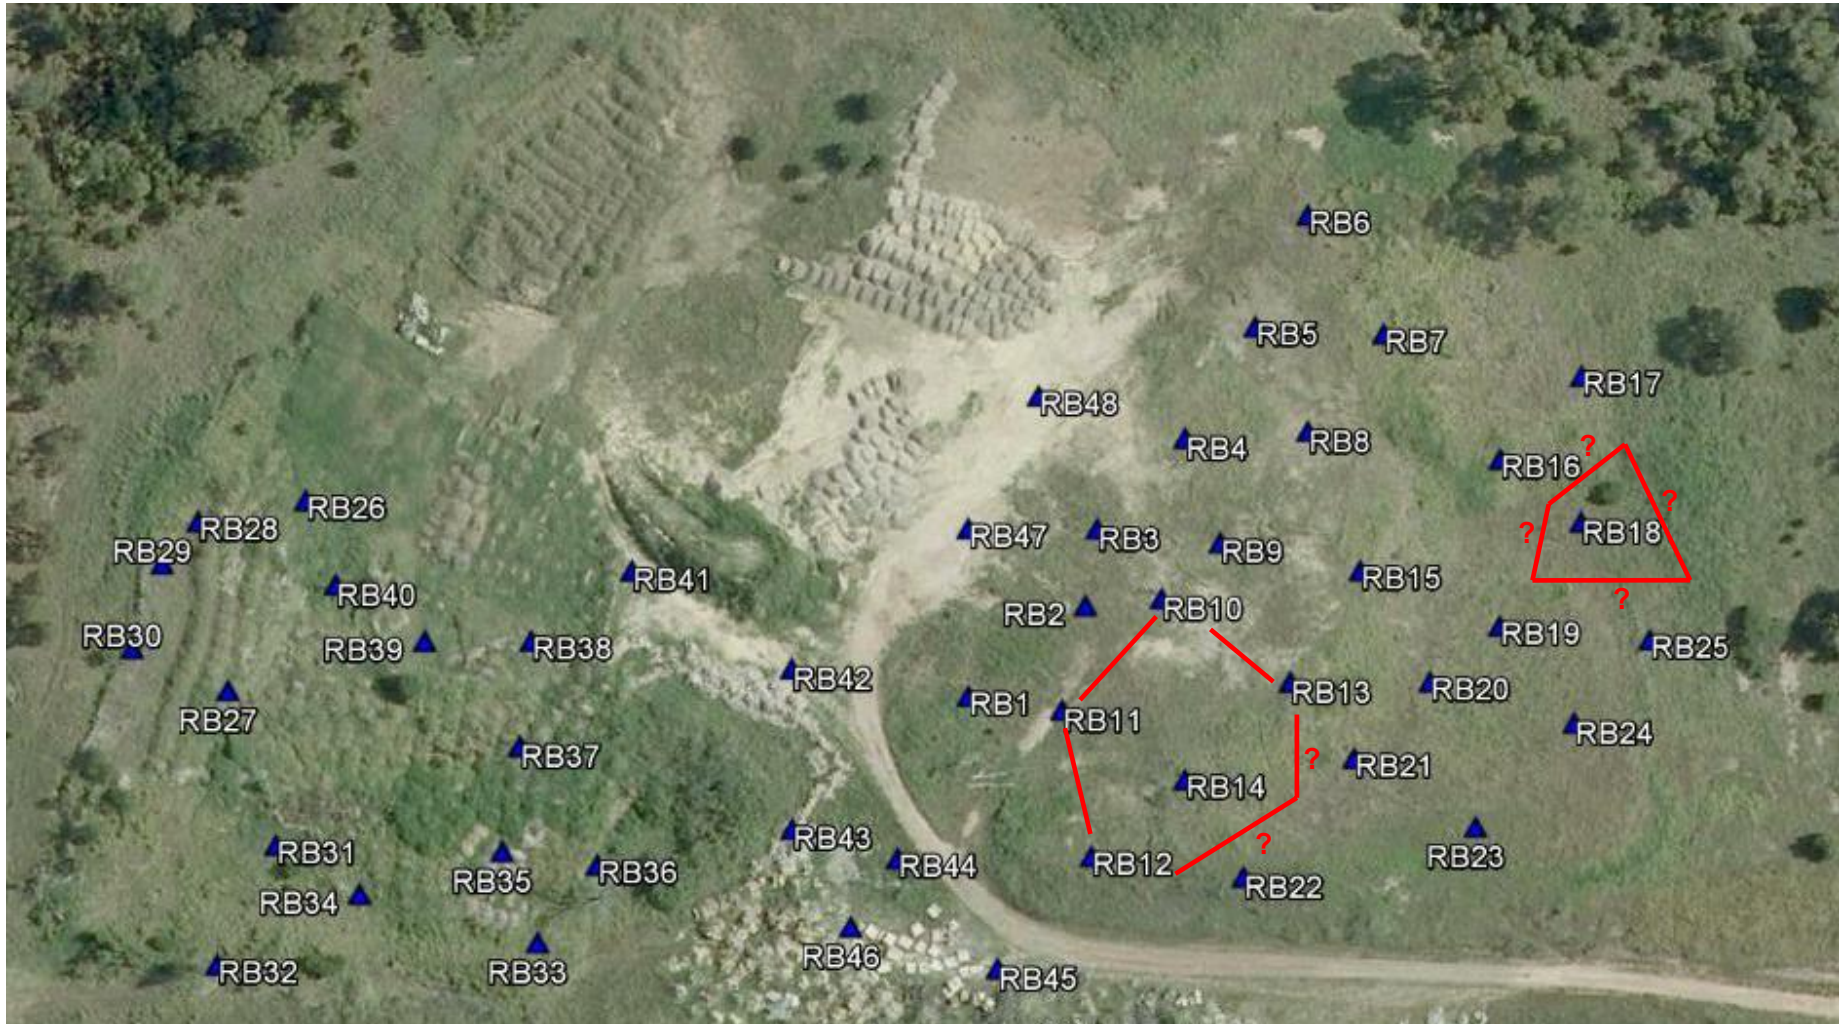
Specific Exemption
 criteria exceedence
 ? Extent of
 exceedence
 unknown
 Approximate
 Scale 1cm: 20m
