2019 ANNUAL WASTE MANAGEMENT REPORT
HYDRO ALUMINIUM KURRI KURRI SMELTER

Prepared By: Kerry McNaughton
Environment Manager

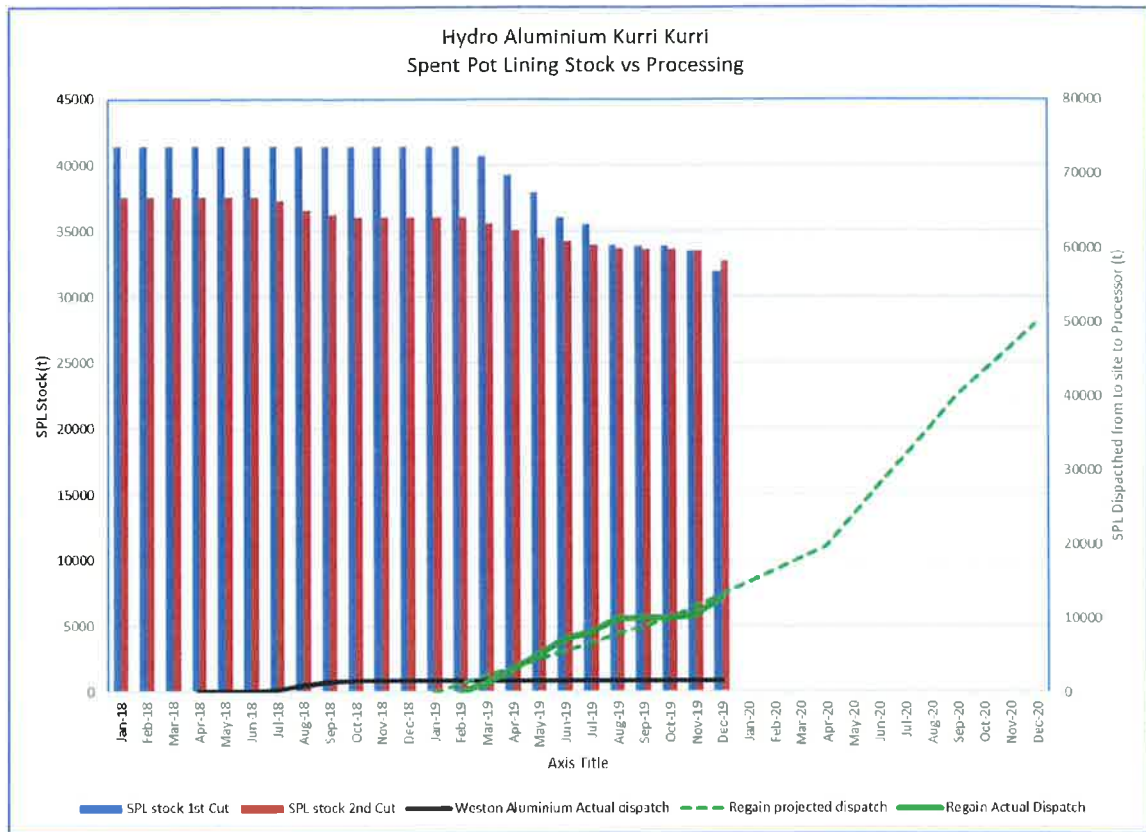
Figure 1: SPL Recycling status

At the beginning of 2019, the SPL stock at Hydro totalled 75982t. During 2019, 12855t have been dispatched off site for processing, resulting in a final stock level at the end of 2019 of 63127t.
